Department of Defense Legacy Resource Management Program

PROJECT 05-106

Conservation of the H.L. Hunley and its Associated Artifacts

March 1, 2006

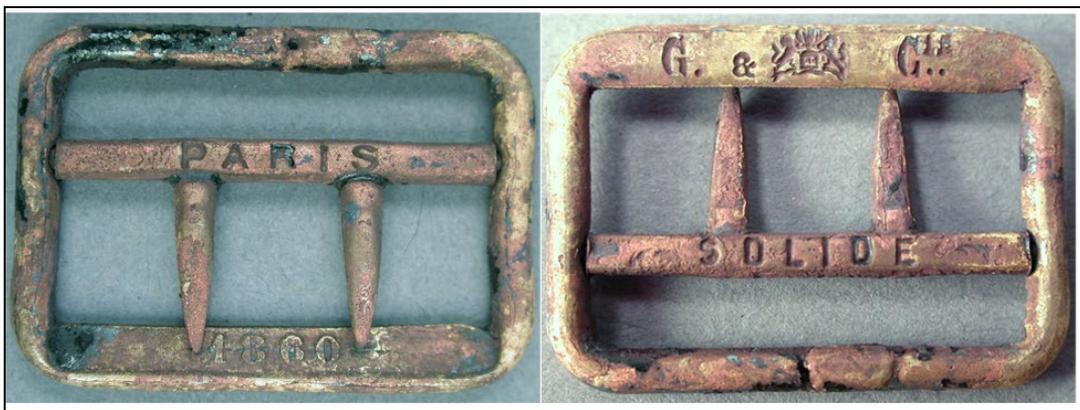
Figure 1: Copper-alloy buckle HL-3336 following conservation.

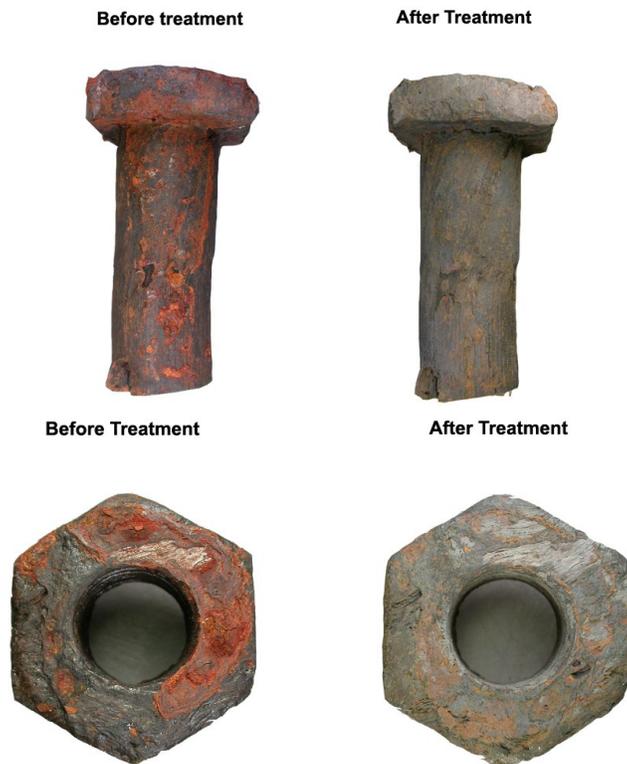
Figure 2: Spar nut (HL-502) and bolt (HL-511) before and after sub-critical treatment.

The technique is based on the use of sub-critical water solutions as the media for the removal of Cl^{-1} from cast and wrought iron. By definition, sub-critical water is water at requisite pressure and heated to a temperature between 100°C and the critical temperature of water, 374°C . In the sub-critical region, the transport properties of water as a solvent media exist between those of liquid H_2O and supercritical H_2O . The hypothesis for this investigation states the employment of sub-critical water solutions could dramatically increase Cl^{-1} removal efficiency and significantly reduce treatment times. As evidenced in Figure 2, project conservators effectively used the technique to treat the nut (HL-502) and bolt (HL-511) that once held the submarine's spar assembly to the bow. Following sub-critical treatment, each artifact's exterior surface was cleaned with a low pressure, 50-micron sodium bicarbonate micro-abrasion unit.

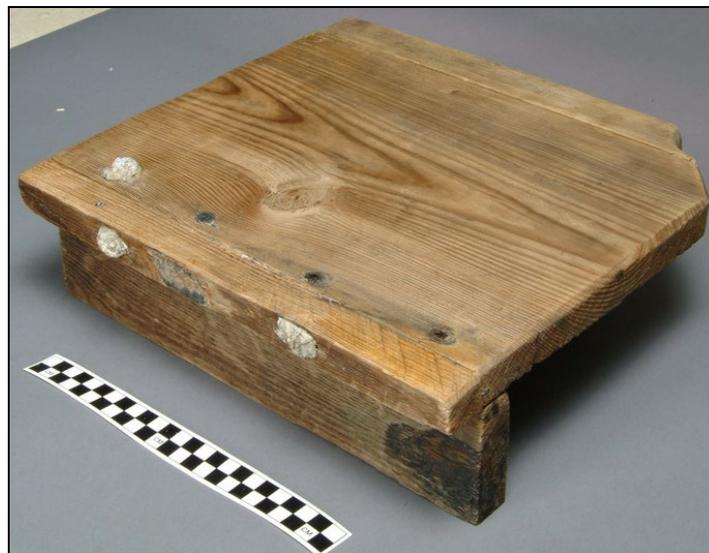
Figure 3: Lt. Dixon's seat (HL-1973) following treatment.

Lt. Dixon's three-piece wooden seat (HL-1973) was cleaned, impregnated with polyethylene glycol (PEG) and subsequently vacuum freeze-dried (Figure 3). Of the wooden matchstick assemblage, several examples exhibited carbonized ends. These were successfully cleaned and conserved, as were the numerous wooden and cork stoppers associated with the crew's individual canteens.
