**Backup Data for
A Case Study of the Adaptive Rehabilitation
of
Buildings 705 and 706
Norfolk Naval Shipyard**

Norfolk Naval Shipyard

**United States Navy
NAVFAC MIDLANT
N40085-10-D-9426**

**DUTTON + ASSOCIATES, LLC
812 Moorefield Park Drive, Suite 126
Richmond, Virginia 23236**

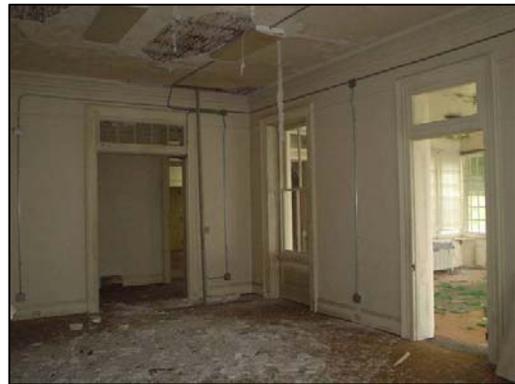
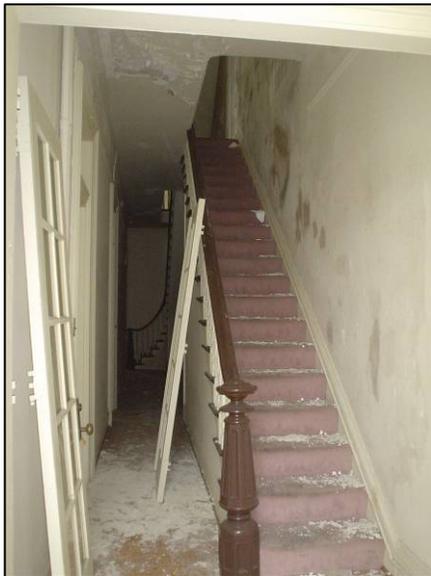
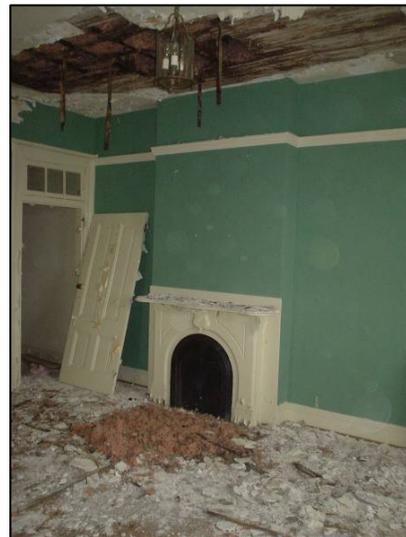
An inspection of the buildings by the project team prior to the design process revealed extensive moisture damage to both the exterior and interior of the buildings. Gutters and drains had become clogged creating standing pools of water against the foundation at ground level, and on flat portions of the roof. Water from the roof had leaked in causing damage to interior features such as the plaster ceilings and walls, wood trim, doors, windows, and sections of floor. The numerous wood frame porches and additions that were not constructed as sturdily in the first place were especially deteriorated. Conditions were worsened by

Representative photographs of the building interiors at the time of inspection

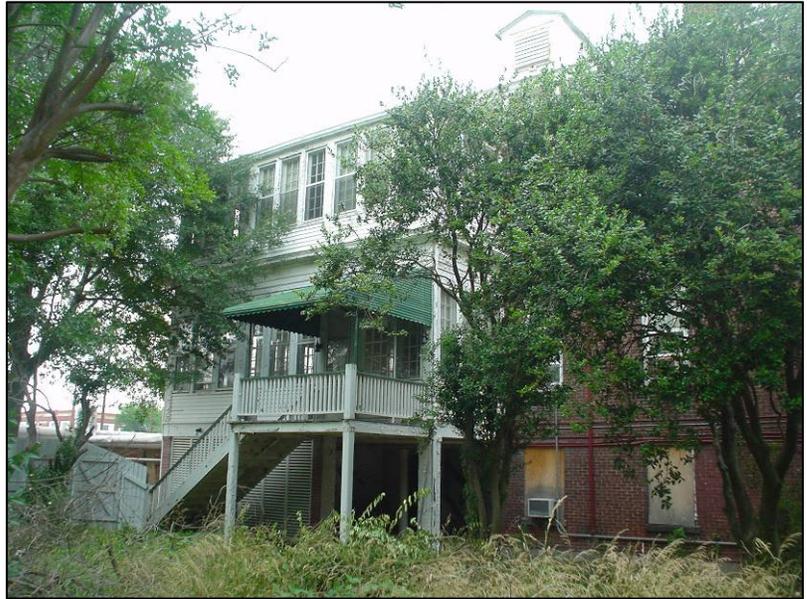
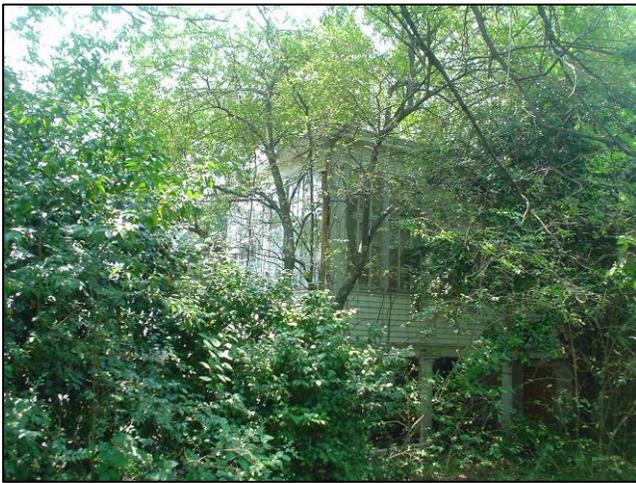
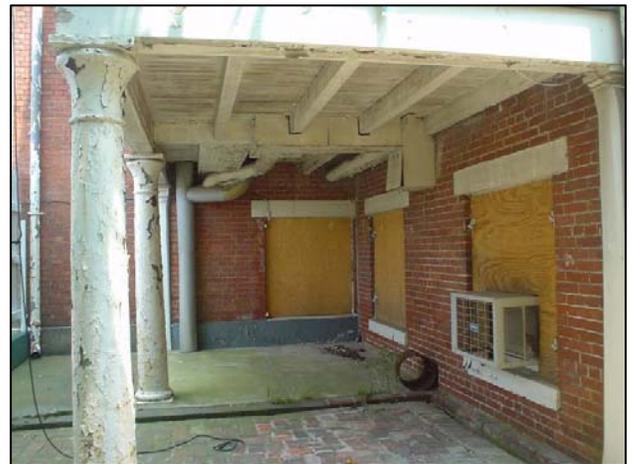
Representative photographs of the building exteriors at the time of inspection

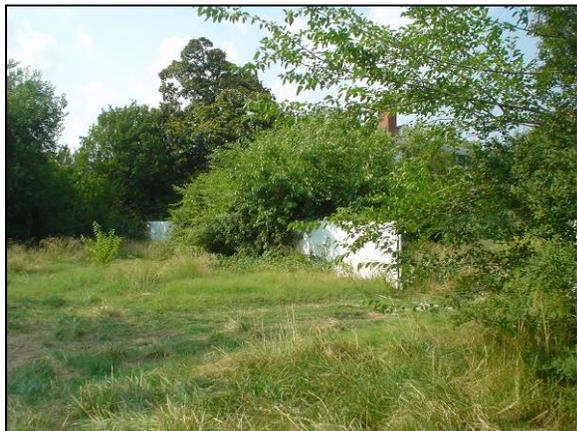
Overgrown vegetation around project site

All of the existing landscaping was removed at the outset of the project. The majority of vegetation was overgrown and causing problems to the buildings themselves and would not meet ATRP requirements. Most of the brick walkways and trench drains had settled unevenly and were trip-hazards in addition to preventing access to existing and proposed underground utilities. Following grading, utility installation, and other site work, new walkways were installed using salvaged bricks and appropriate vegetation was planted. The trench drains were not reinstalled because they were no longer necessary with proper grading.

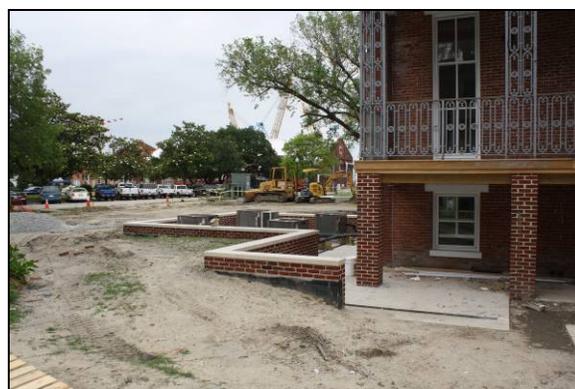
water level. While the site is now dry, the land was not graded properly to allow adequate draining away from the buildings, and during periods of heavy rain, runoff would drain directly towards the building foundations, especially to their rear. This was corrected by bringing in additional fill to slope ground away from the structures. Because fill could not be placed immediately up to the buildings' foundations because of doors and windows at ground level, a retaining wall had to be built around the perimeter of the rear of the buildings to place fill against. The area between the knee walls and the buildings was then paved with drain systems installed.

*Retaining wall around the perimeter of
Building 705*

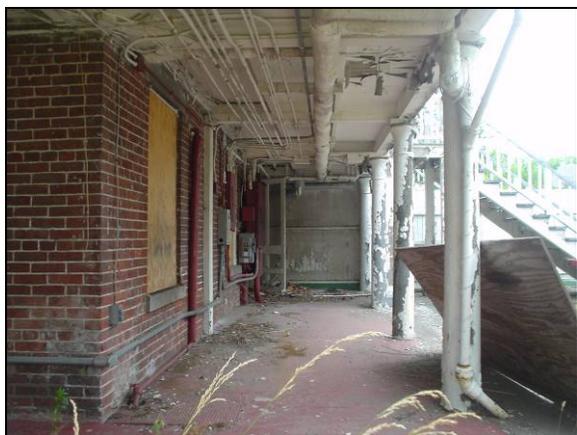
One material that was completely abated from both buildings was asbestos. Asbestos was found in pipe insulation, floor tile, window glazing, and roof tar. Fortunately, many of these elements were being removed from the buildings anyways so the abatement did not cause significant increases in time or money.

Numerous lead and asbestos pipes beneath porches

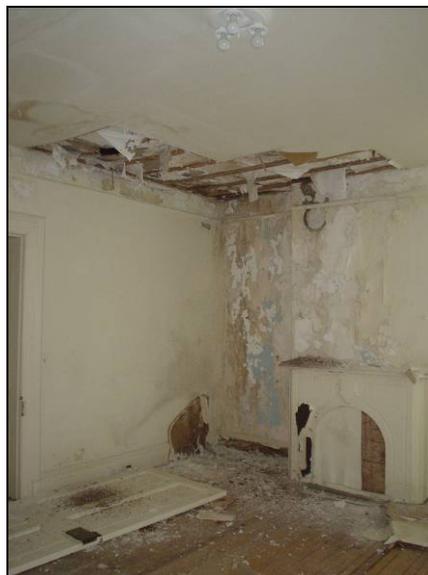
Excessive mold and mildew growth caused by moisture infiltration was present and had to be abated from both buildings. Correction involved sealing the roofs and ventilating the basements to decrease future moisture levels.

Moisture infiltration with mold and mildew

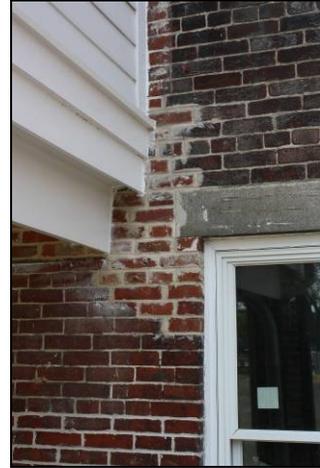
Repairs were also made to the above-ground brick structural system to correct shifting and cracking bricks and repoint sections of soft and crumbly mortar. Many of the wooden door and window lintels were deteriorated and required repair to ensure that no additional brick movement could occur.

*Section of repaired
and repointed brick*

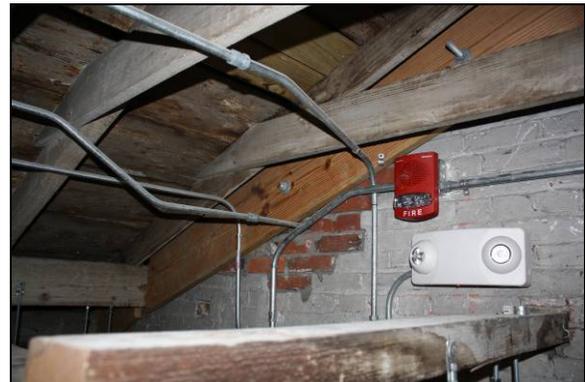
The interior structure of the building required repair as many of wooden joists, beams, girders, and studs showed signs of termite and moisture damage. Additionally, many of these elements had to be reinforced and strengthened to meet current code requirements. The floor framing had to be strengthened and upgraded from 40 pounds per square foot (psf) to 50 psf live load to support the added weight of modern office equipment.

*New “Sister” bracing against party wall in
attic*

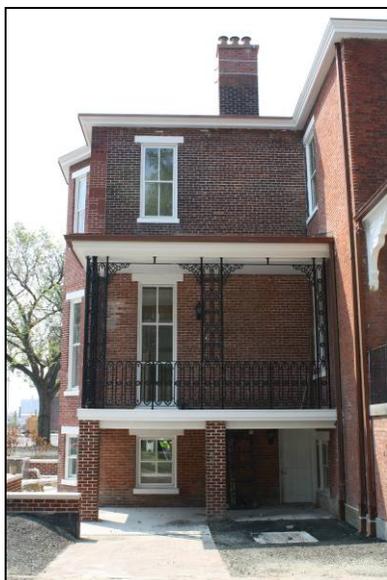
Most of the porches attached to both buildings were non-original and in poor condition, and therefore removed as part of the renovations. Porches that were retained include the small one-story porches with ironwork on the front of Building 705 and the enclosed two-story porches near the front of Building 706. New structural supports had to be provided for all of the retained porches, and new similar iron railings replaced those on Building 705.

Replaced wrought iron porch railings and supports

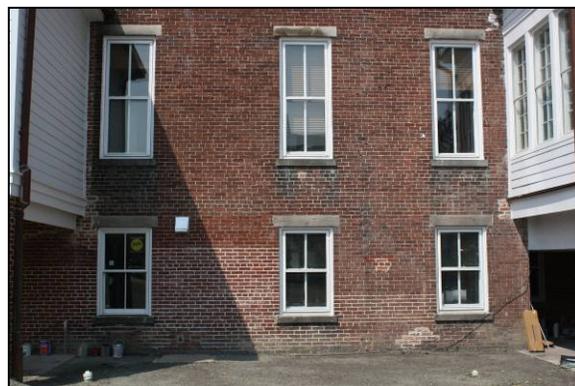
Nearly all of the historic windows on both buildings were in need of repair, but not too far deteriorated to warrant replacement. Only two windows per building had to be replaced due to condition. In these cases, replacements that match the originals in size, style, and light configuration were used. The original plan was to install interior storm windows; however, exterior storm windows with protective laminate film were installed on of all windows to meet ATFP requirements and done so in a manner consistent with the Secretary of the Interior's Standards. All windows were made operable to allow ventilation.

Replaced window (bottom left)

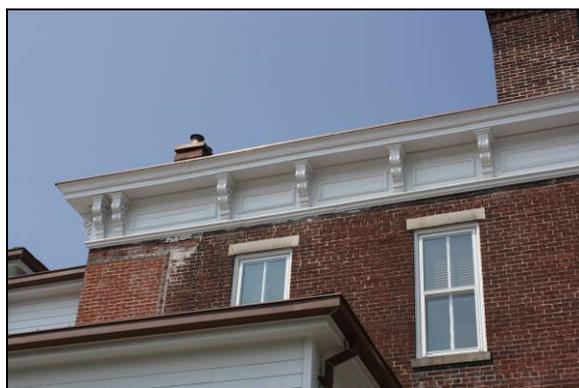
Most exterior detailing on the buildings was in repairable condition and was retained. A portion of cornice and several brackets on Building 706 were determined to be too far deteriorated to preserve and were thus replaced with reproductions that blend seamlessly with the original materials.

Section of replaced cornice and bracket

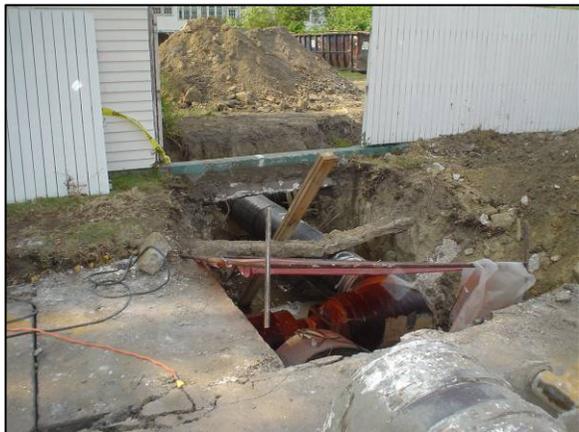
Buried utilities discovered at the site
