## STUDY OF ANTITERRORISM/ FORCE PROTECTION (ATFP) BASE ENTRANCE IMPROVEMENTS IN A HISTORIC DISTRICT

FINAL REPORT

SEPTEMBER 2003

Naval Facilities Engineering Command  
Southern Division

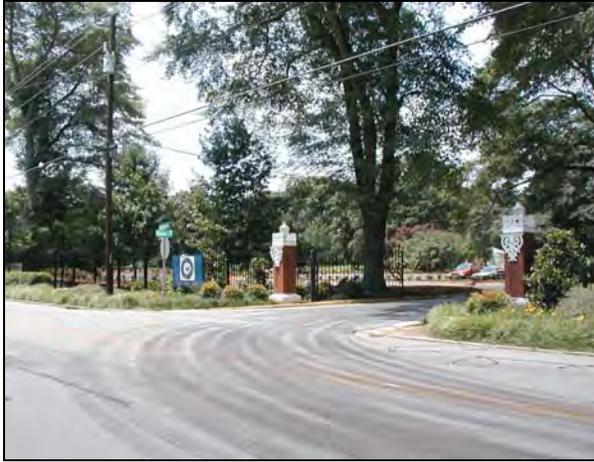
The entrance lacks a true response zone. There are no barriers of any kind located beyond the access control zone. The facility also lacks any type of active barrier.

**Photo 1. Approach from Avenue B showing historic gate piers and existing steel perimeter fence.**

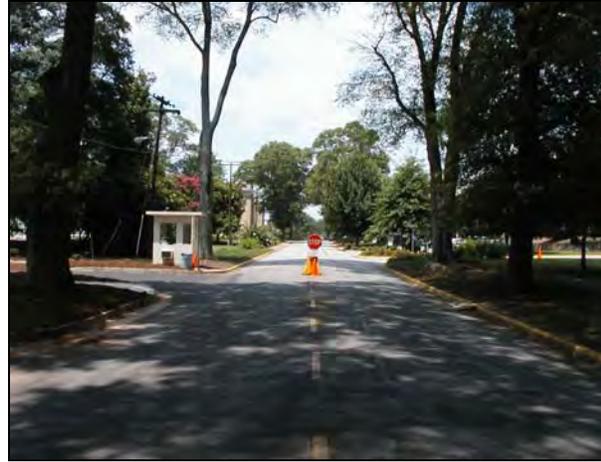
**Photo 2. Approach zone. Note that sentry booth has since been moved to a new location on the other side of the parking lot drive.**

- Visitors who stop at the booth with questions can cause a backup.
- Low lighting levels from a single light on the sentry booth and a single parking lot pole light.
- Pedestrians walk up the road with the vehicles.
- Sentry booth is located adjacent to the exit lane, not between the entry and exit lanes.
- No restroom facilities.
- No weather protection (canopies) over the sentry booth and inspection areas.
- No reinforcement to prevent high-speed vehicles from ramming the fence directly opposite Avenue H.

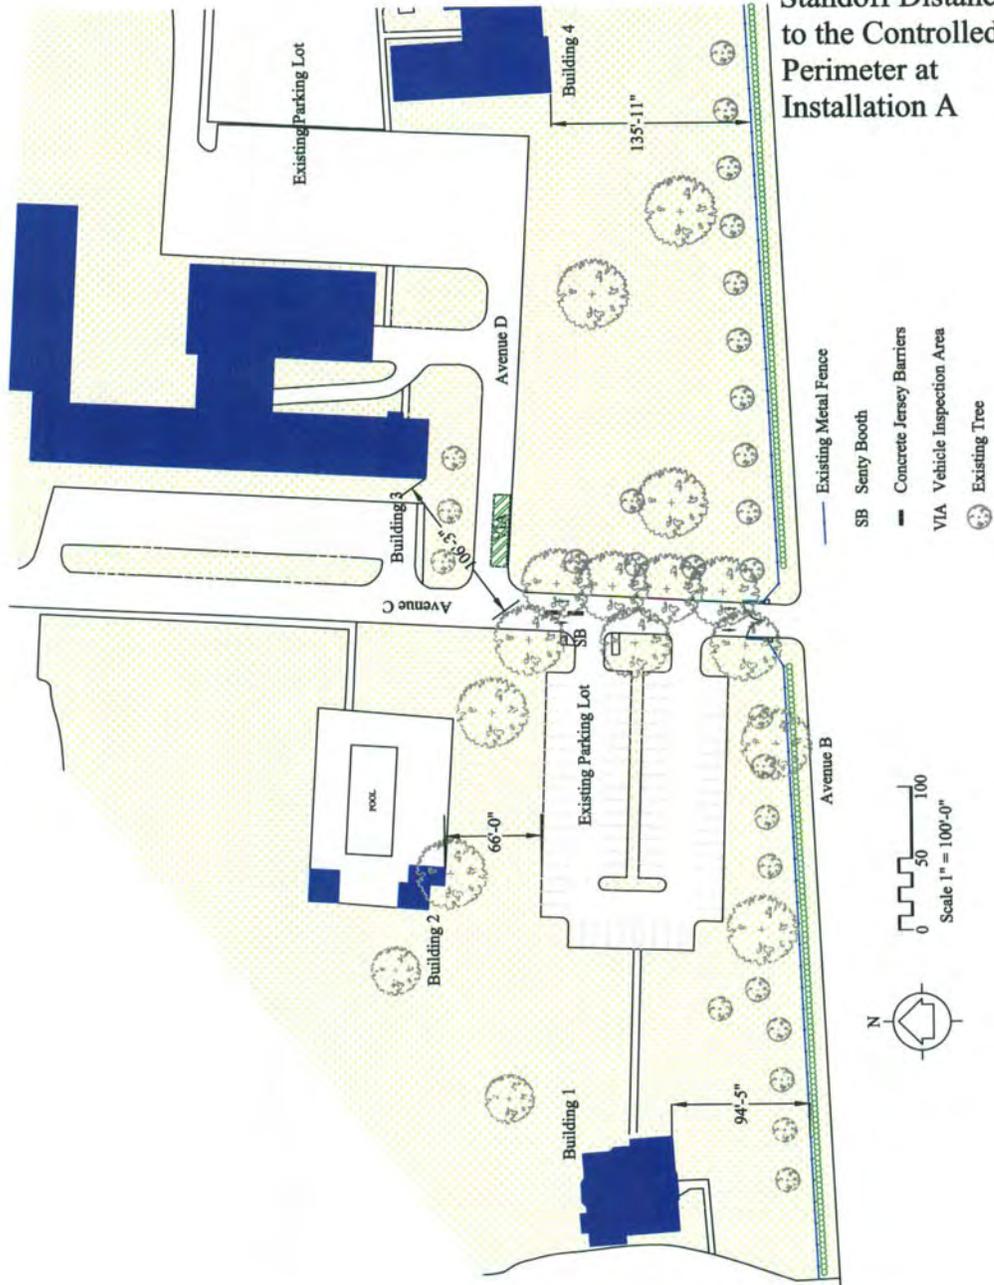
Map 6 - Existing Standoff Distances to the Controlled Perimeter at Installation A

Building 3 is a billeting facility located approximately 106' from the intersection of Avenues C and D. This building stands within the recommended 148' standoff distance from a controlled perimeter. In addition, the current vehicle inspection area along Avenue D is located within 82' of Building 3. Building 4 is a historic primary gathering building and is approximately 136' from the perimeter fence and 346' from the curb of Avenue C.

Because it is an existing facility, Building 3 is not required to maintain recommended standoff distances according to UFC 4-010-01. However, if an Explosive Weight 1 blast were to occur inside this distance, the explosion could cause property damage and casualties. In addition, future renovations of this facility may be required for compliance with UFC 4-010-01. A reduced standoff distance does not preclude major renovation of a facility, but it would mean additional costs for further analysis and hardening, if necessary.

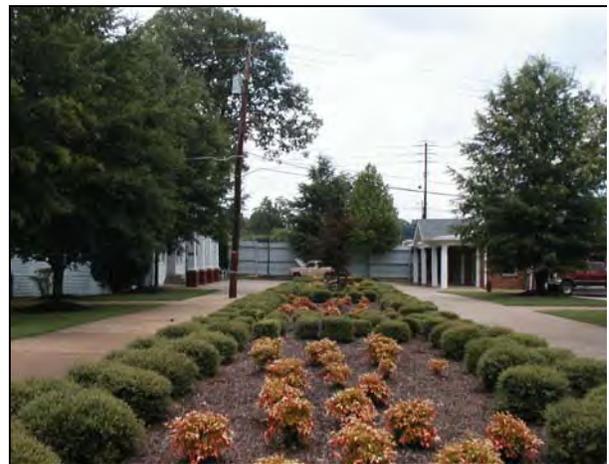
- Close proximity to nearby Buildings 1, 2, and 3, thereby increasing these buildings' exposure to an Explosive Weight 1 blast, which is typically associated with buildings adjacent to a controlled perimeter. Buildings 1 and 2 are actually both inside the perimeter clear zone.
- Highway A is a significant thoroughfare with periodically high traffic that would require the construction of a turning lane in each direction to accommodate vehicles entering and exiting the installation.
- Due to anticipated traffic volume through this entrance, a traffic signaling device would likely be required on Highway A.
- Regular pedestrian traffic would not pass through this entrance since the existing mass transit center is located close to Entrance 4.
- Inadequate vehicle stacking space, potentially spilling traffic onto Highway A.
- Inadequate space available for a vehicle inspection area.

**Photo 4. View of Entrance 2 (original gate) showing planting bed in the pedestrian plaza.**

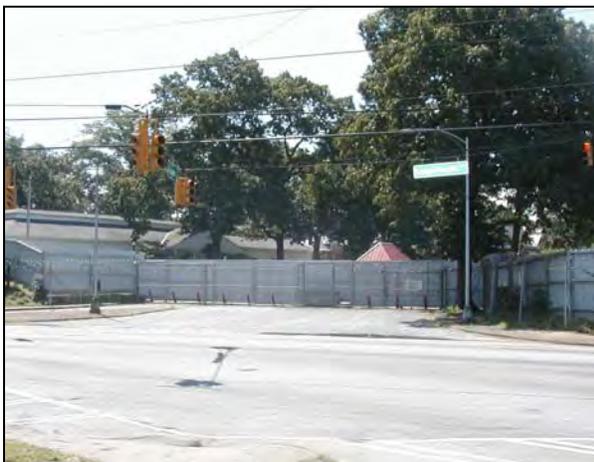
The access drive to this gate is part of a five-way intersection and is served by a traffic signal. The alignment of the intersection could allow vehicles to ram the gate at high speeds.

**Photo 5. View of Entrance 1 from off-base intersection.**

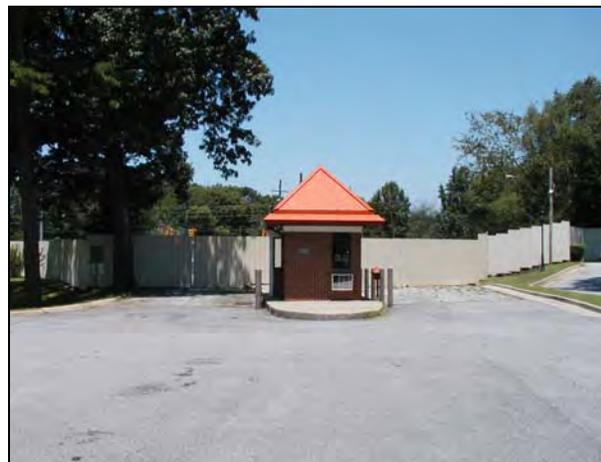
The entrance currently has a small approach zone and an access control zone, but lacks a response zone. The approach zone consists of a large paved area without channelization lanes. The access control zone consists of a vacant sentry booth. There are neither active barriers nor canopies to facilitate guard and inspection operations.

**Photo 6. View from on post of Entrance 1 from access road, with existing sentry booth.**

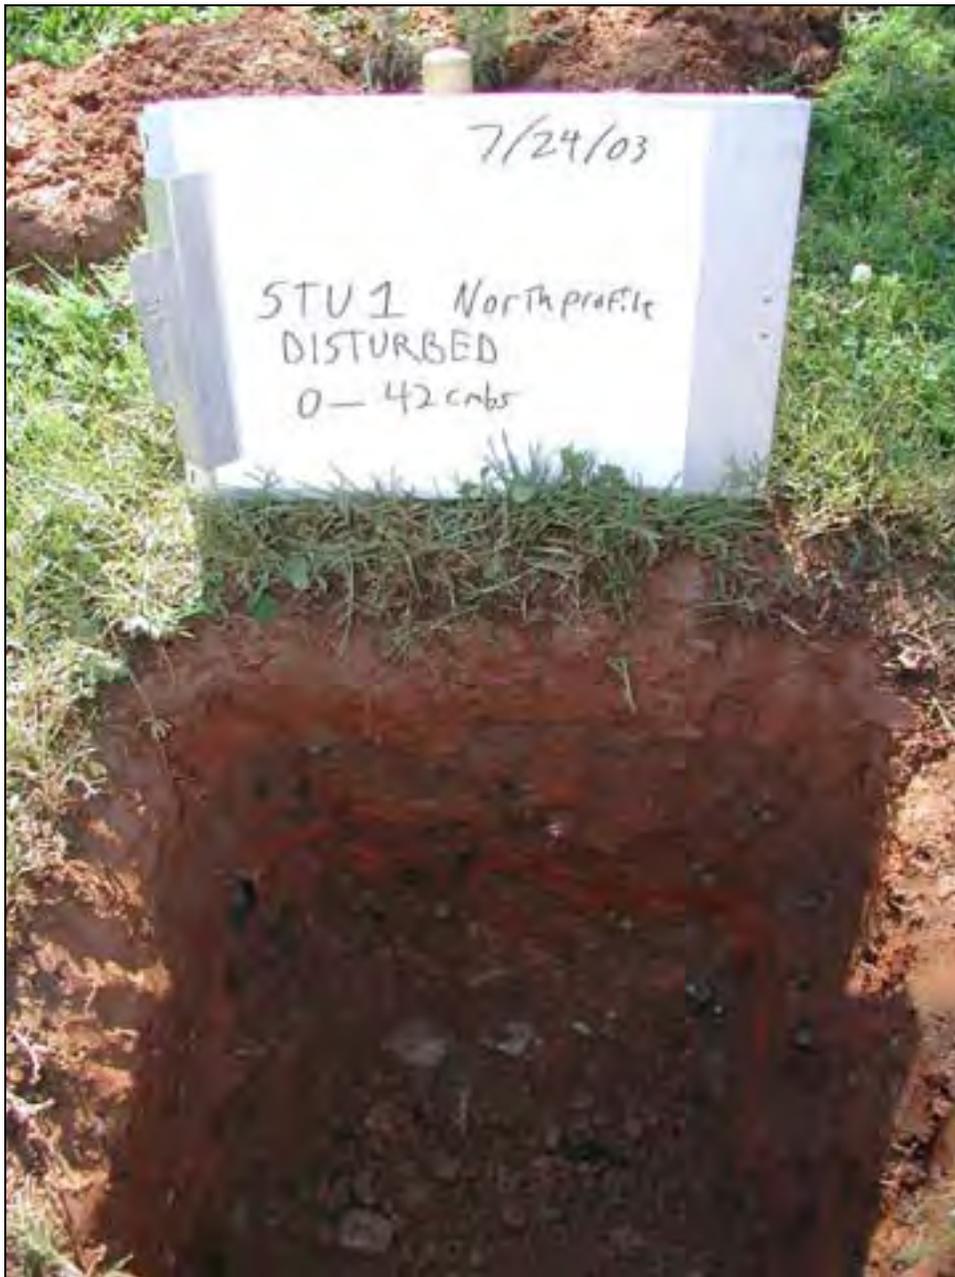
Only one STU could be placed because of the heavy modifications and paving of the project area. This STU was situated on a manicured grass meridian between a pedestrian walkway and a parking lot (Figure 3-13). The STU revealed a soil that consisted of sandy fill mixed with assorted materials, including unsorted rocks, gravel, and chunks of asphalt to a depth of 17 inches (42 cm) (Figure 3-14). The materials were most likely the result of landscaping and previous episodes of construction and demolition in the project area. No prehistoric or historic period artifacts were present.

**Figure 3-14. Disturbed north profile of STU at Entrance 2.**

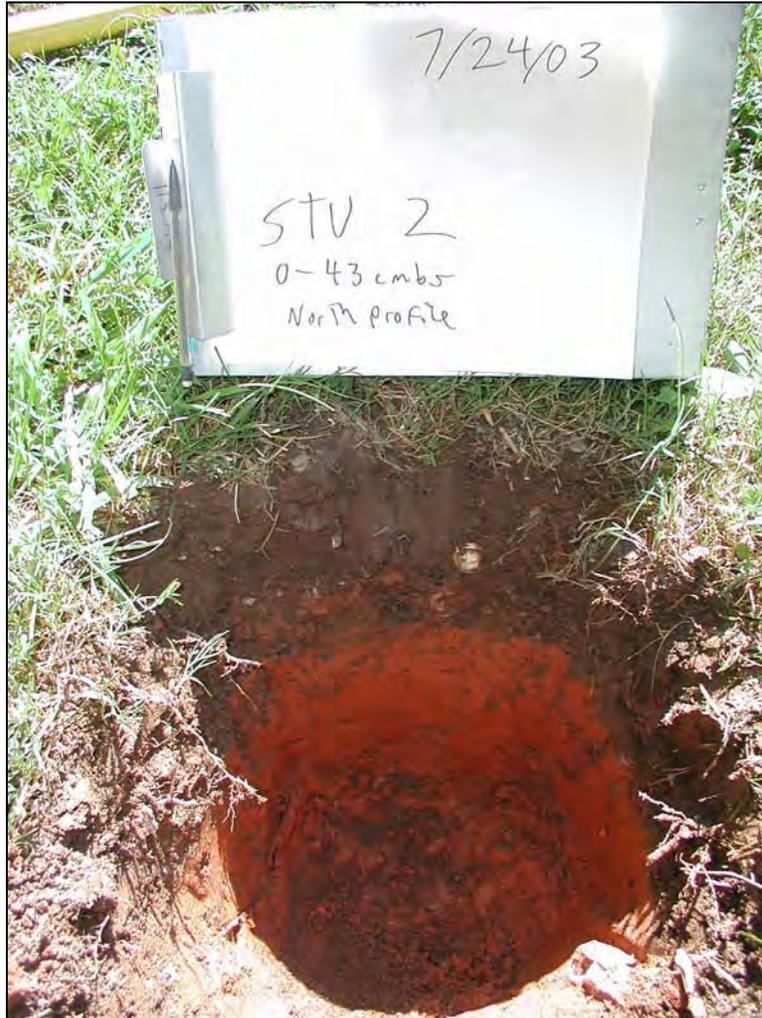
the slope from Entrance 1. Road gravel was observed 8 inches (20 cm) below surface before subsoil. The soils indicate disturbance from road construction (Figure 3-23).

**Figure 3-23. North profile of STU 2 at Entrance 1.**
