2021 ANNUAL REPORT:

PROGRAM COMMENT FOR DEPARTMENT OF THE ARMY INTER-WAR ERA HISTORIC HOUSING, ASSOCIATED BUILDINGS AND STRUCTURES, AND LANDSCAPE FEATURES (1919-1940)

Submitted by:
Army Federal Preservation Officer,
Office of the Assistant Secretary of the Army for
Installations, Energy and Environment

Submission Date: 10 January 2022

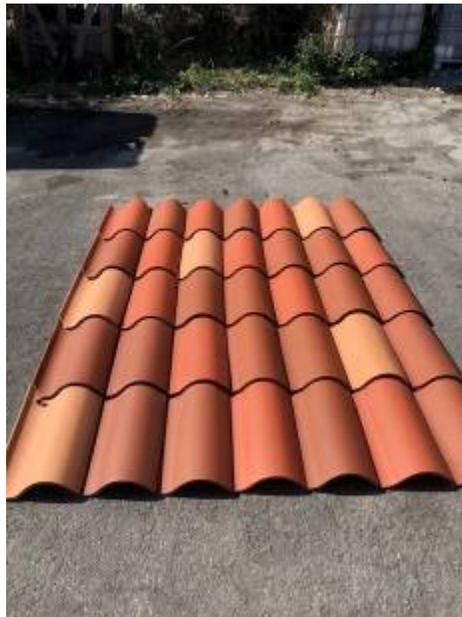
Fort Bragg, NC: A building materials replacement occurred for clay tile roofs at Fort Bragg in the Normandy neighborhood. The action was implemented by the Army privatized housing partner Corvias. The extant terra cotta tile roofs were prone to water infiltration and mold. Application of the Building Materials Criteria and Building Materials Selection procedure were appropriately implemented and documented. In-kind replacement terra-cotta tiles were selected for use (Figure 1). Work was initiated in February of 2021.

Figure 1: Sample of Replacement Terra Cotta Tiles Used at Fort Bragg

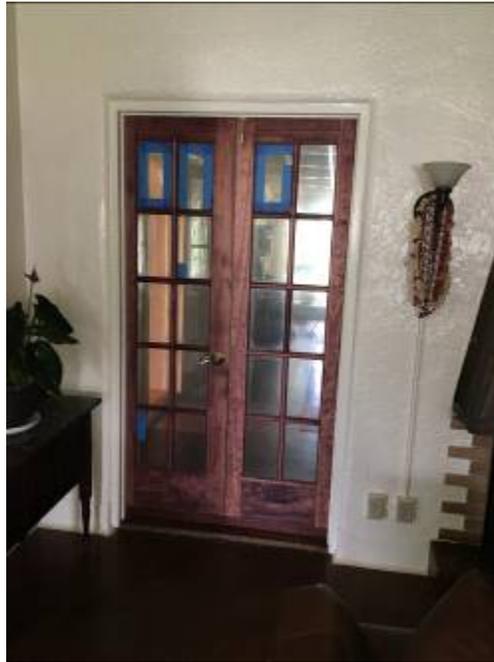
U.S. Army Garrison, HI (USAG-HI): Three building materials replacement actions occurred at the USAG-HI, under the supervision of Lendlease. First, interior doors were missing from one property at Wheeler Army Airfield. These doors originally were bronze. A replacement material of wood painted to appear with a bronze coloration were chosen (Figure 2).

Figure 2: Wheeler Army Airfield Wooden Replacement Doors

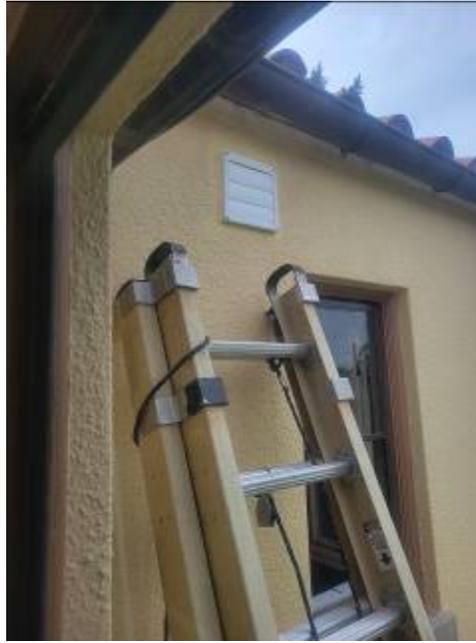
Fort Sill, OK: Fort Sill was facing mold issues at 5654 Searby Court due to the lack of bathroom fans in this Inter-War era housing unit. The proposed solution was the installation of a bathroom fan on a secondary elevation of the dwelling.

Figure 3: Fort Sill Installed Bathroom Vent on a Secondary Elevation

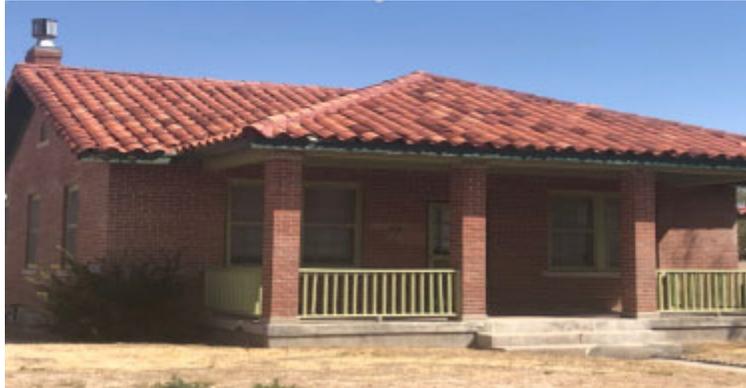
Fort Bliss, TX: Fort Bliss sought to renovate 98 red brick dwellings on site. Renovation would include repair and replace the roofs and fascia, and replacing kitchen and bathroom flooring, interior doors and hardware, bathroom sinks, lighting, windows, and exterior doors.

Window replacements will be undertaken to install six-over-six vinyl windows that fit the current opening in order to mitigate asbestos windows currently in place. Fiberglass panel doors

have been selected as entries. Existing clay tile roofs will be replaced with more durable imitative materials units that replicate the appearance of the original clay tile.

Figure 4: Example of a red brick home at Fort Bliss

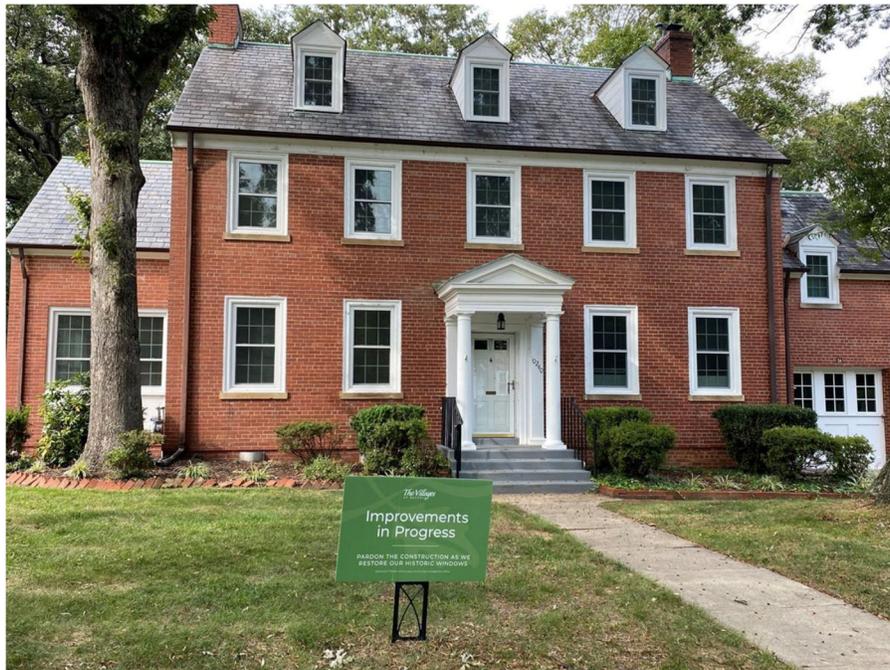
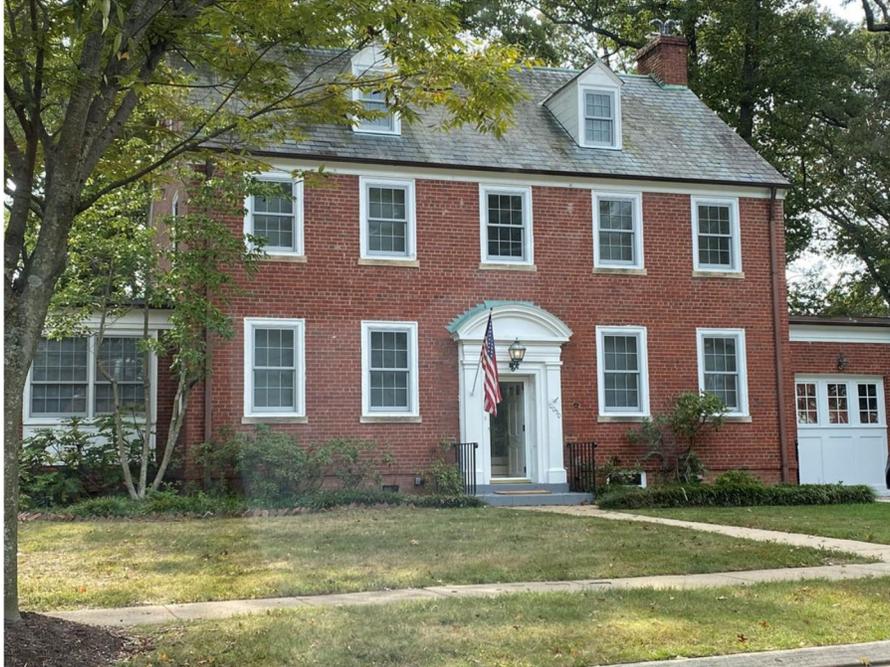
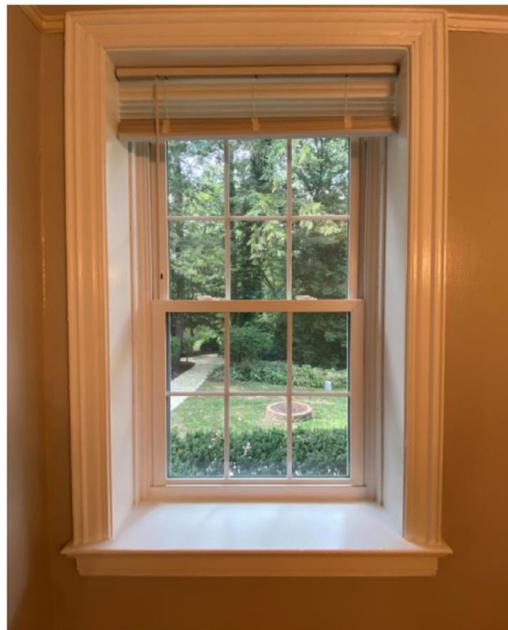
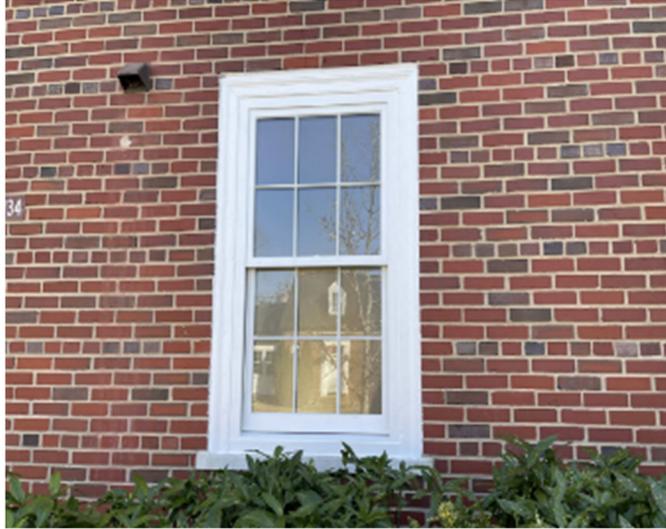
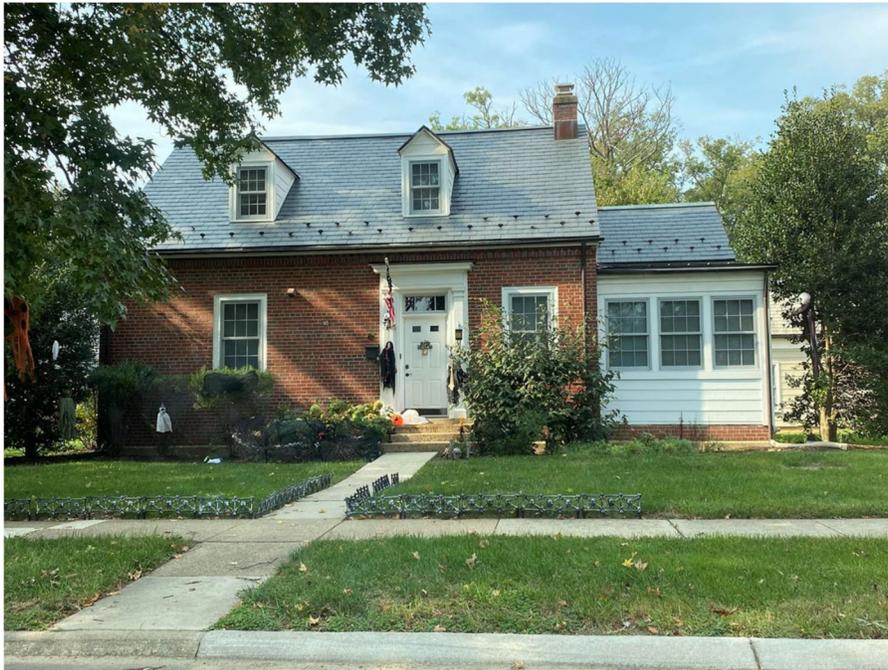
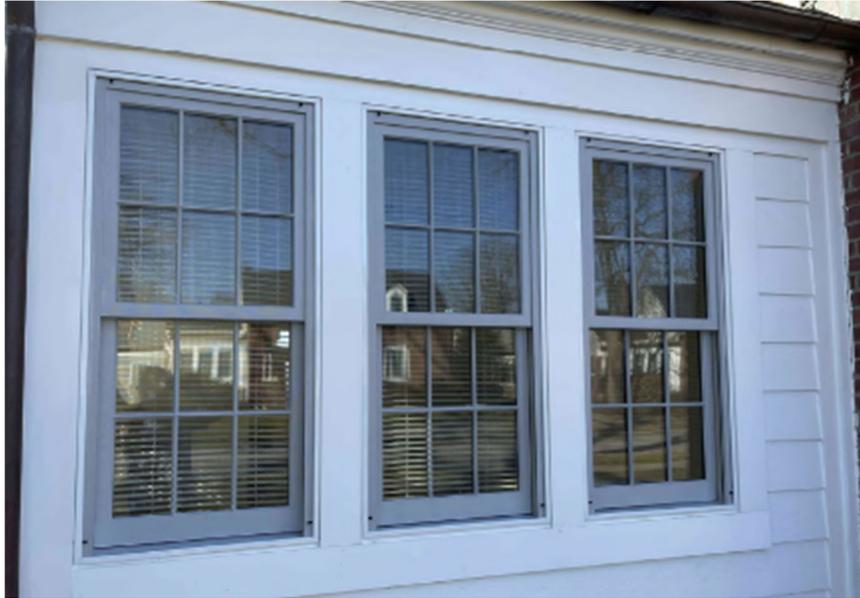
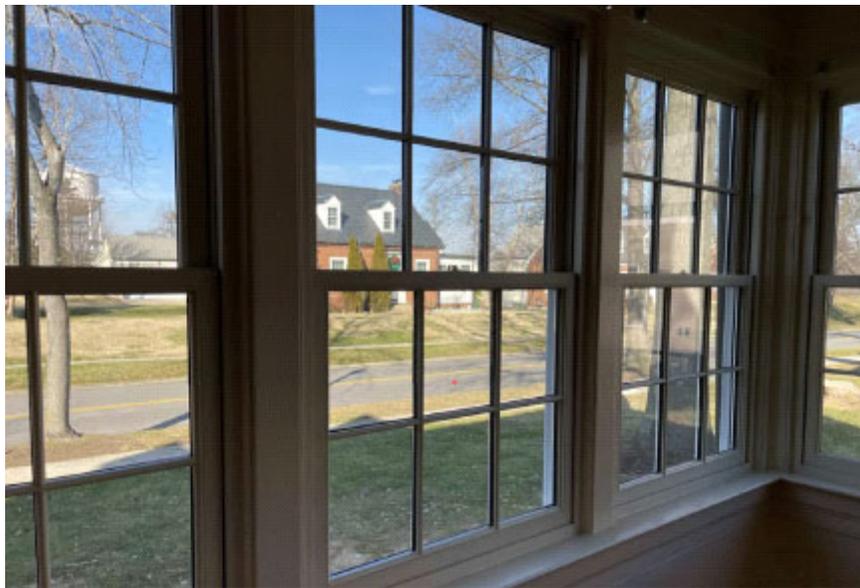
Fort Belvoir undertook the replacement of windows in Inter-War era housing units. The housing partner on site, reported that previously, historic window rehabilitation as required by the NHPA Programmatic Agreement that was in place prior to the Program Comment cost \$120,000 per home and took 120 days to complete the project for each house, and the PA required in-kind wood replacement units cost \$80,000 and took 30-to-45 days to be installed. Now, operating under the Program Comment with the flexibility to use imitative substitute building materials, window replacement costs \$30,000 per house and takes 14 days to complete, with modern industry standard windows that replicate the original historic windows.

Figure 5: An example of replaced windows at Fort Belvoir

Figure 6: An example of replaced windows at Fort Belvoir

Figure 7: A replacement window at Fort Belvoir – interior view

Figure 8: A replacement window at Fort Belvoir – exterior view

Figure 9: New replacement windows at Fort Belvoir

Figure 10: Exterior image of window replacements at Fort Belvoir

Figure 11: Interior image of replacement windows at Fort Belvoir

Overall, the housing partner was able to save \$5,000,000 using imitative substitute materials for window replacement in these housing units, while also maintaining the historic character of the housing. The housing partner at Fort Belvoir stated that the Inter-War Era Historic Housing Program Comment:

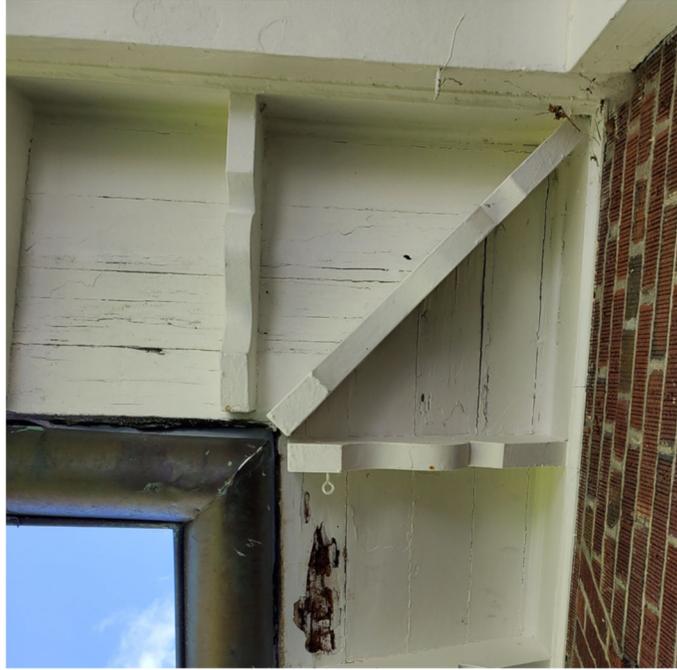
Joint Base Lewis McCord, WA: At Joint Base Lewis McCord (JBLM) WA two building materials replacement efforts were undertaken. First, in the Greenwood Historic District, rot replacement was undertaken under roofs. Replacement was made in-kind with cedar board (Figure 12, 13).

Figure 12: Before image of rotting wood members at JBLM

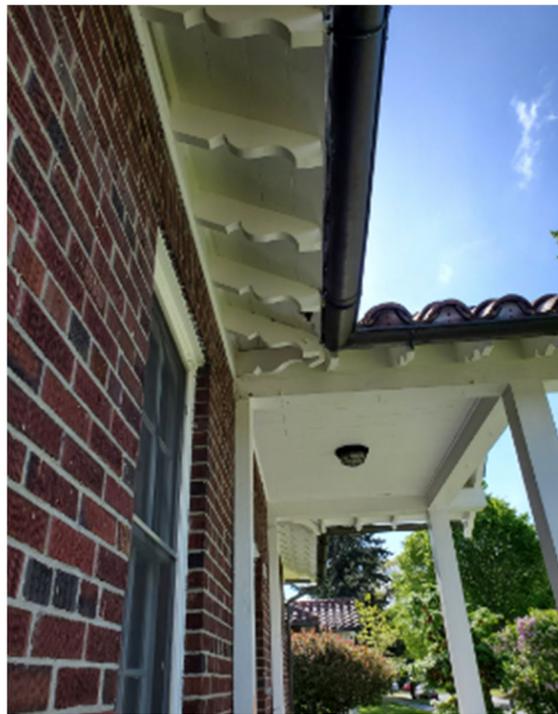
Figure 13: After image of replaced rotting members with in-kind wood

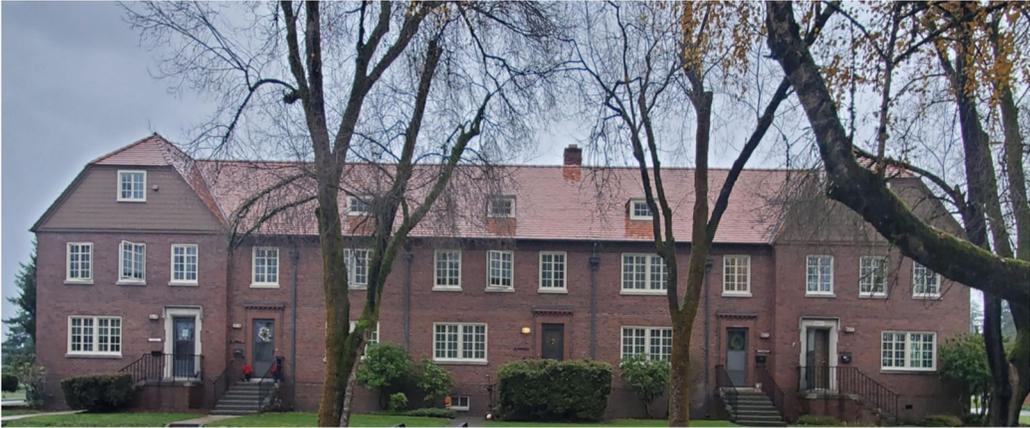
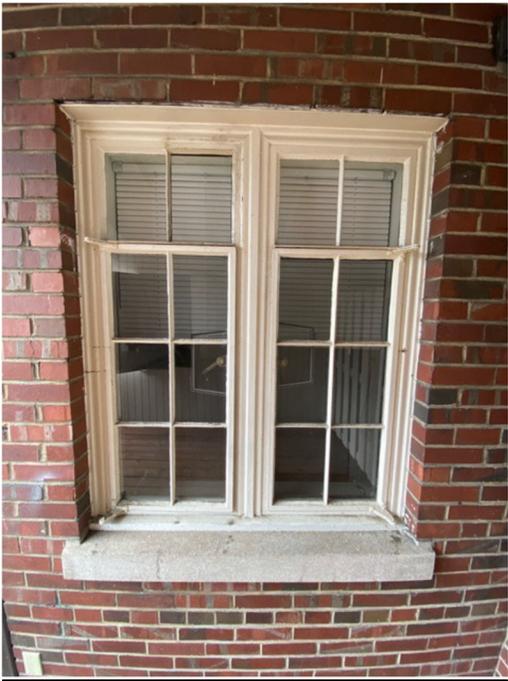
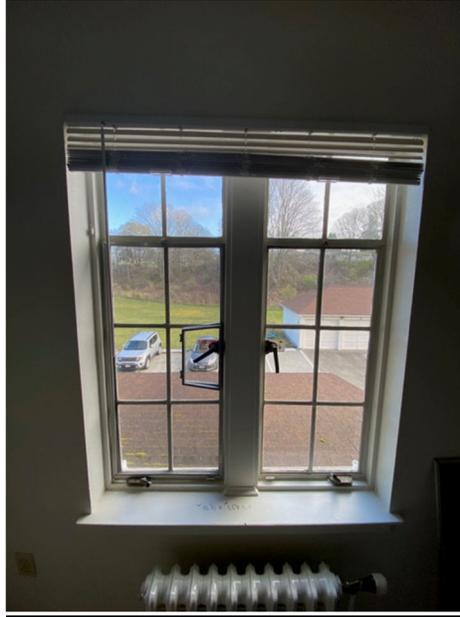
Next, 60 units in the Greenwood Historic District underwent window replacement. The original historic windows had been previously replaced at some point in the past with steel single-pane casement units. Aluminum clad wood casement units were selected to replace steel single-pane

casement units. The current windows were painted with lead, difficult to operate, and did not meet emergency egress requirements (Figure 14, 15, 16).

Figure 14: Replaced windows in the Greenwood Historic District, JBLM

Figure 15: Exterior image of a replacement window at JBLM

Figure 16: Interior image of a replacement window at JBLM

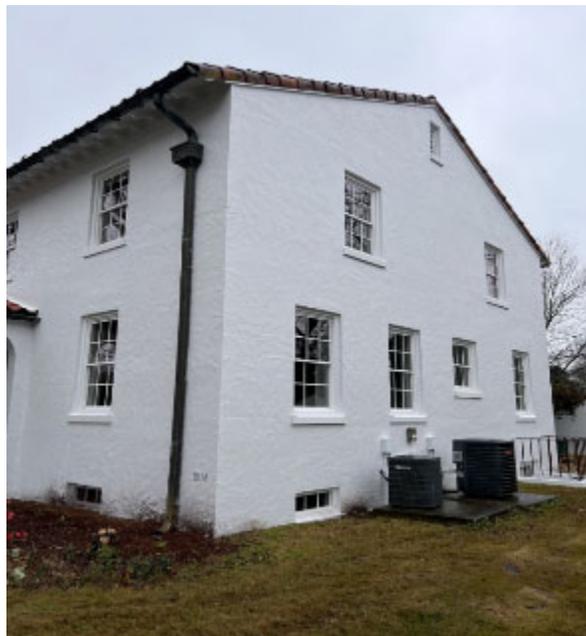
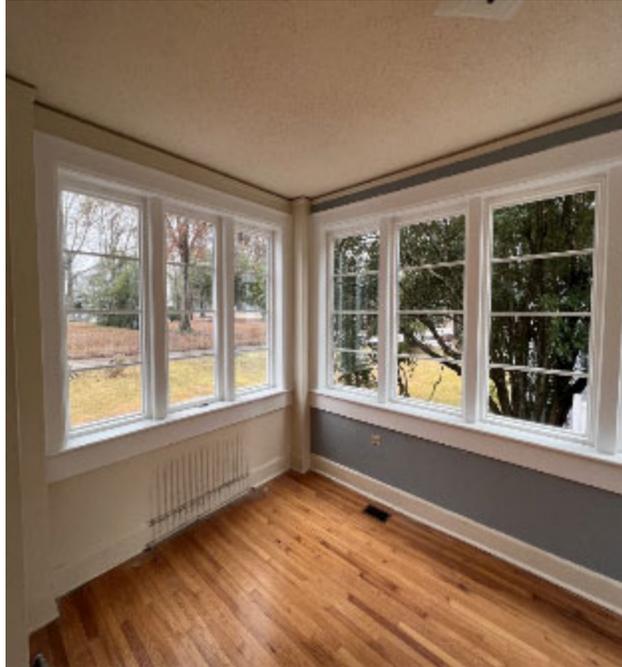
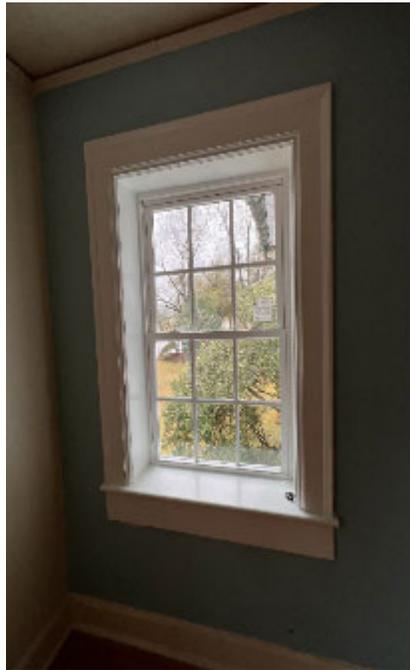
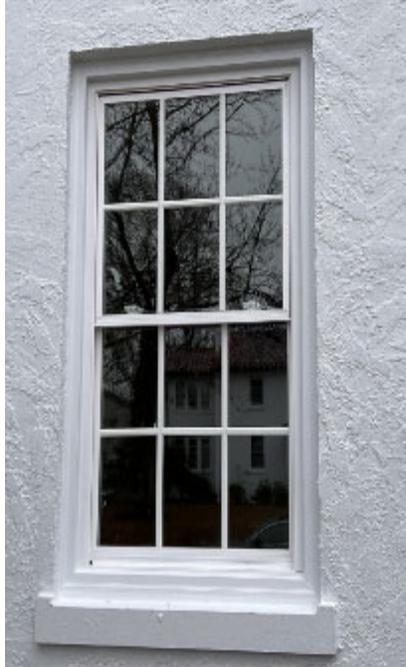
Fort Benning, GA. Fort Benning undertook the replacement of windows in ten Inter-War Era houses that presented lead-based paint hazards. Windows were removed and replaced with vinyl replicas. (Figures 17, 18, 19, 20), eliminating the lead-based paint hazard and improving operability.

Figure 17: Exterior image of window replacements at Fort Benning

Figure 18: Interior image of window replacements are Fort Benning

Figure 19: Interior image of window replacements at Fort Benning

Figure 20: Exterior image of window replacements at Fort Benning

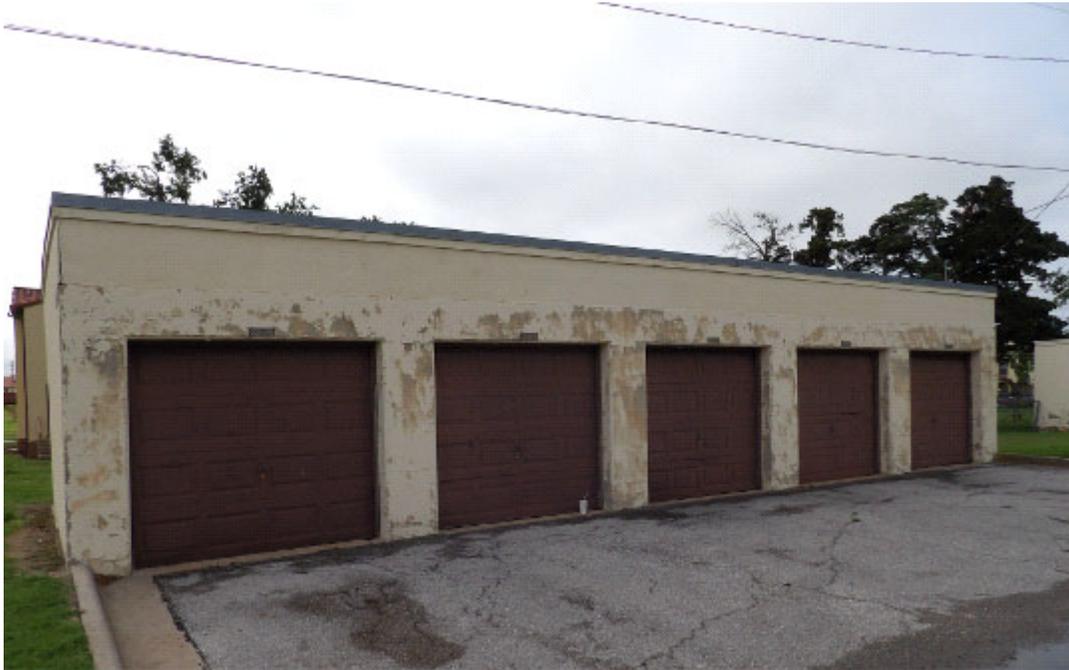
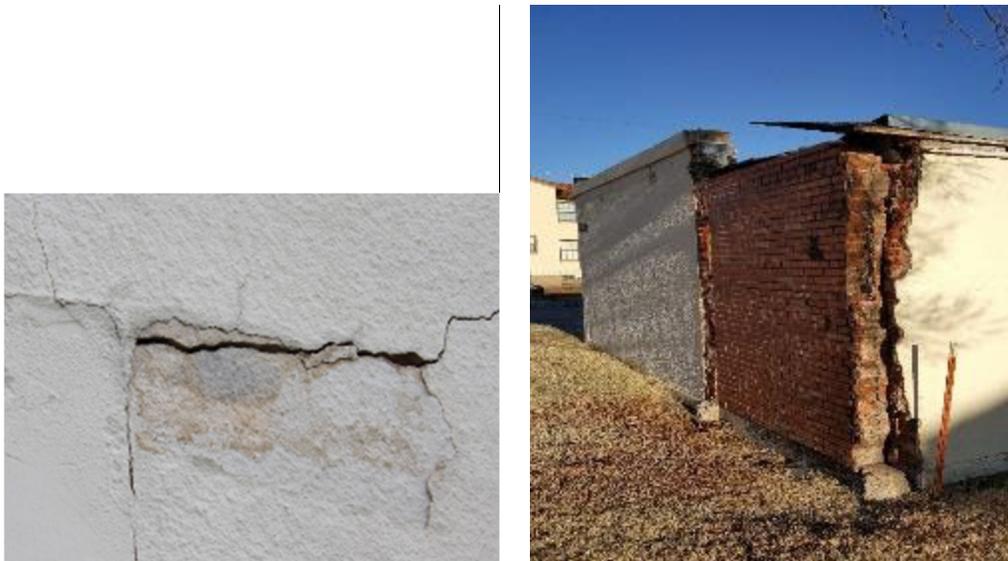
The ten garages are highly deteriorated and have not been used as garages for over 50 years. Due to the era during which they were constructed, modern full-size vehicles cannot be parked in the garages in a manner that will allow personnel to open vehicle doors to enter or exit the vehicle. Therefore, they cannot be reutilized for their intended purpose. Several buildings are unsafe due

to wall separations and aging materials. Stucco is severely cracked and separated in many areas. The interiors show signs of continued water damage. Lead-based paint is present and Chlordane has been detected under the slabs.

Figure 23: Example of garages proposed for demolition in Quanah Parker Square, Fort Sill

Figure 24: Examples of deterioration of garages in Quanah Parker Square neighborhood, Fort Sill

Replacement construction will include ten garages that accommodate modern vehicle sizes and safe conditions totaling 15,290 sf. The new garages will be built in the same location as the historic garages, and are compatible with the historic character-defining features of the historic garages including one-story massing and imitation stucco (via the use of National Gypsum and the Perma Base System). Slightly increased garage bay-widths will allow the residents to utilize the garages for their intended purpose. There are no plans to inventory or salvage any historic elements of the garages due to their utilitarian design and highly deteriorated conditions.

Demolition of existing units and construction of new garage facilities is the preferable means of disposition of the buildings in order to better accommodate new, usable parking in the neighborhood, which currently is limited. The estimated cost to demolish and replace the 10 buildings is \$2,140,207.00, or \$140.00 per square foot. The estimated cost to rehabilitate the buildings is \$865,050.00, or \$57.00 per square foot. The estimated cost of replacement construction is \$83 dollars more per square foot than rehabilitation. Demolition and replacement construction is justified based on the need for parking garages and functionality considerations that impact the overall quality of life of the resident military families (Figures 24, 25, 26).

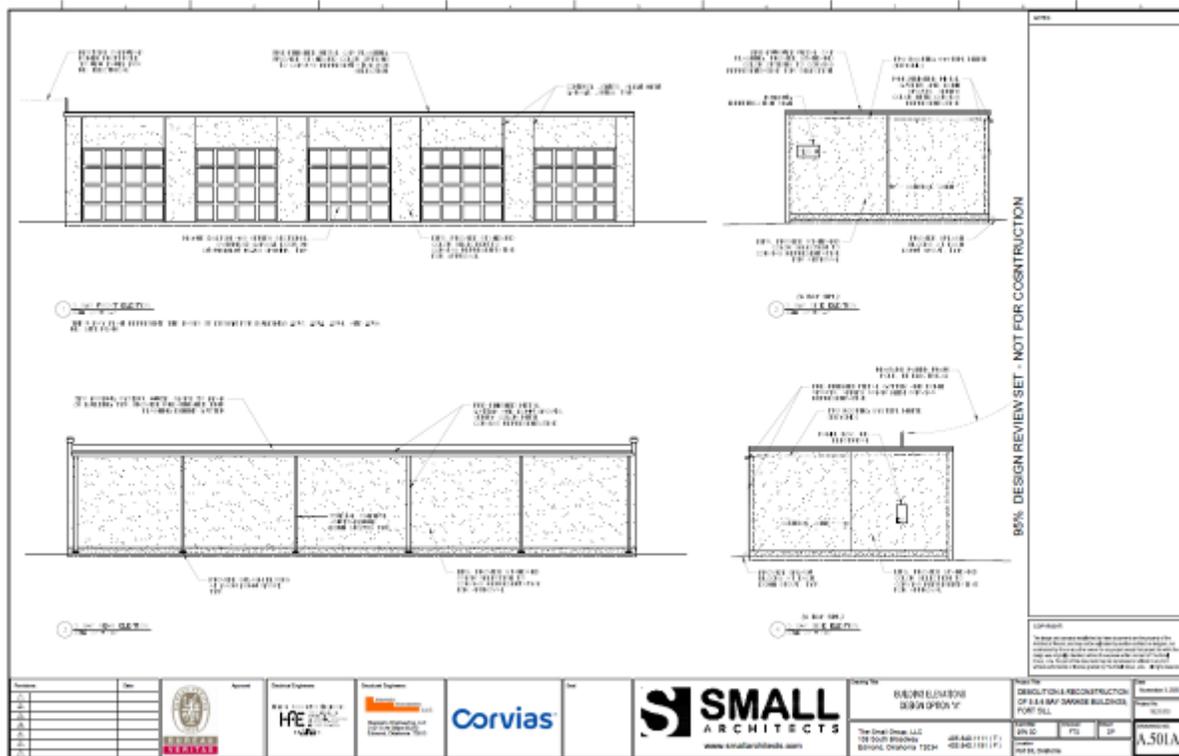
Figure 25: Architectural plan for new garage replacement construction at Fort Sill
