NAUTICAL ARCHAEOLOGY

Conservation and Management Strategies Applied to Post-Recovery Analysis of the American Civil War Submarine *H. L. Hunley* (1864)

Paul Mardikian

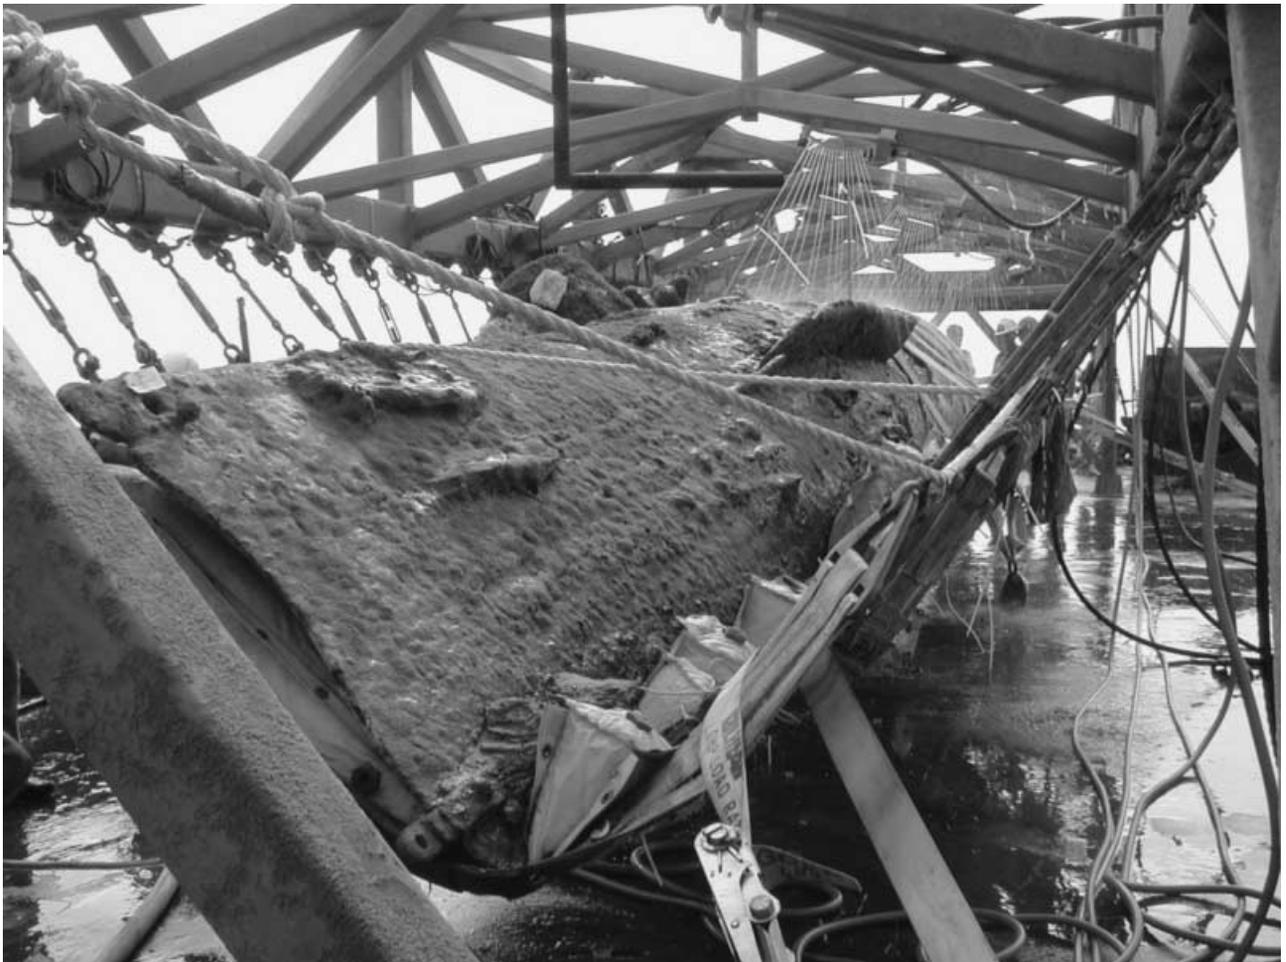
Figure 1. The *H.L. Hunley* on the barge en route to Charleston. Note the 45° angle of the submarine on its starboard side and the spray down system attached to the truss. (Copyright, Friends of the Hunley Inc., 2000)

lifting and transportation operations by Ocean-ering International. Since the concretion covering the hull was apparently intact after the raising, there was no need to use hydraulic cement or other products similar to those used in 1996 and 1999 during underwater surveys of the submarine.² The objective was to make sure that exposure of *Hunley* to the atmosphere would not induce adverse chain reactions. Since the surface of the hull would remain sealed off whether intact or patched, and the amount of time between *Hunley*’s recovery and placement in its tank would be less than eight hours, the decision was made to keep the submarine visible to the public once it was on the recovery barge. However, the submarine was constantly wetted with salt water during its trip back to Charleston so it would not dry out.

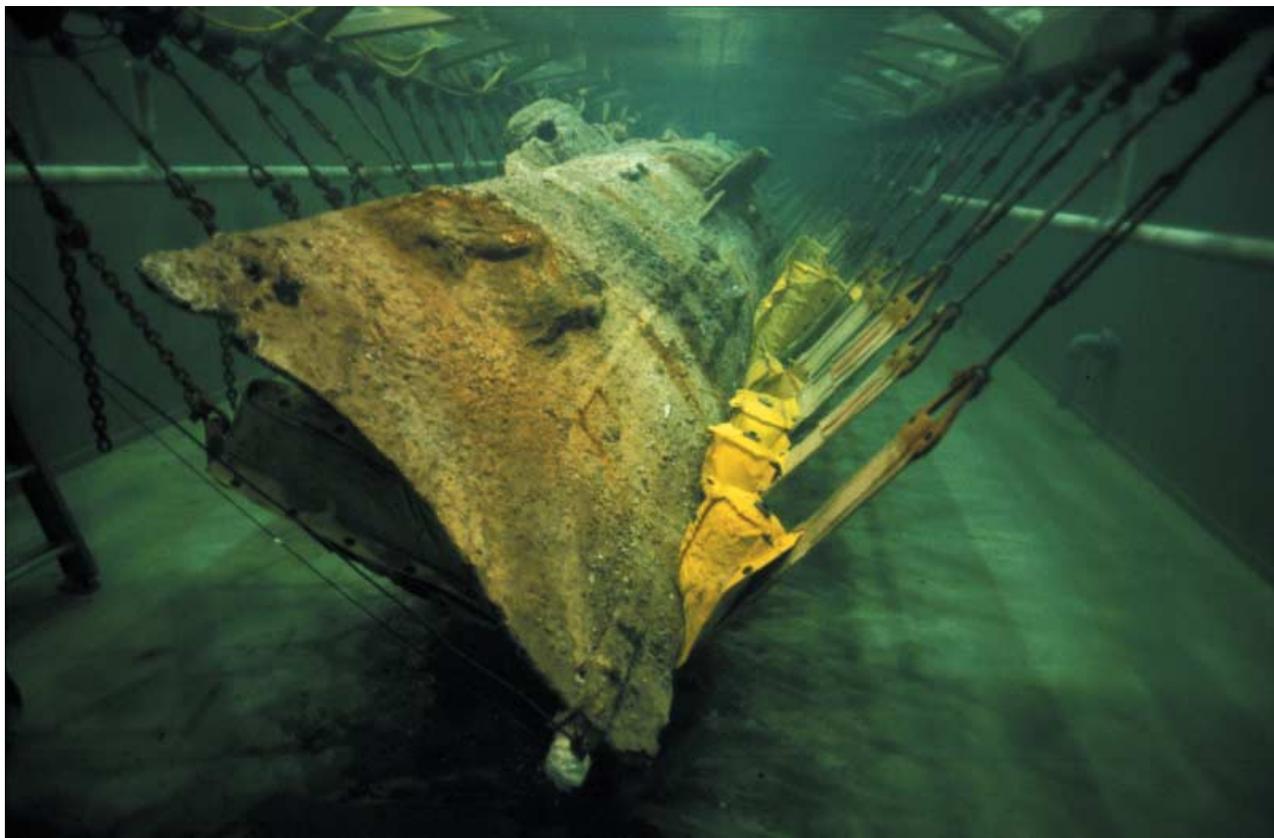
Figure 3. *H.L. Hunley* resting in its tank at the Warren Lasch Conservation Center soon after its recovery. Note the anodes in the white perforated pipes parallel to the hull. (Copyright Friends of The Hunley Inc., 2001)

We elected to install the impressed current system in the tank and were assisted by Corrosion Control, Inc., who provided all of the engineering work. The protection system is safe for the submarine and those working on it,⁴ is simple to install in the tank, and can be easily modified to suit the particular needs of the excavation and conservation teams. It consists of two 40-foot long anode segments⁵ (Fig. 3). These are suspended from the truss and oriented parallel to the hull in pre-drilled PVC pipes. The pipes support the anodes, ensure that they do not come in contact with the truss, and provide more uniform protection for the submarine. Fig. 4 shows how the negative cable is attached to the former spar connection. The decision was made also to protect the mild-steel truss with the impressed current.

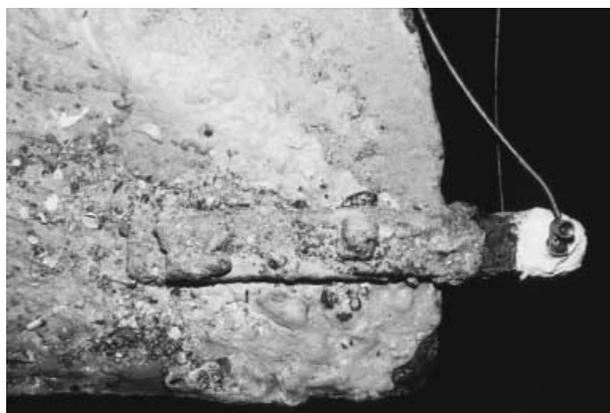
Figure 4. The resistive effect of the riveted seams being negligible, the main connection to the hull was made at the former spar connection using a modified bolt covered with an epoxy coating. (Copyright Friends of The Hunley Inc., 2000)

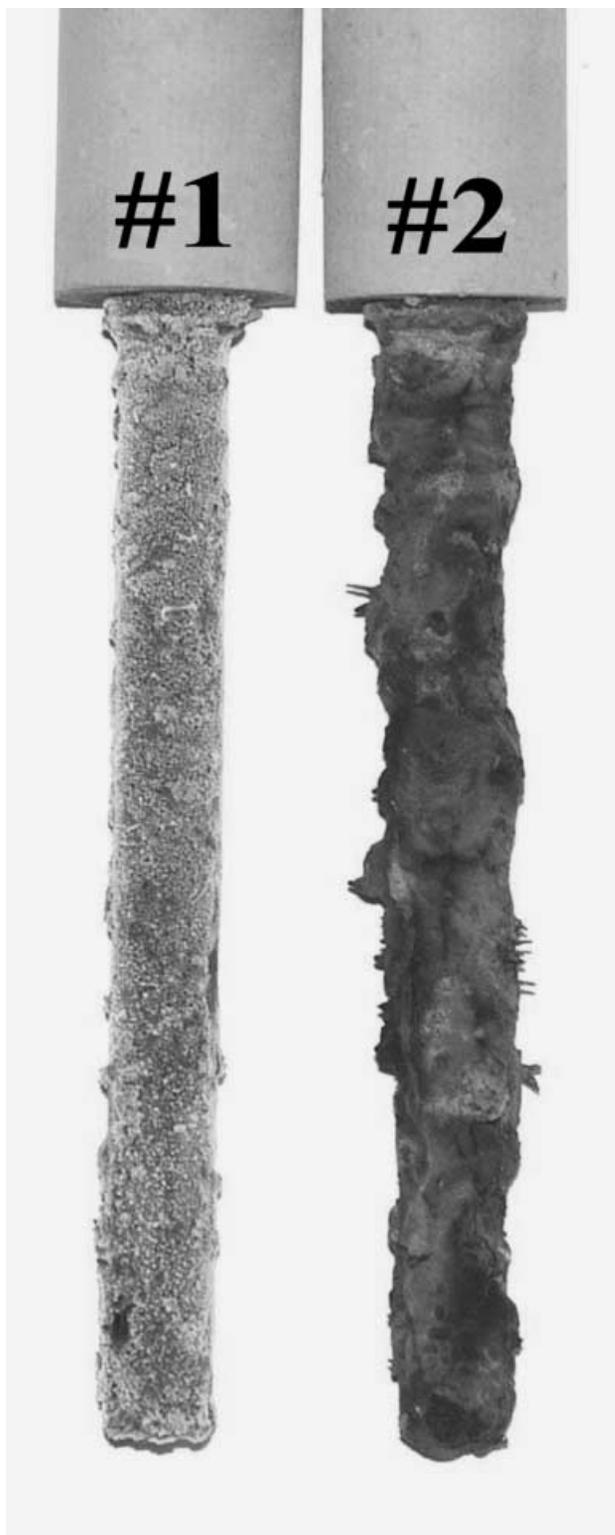
Figure 7. Photograph of mild steel test probes taken on August 27, 2003. (Copyright Friends of The Hunley Inc., 2003)

In order to quantify and visibly assess the effect of the impressed current on metal similar to the hull of the *Hunley*, two mild steel probes connected to a MS0500 corrosion-monitoring meter were placed in the *Hunley* tank soon after its recovery (Fig. 7). Visible changes have occurred on both electrodes: electrode 1 is covered with a white deposit (possibly carbonates) but still has a smooth surface, while electrode 2 is showing a disrupted surface and signs of active corrosion. Using the corrosion meter readings shown in Fig. 8 a corrosion rate can be calculated. The calculated corrosion rates and other data are summarized in Table 2. The last reading, taken on August 27 2003, indicated that the unprotected control probe 2 was corroding at a rate almost 8 times

faster than the protected probe 1. Based on these results, we would expect a similar level of protection on the submarine. It should be noted that the measured value of 0.034 mm/year on the protected probe is identical to the long-term corrosion rate (0.03 mm/year) predicted by Dr Ian MacLeod in 1998 (Murphy, 1998: 117). These data seem to indicate that the impressed current protection has brought the submarine back to its pre-disturbance long-term corrosion rate.

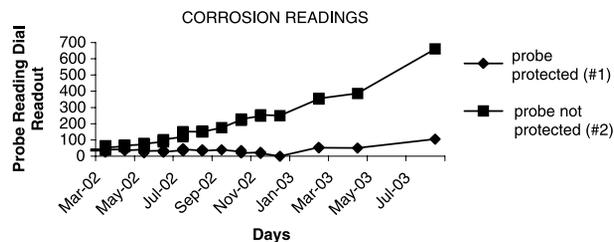
Figure 8. Probe corrosion readings.
