## **Archaeological Investigation and Remote Operated Vehicle Documentation: Confederate Commerce Raider *CSS Alabama* - 2002**

April 1, 2004

**Gordon P. Watts, Jr., Ph.D.  
Institute for International Maritime Research, Inc.  
P. O. Box 2494  
Washington, North Carolina 27889**

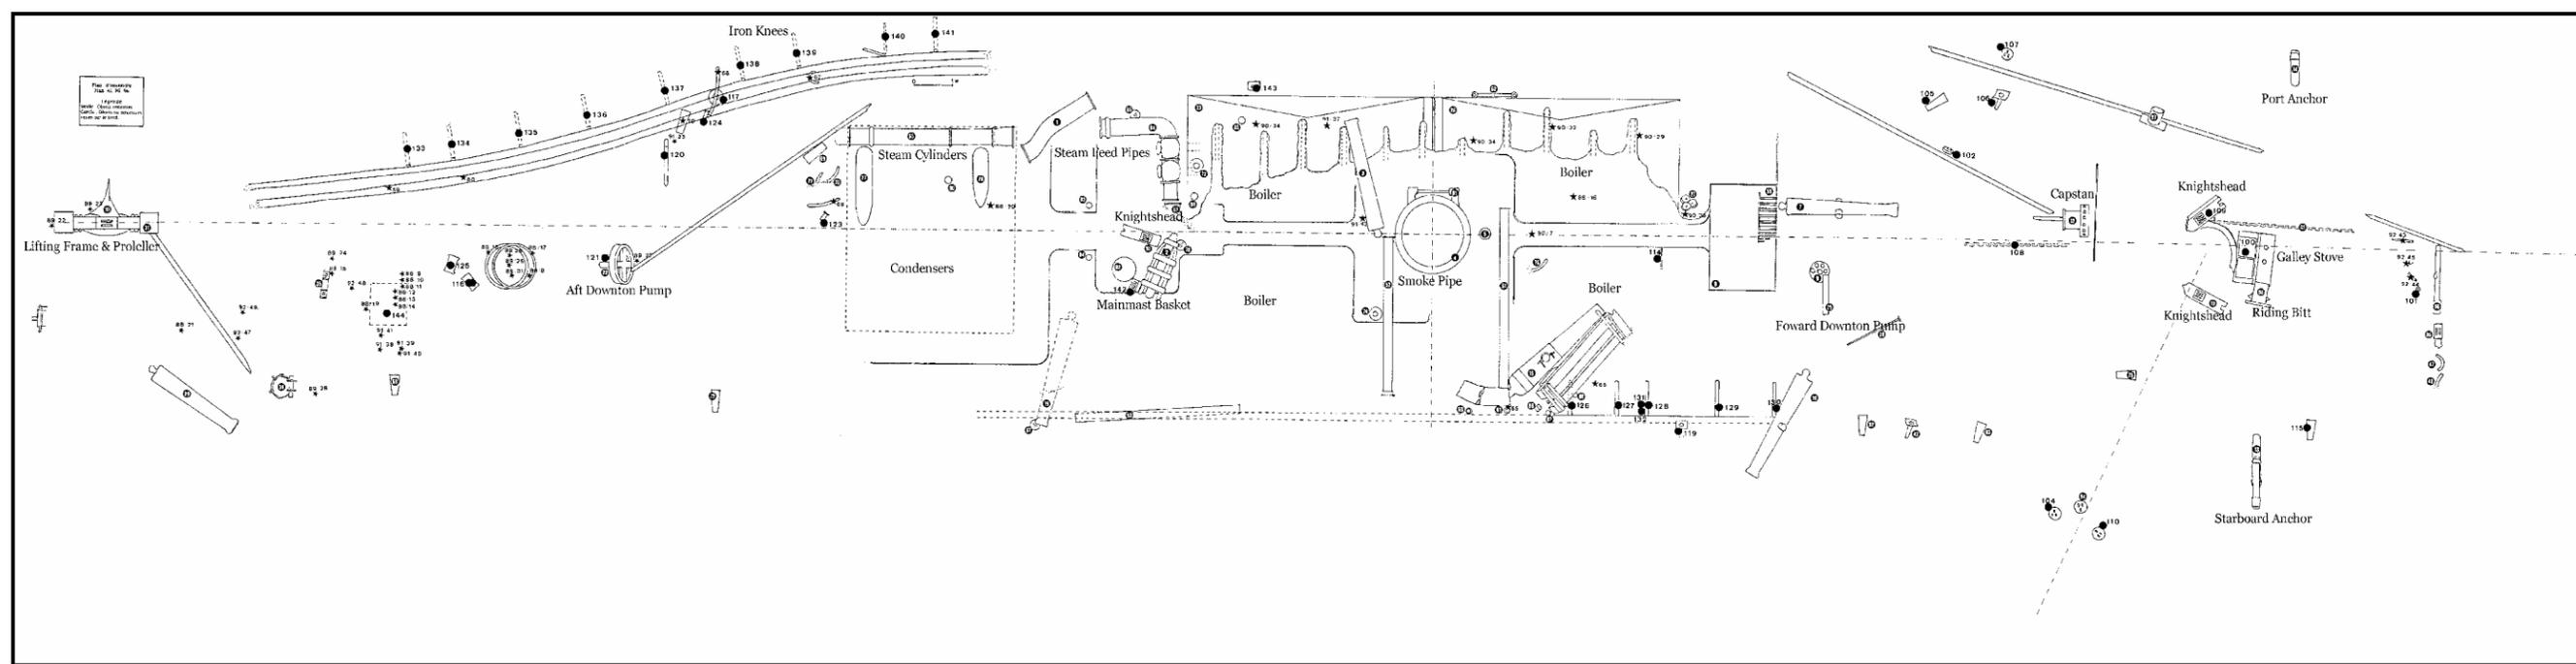
Figure 2. CSS Alabama Site Plan (Guérout 1994).

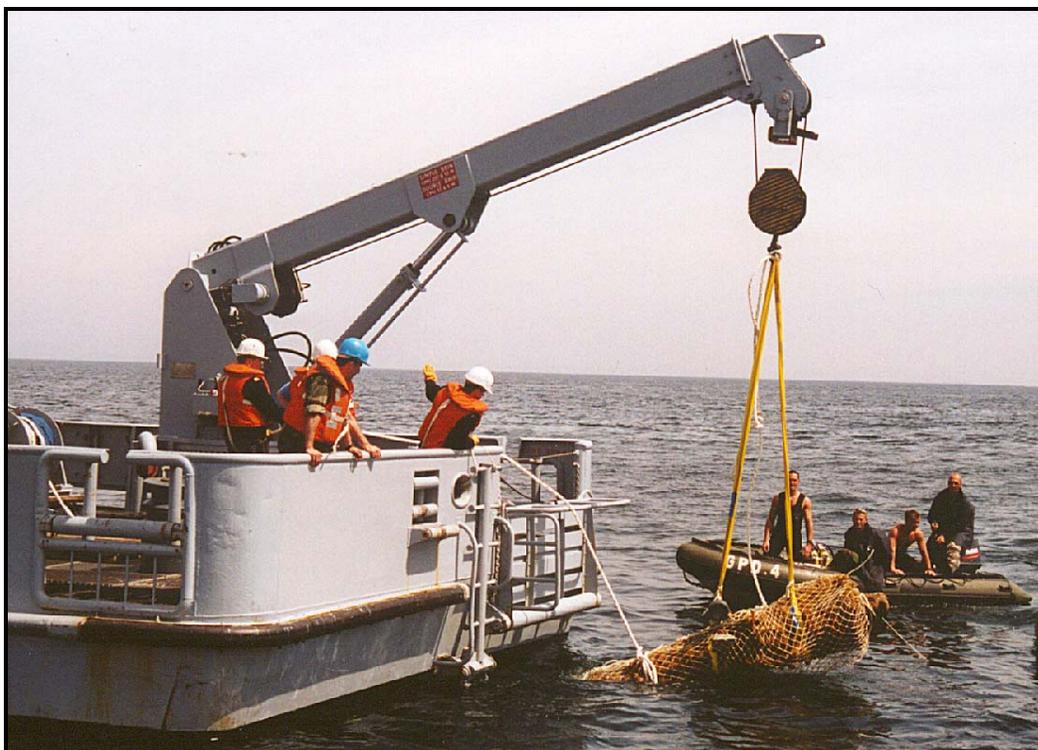
**Figure 4. Recovery of one of the British Royal Navy pattern 32-pounders during the 2001 investigation of *CSS Alabama*.**

Investigation of the *CSS Alabama*, during the summer of 2001, was a continuation of previous research and management priorities. On-site operations focused on documentation of the exposed wreck structure, test excavation in the hull aft and recovery of selected and “at risk” artifacts. Documentation of the wreck structure was to have been based on use of the U. S. Navy research submarine *NR-1* and a U. S. Navy ROV. Unfortunately, authorization for use of the *NR-1* and ROV could not be obtained from the French government and the primary research objective had to be abandoned. Without data from the proposed *NR-1* and ROV surveys, the focus of on-site activity was shifted to excavation and artifact recovery. A test excavation in the stern produced a number of interesting artifacts and new information concerning the nature, scope and degree of preservation of the archaeological record within the *CSS Alabama*’s surviving hull structure. Efforts to recover the aft pump were again suspended until a better understanding of the methods of attachment could be determined (Watts 2001). With assistance from the French Navy, one of the *CSS Alabama*’s two Blakely patent British Royal Navy pattern 32-pounders was recovered (Figure 4).

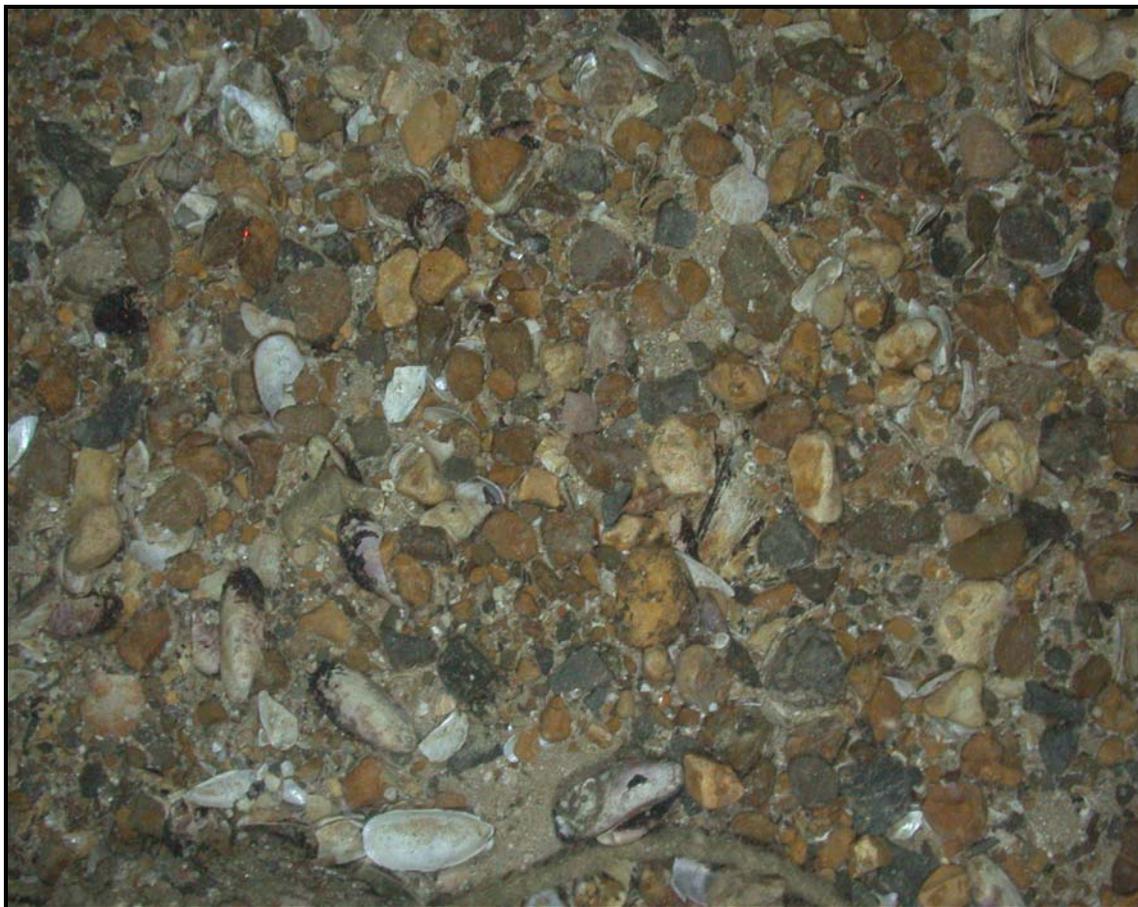
**Figure 6.** Sample of bottom surface sediment at the CSS *Alabama* wreck site.

During the tidal cycle, currents flowing over the wreck site can exceed four knots. In addition to restricting on-site research activity, currents have had an important effect on the wreck. The *Alabama* lies on a hard bottom consisting of rocks, pebbles, shell hash and sand (Figure 6). That environment limited scour settling of the hull. With the exception of sand and shell deposited within and around the wreck, most of the vessel structure remained exposed to the water column elements. That highly dynamic water column environment contributed to the deterioration of virtually all exposed structural remains. During the life of the project, more than a meter of bottom surface sediments, mostly shell hash, have been observed to migrate rapidly away from the wreck and return. In this highly abrasive environment, the *Alabama's* exposed hull remains, already weakened by biological activity, have deteriorated to the approximate level of the stable bottom surface below the shell hash.

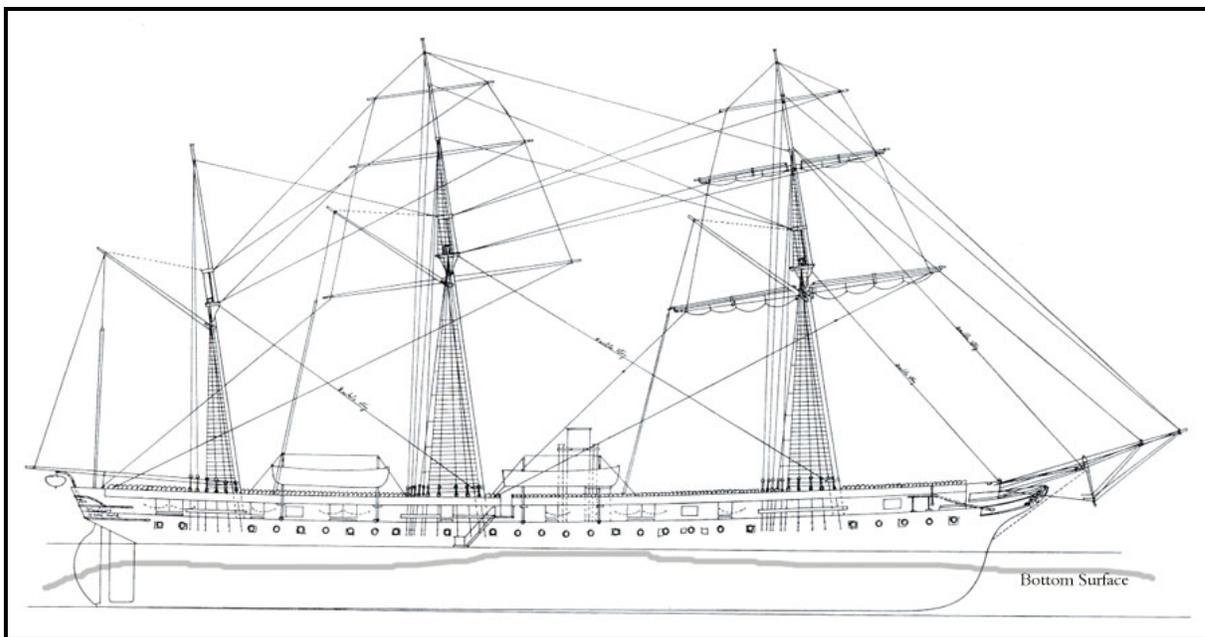
**Figure 7. Projection of surviving hull remains plotted over drawing of the CSS *Alabama* by Andrew Bowcock.**

Only the unexposed lower hull and amidships portions of the starboard side of the *Alabama* survive intact. The hull lists approximately 30 degrees to starboard and is oriented perpendicular to the prevailing current pattern. Depth measurements taken by the divers using a submersible, precision depth recorder confirm that sediment consisting of shell hash, pebbles and sand has accumulated within and around the *Alabama* to a depth of almost three meters (Figure 7). The major accumulation of material is amidships and is probably a result of the *Alabama's* machinery and boilers. Amidships, the port side of the hull is exposed to the approximate position of the turn of the bilge while the starboard side could survive to the approximate location of the lower deck clamp. Toward the stern, the depth of sediment rapidly decreases to the approximate level of the propeller shaft. At the stern, a little less than half of the propeller is exposed along with the top of the brass frame that lifted it clear of the water. No evidence of the stem was observed, which made it difficult to determine the amount of sediment accumulation forward. It is also possible that the hull may not lie on an even keel fore and aft and the amount of surviving structure is considerably less (Figure 8). Very little of the surviving hull structure is exposed at the site.

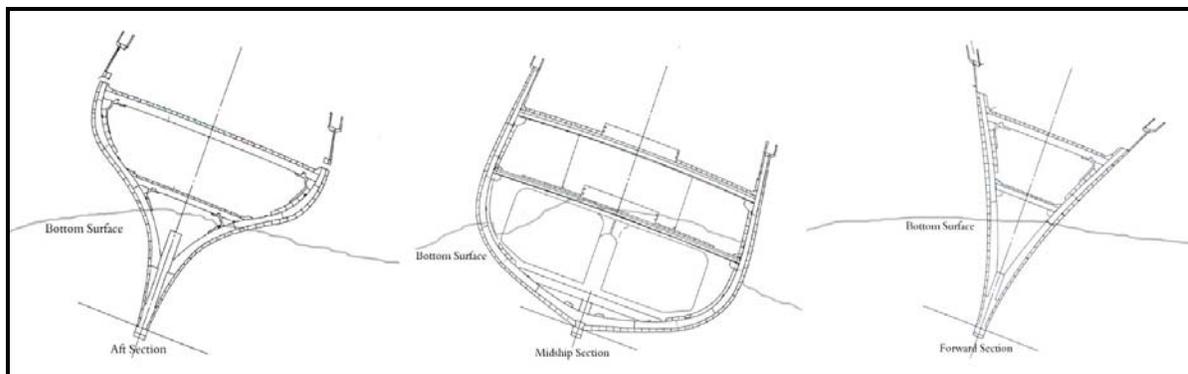
**Figure 8. Projection of surviving hull structure beneath bottom sediment plotted over hull sections drawn by Andrew Bowcock.**

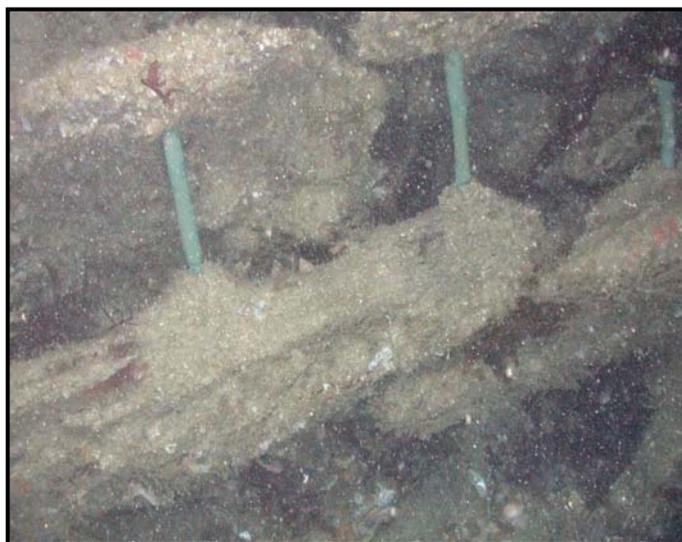
Forward of the lifting frame and propeller, the port side of the hull is defined by exposed frames, planking and ceiling (Figure 9). Although sporadically covered by migrating

**Figure 9. Exposed hull remains on the port quarter forward of the lifting frame.**

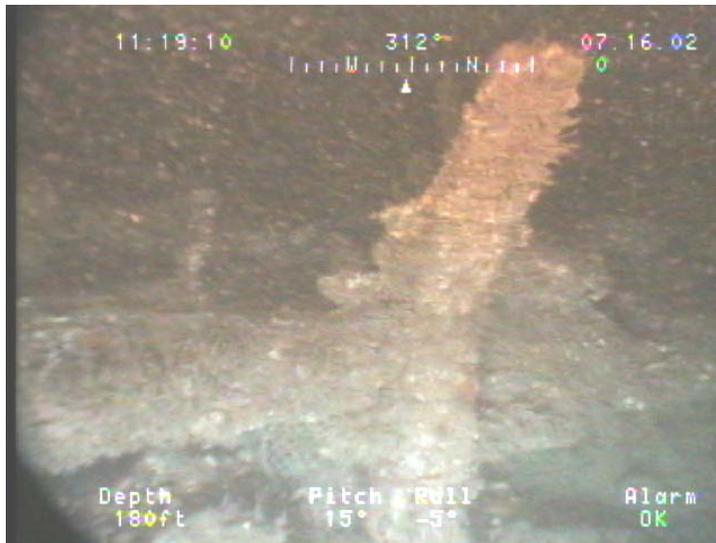
**Figure 10. Iron knee attached to port deck clamp.**

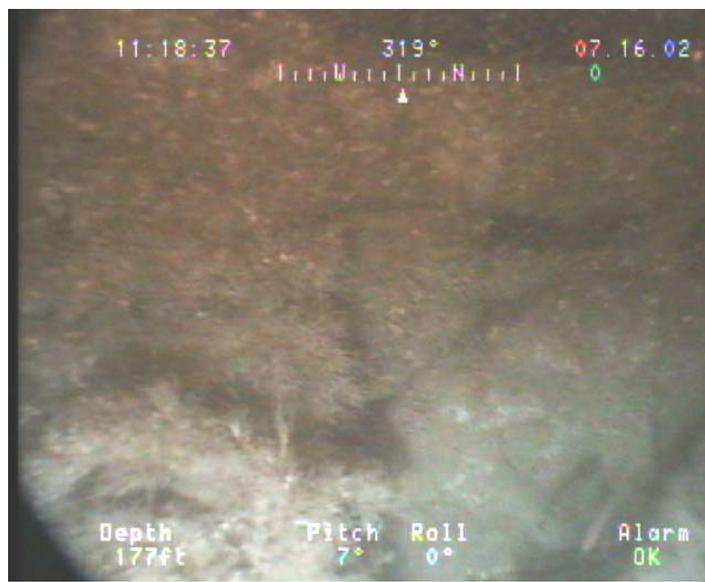
Much of the *Alabama's* steam machinery is accessible. The two steam cylinders lie athwartships, just inside the lower hull aft of the boilers. Both cylinder heads, their beds and associated valve chests are exposed (Figure 11). A large steam pipe from the aft face of the aft boilers extends aft across the outboard ends of the cylinders (Figure 12). Debris and sediment cover the center of the engines and both of the condensers located to starboard.

**Figure 11. Forward steam cylinder head.**

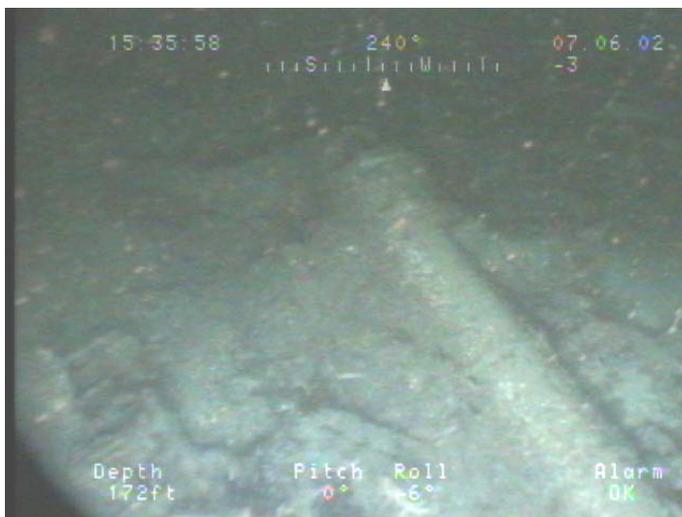
**Figure 12. Main steam feed pipe from boilers.**

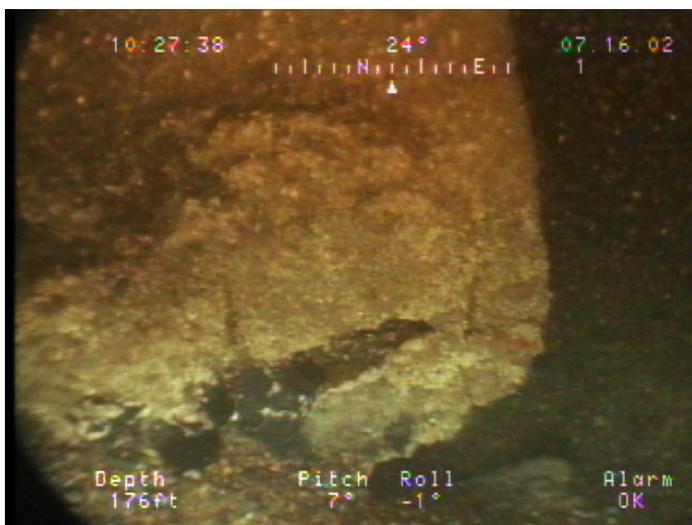
**Figure 13. Forward port boiler firebox .**

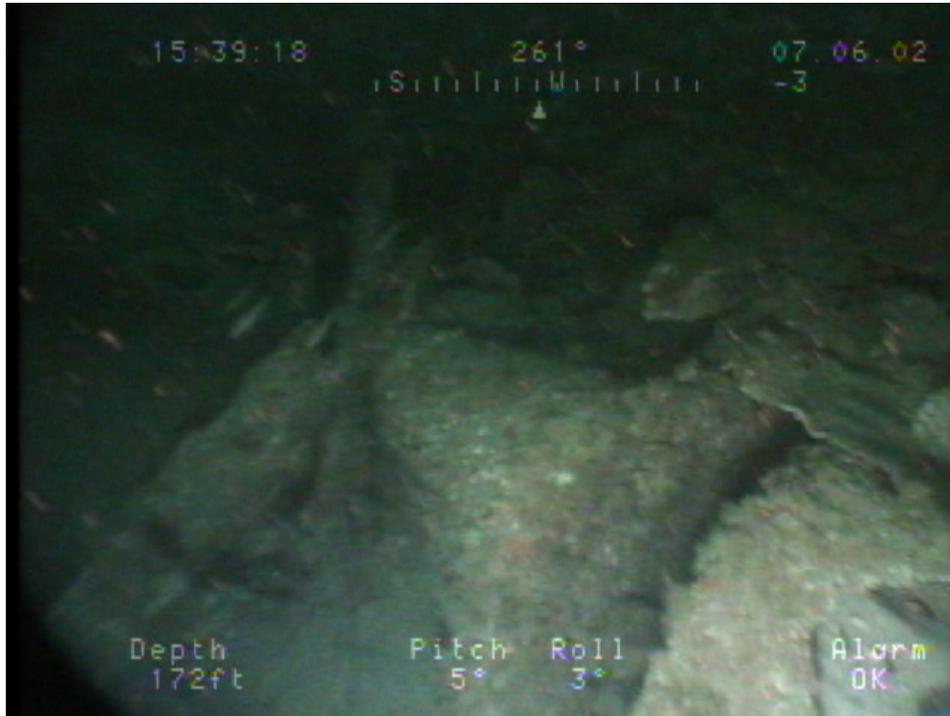
Forward of the steam engines, the outboard sides of two of the *Alabama's* four boilers are exposed. Each of the port boilers is rectangular with a longitudinally rounded upper and lower shell. The lower outboard forward face of the forward boiler is exposed to the point that one of the firebox doors is periodically visible (Figure 13). The top of the port boilers are obscured by collapsed iron deck structure but the flues that connected them to the single smoke pipe are partially exposed (Figure 14). The starboard boilers are covered by sediment and debris from the iron decks above them. The base of the retractable smoke pipe that was centered between the four boilers extends approximately six feet into the water column (Figure 15). Forward of the smoke pipe an 8-inch copper steam blow off pipe that served the forward boilers remains standing. Aft of the smoke pipe a section of the 8-inch copper steam blow off pipe that served the aft boilers lies on the bottom athwartships. Although the shaft tunnel and propeller shaft are covered by

Figure 14. Crushed flues that connect the boilers to a common smoke pipe.

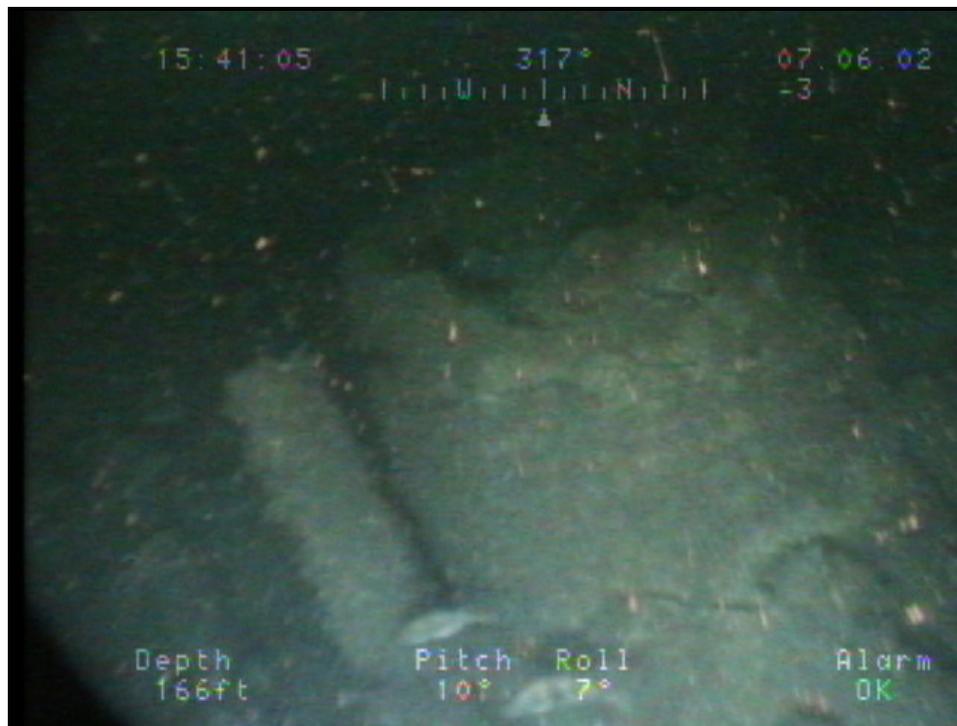
Figure 15. Smoke pipe and forward steam blow off pipe.

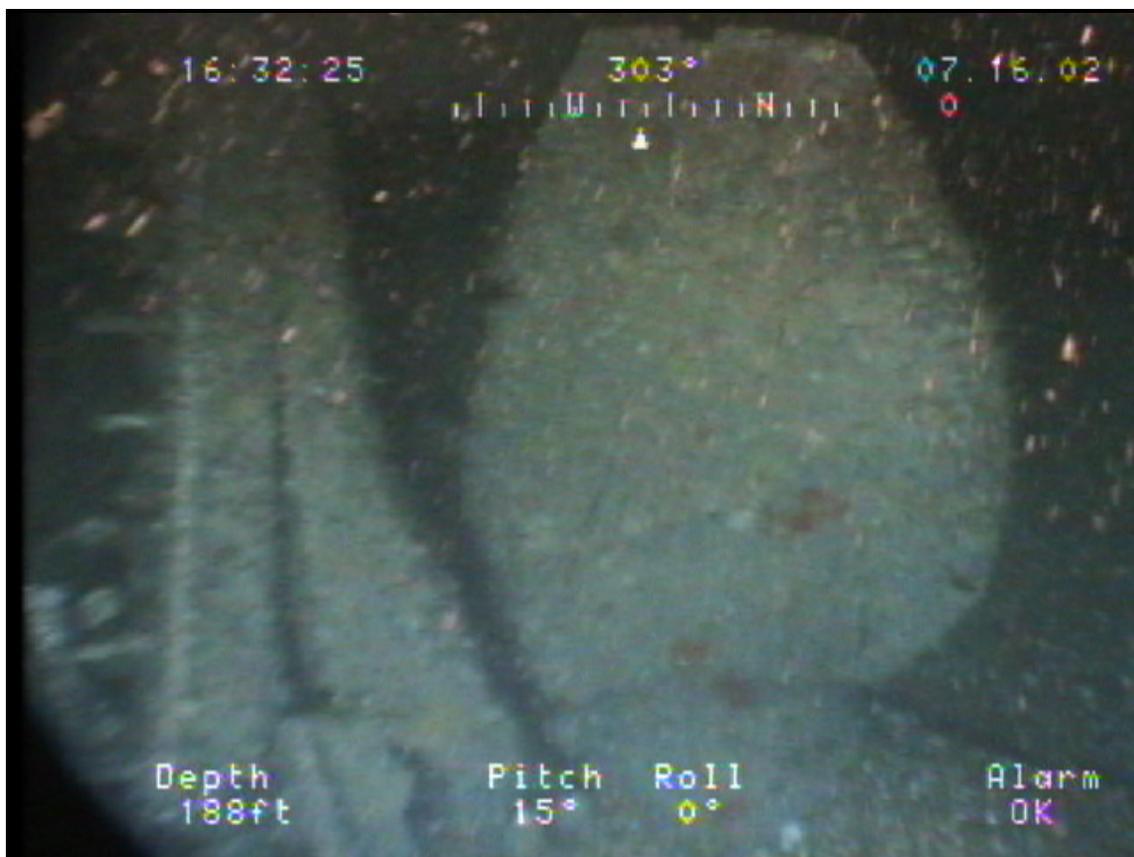
**Figure 16. Lifting frame and propeller.**

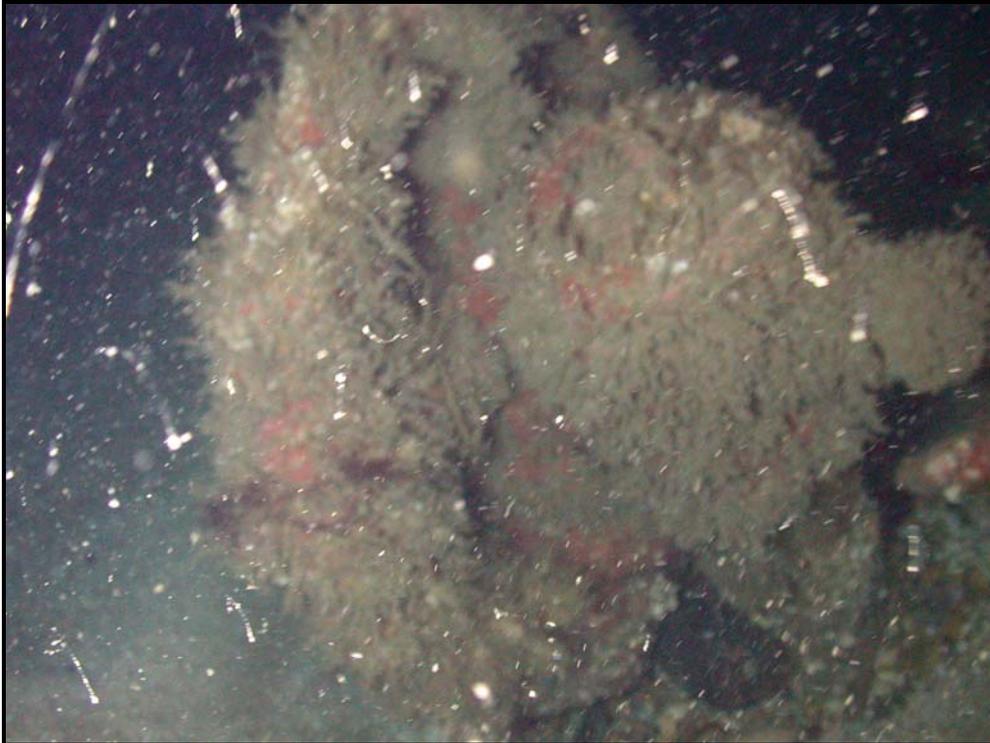
of the location where the remains of the ship's wheel were found in 1988, the aft Downton pump survives intact (Figure 17). The base of the pump remains plumbed to a valve chest that provided several options for source water. A fire nozzle with intact leather hose was recovered from the base of the pump in 2001. The second Downton was mounted forward of the boilers. Although the pump was intact as late as 1995, it appears to have been damaged by trawling or anchoring and the wheel was found broken in 2002 (Figure 18). The base of the pump appears to remain connected to its valve chest.

Figure 17. Aft Downton pump.

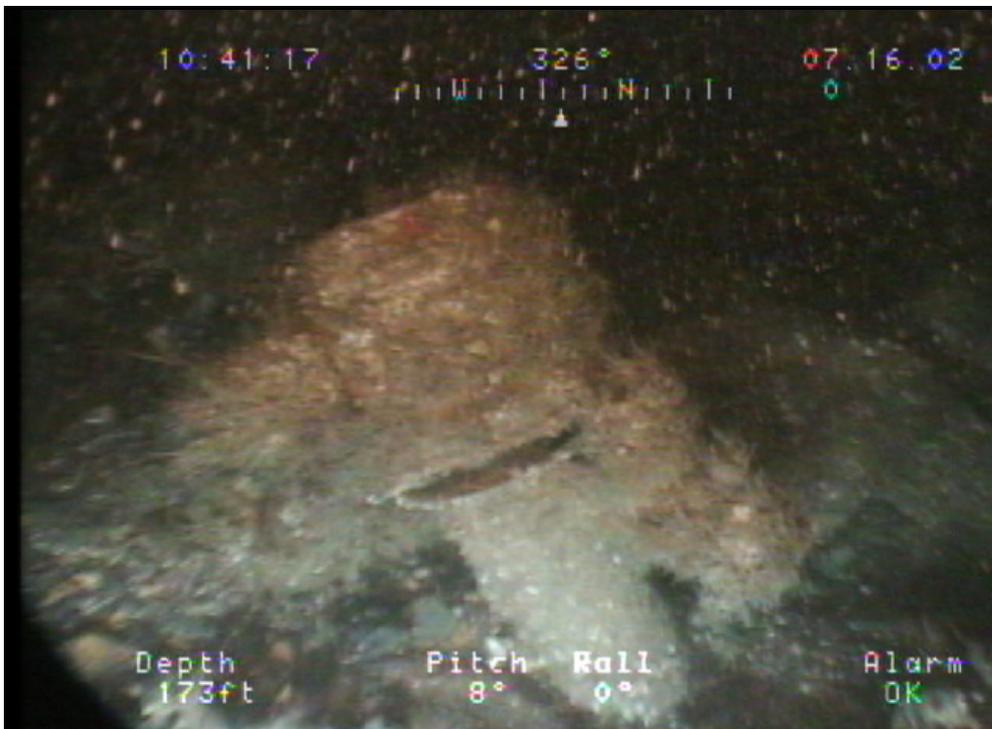
Figure 18. Damaged forward Downton pump.

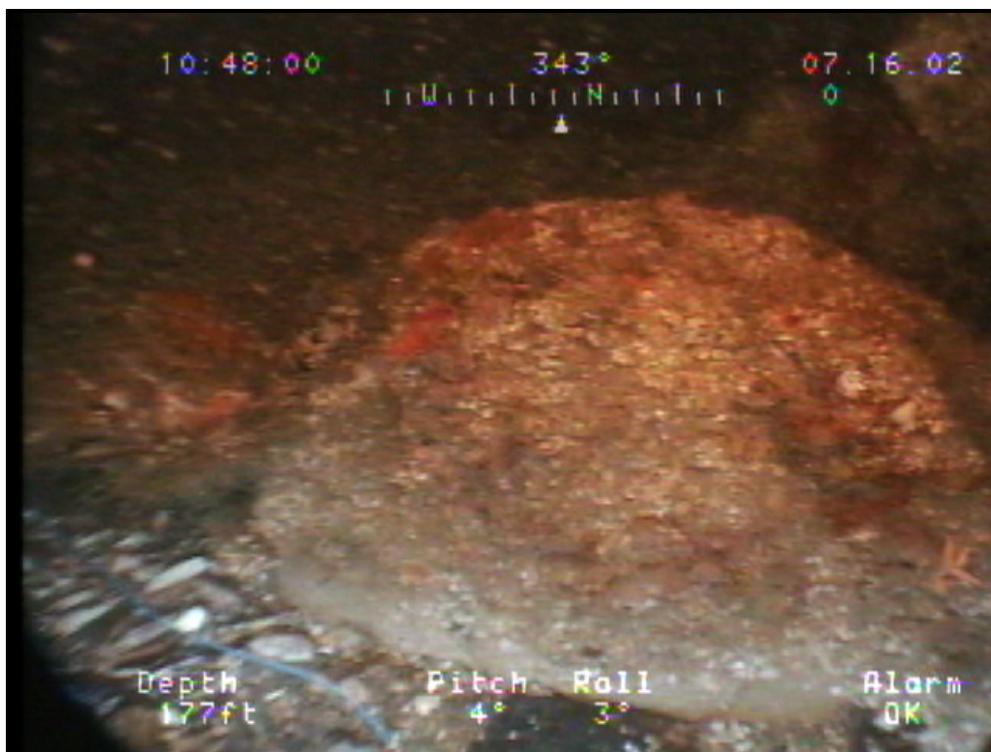
Frontward of the forward coal bunkers, an iron capstan is exposed on the bottom (Figure 19). Anchor chain stretches forward toward one of the large cast iron riding bitts, that was mounted on deck near the foremast (Figure 20). Just aft of the riding bitt, two knights from the foremast fife rail were found. Both knights were fitted with brass knightheads and fairleads for three internal sheaves (Figure 21). A third knight with similar fairleads and sheaves was found near the base of the mainmast between the aft boilers and the engines. Smaller, less obvious port lights with lead

Figure 19. Top of the capstan.

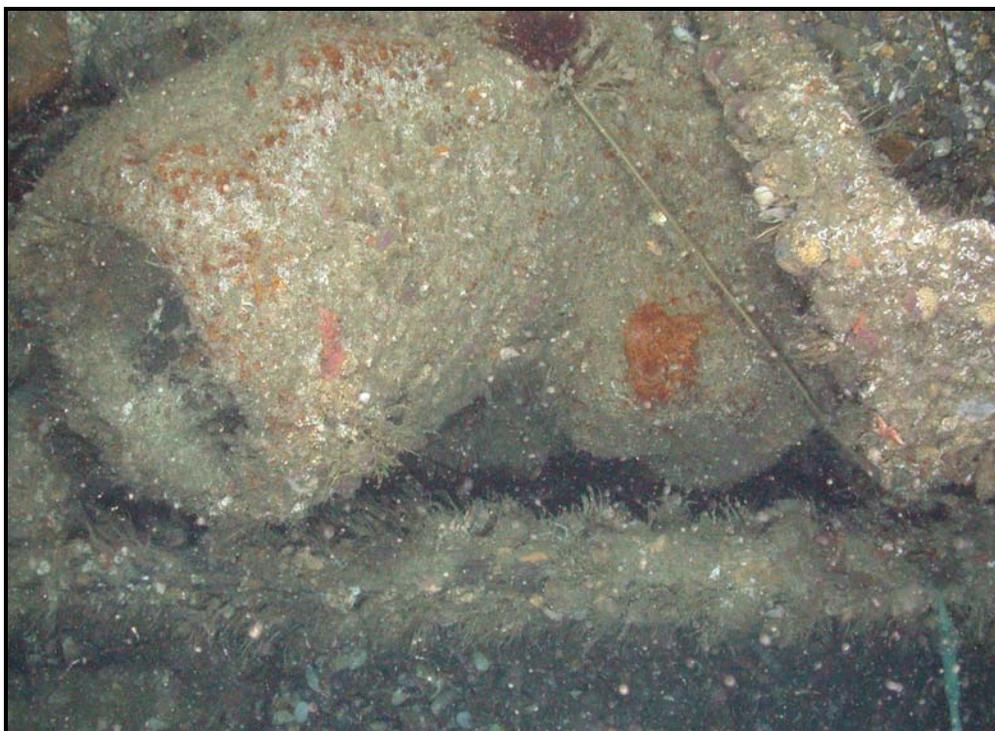
Figure 20. Iron riding bitt.

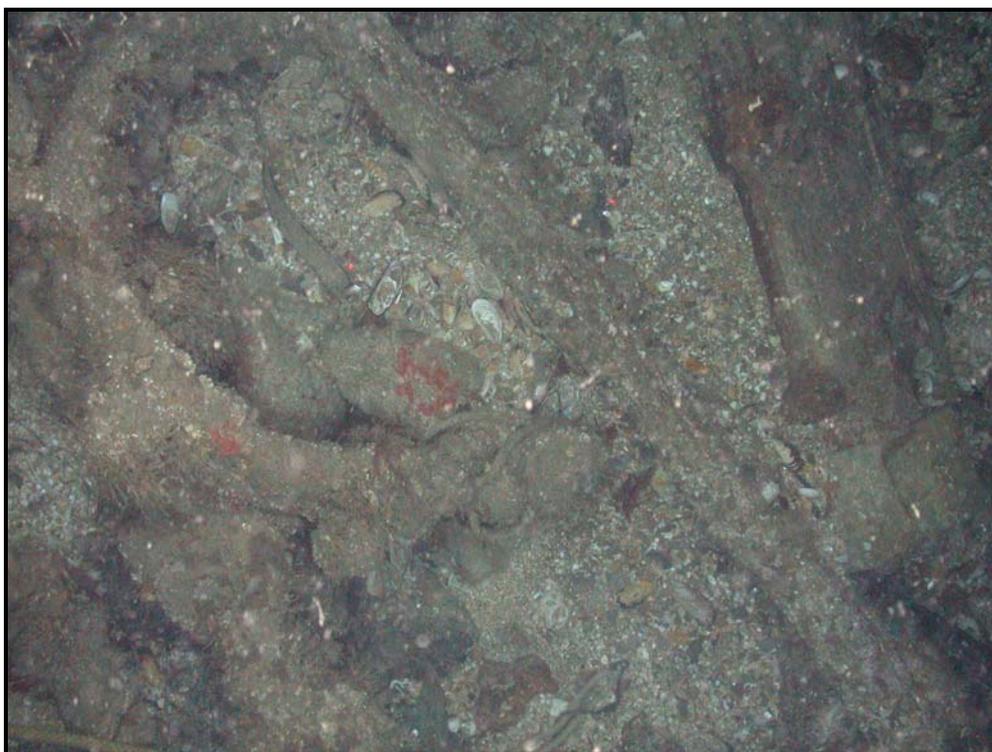
**Figure 21. One of the foremast knightheads.**

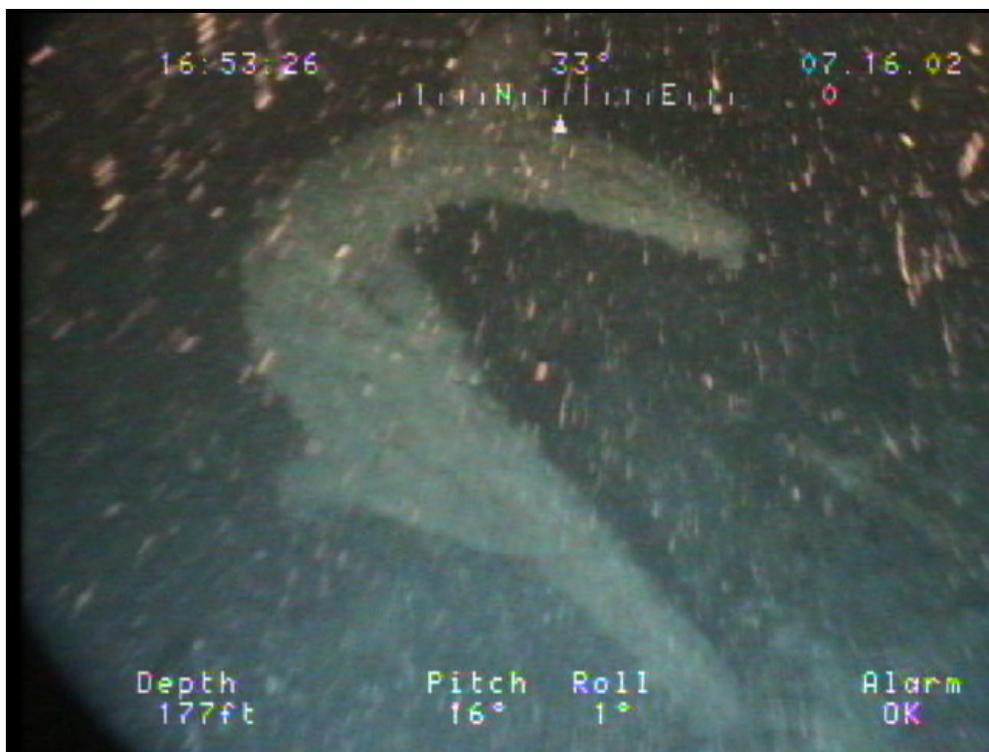
The *Alabama's* ground tackle was comprised of Trotman patent anchors. The starboard Trotman was apparently catted when the commerce raider sank. It now protrudes upside down from the bottom immediately outboard of the surviving hull structure. The crown juts approximately five feet into the water column and the arms are perpendicular to the hull (Figure 24). Only one arm and fluke of the port Trotman is exposed on the opposite side of the hull (Figure 25). Lying adjacent to

**Figure 24. Starboard Trotman anchor.**

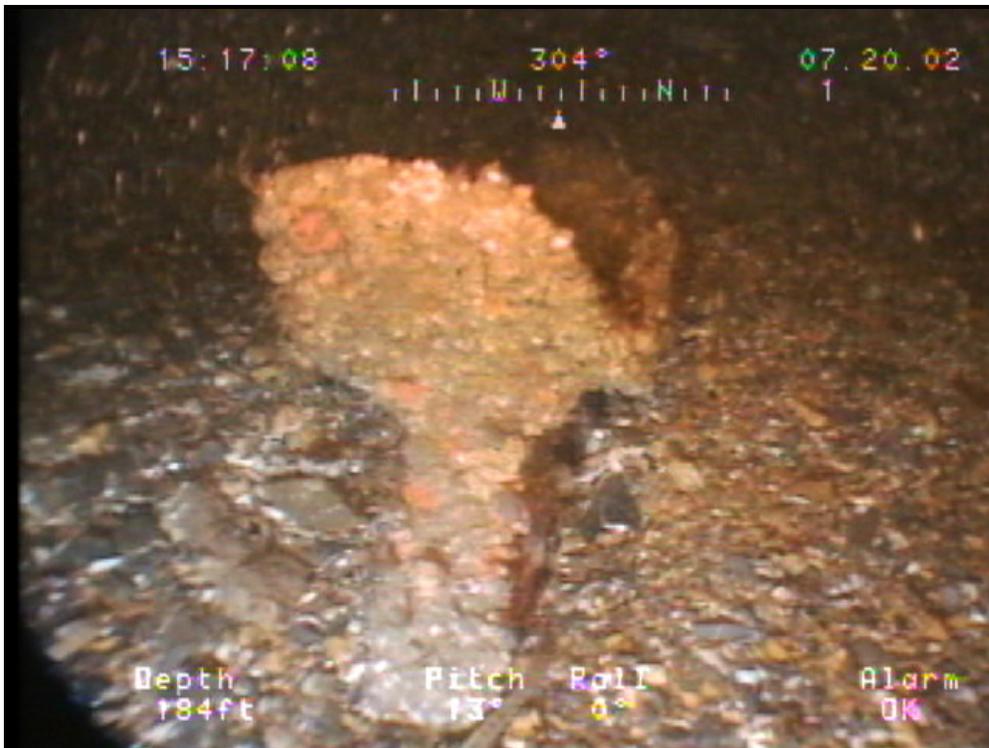
Figure 25. Fluke of the port Trotman anchor.

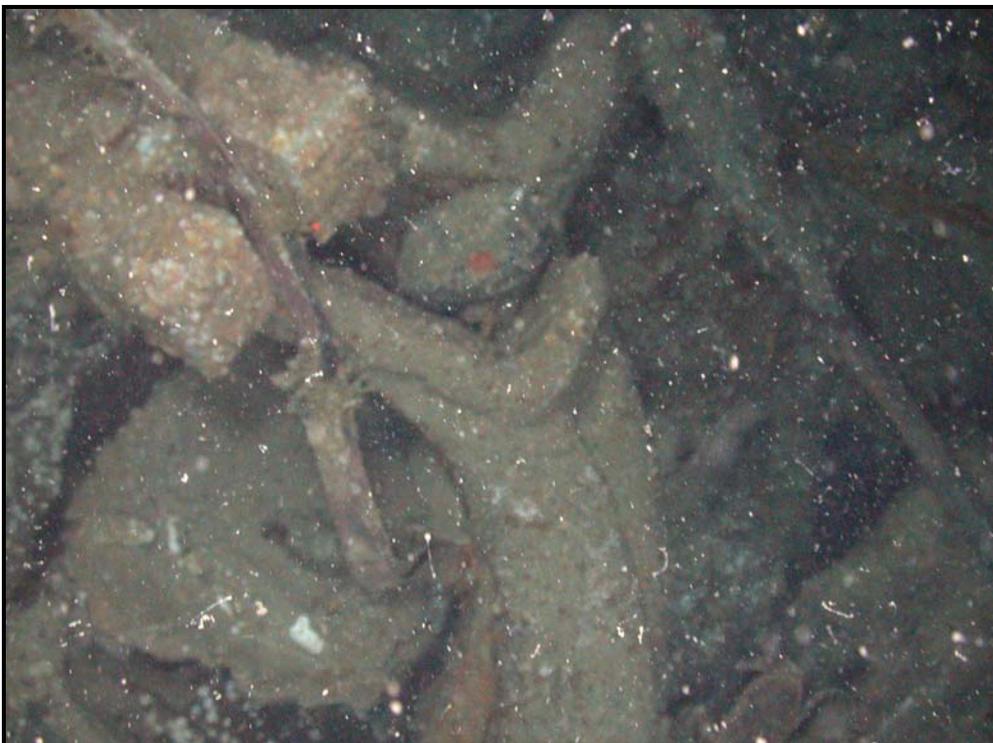
Figure 26. Flukes of two disassembled Trotman anchors near stove.

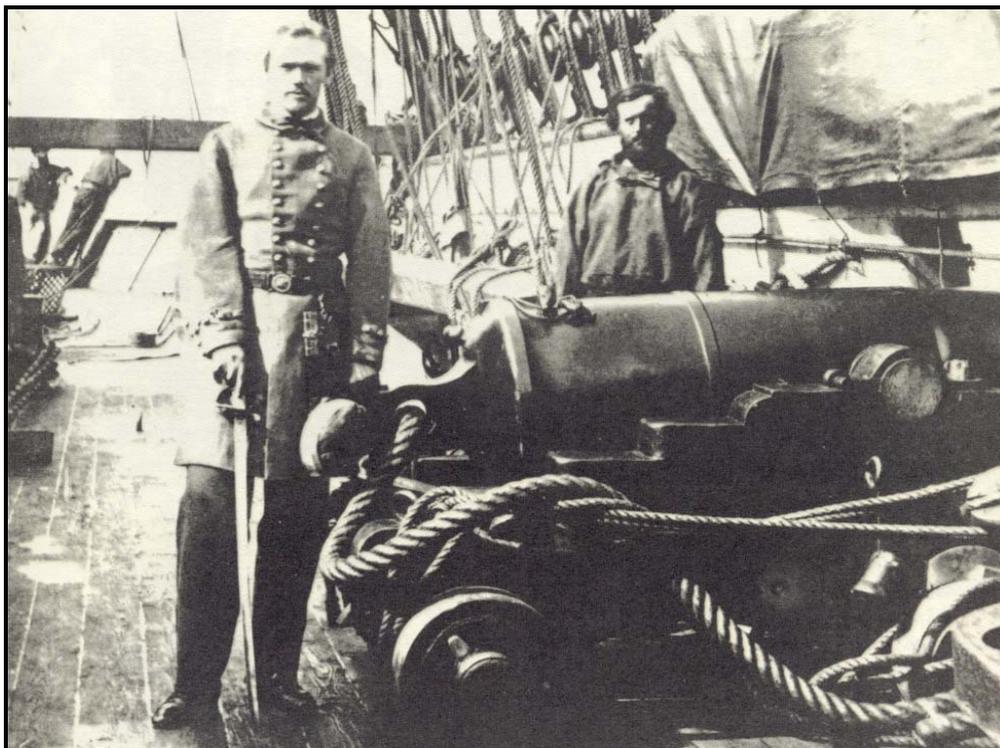
**Figure 27. British Royal Navy pattern 32-pounder on *Alabama's* starboard bow.**

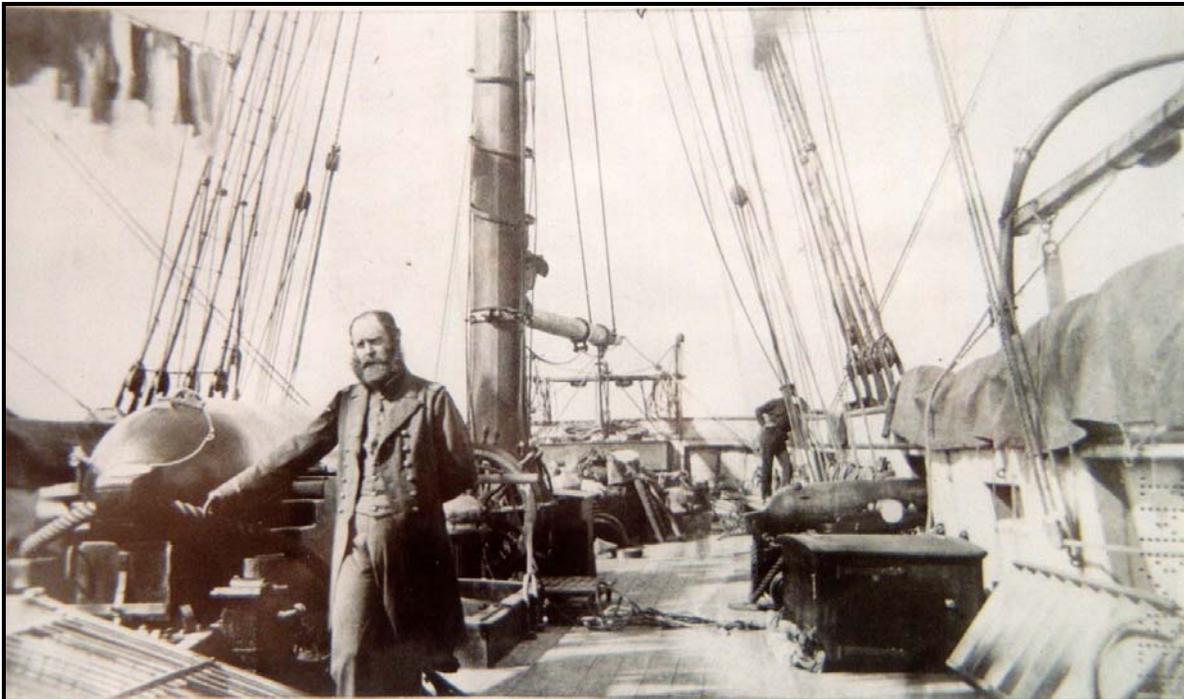
**Figure 28. Kell at the aft pivot gun and a Fawcett, Preston and Company 32-pounder on the port quarter.**

The CSS *Alabama* was to be fitted with eight pieces of ordnance in the Azores. Six of those pieces were 32-pounder smooth bores. Seven cannon have been identified at the wreck site. Two of the cannon were cast from a British Royal Navy pattern (Figure 27) and three were of a more modern pattern (Figures 28 and 29) produced by Fawcett, Preston and Company in Liverpool. A Blakely Patent 7-inch 100-pounder rifle was mounted on a pivot carriage forward (Figure 29) and a 68-pounder smoothbore was similarly mounted aft (Figure 28). One of the Blakely Patent 32-pounders was found lying across the starboard side of the hull forward of the boilers. A second Blakely Patent 32-pounder was identified outside the hull structure, immediately forward of the propeller and lifting frame. The forward Blakely Patent 32-pounder was recovered in 2000. Both of the British Royal Navy pattern 32-pounders have also been identified. One lies inside the hull starboard and forward of the boilers and adjacent to the forward Downton pump. A second was identified on the iron deck structure immediately aft of the smoke pipe. The

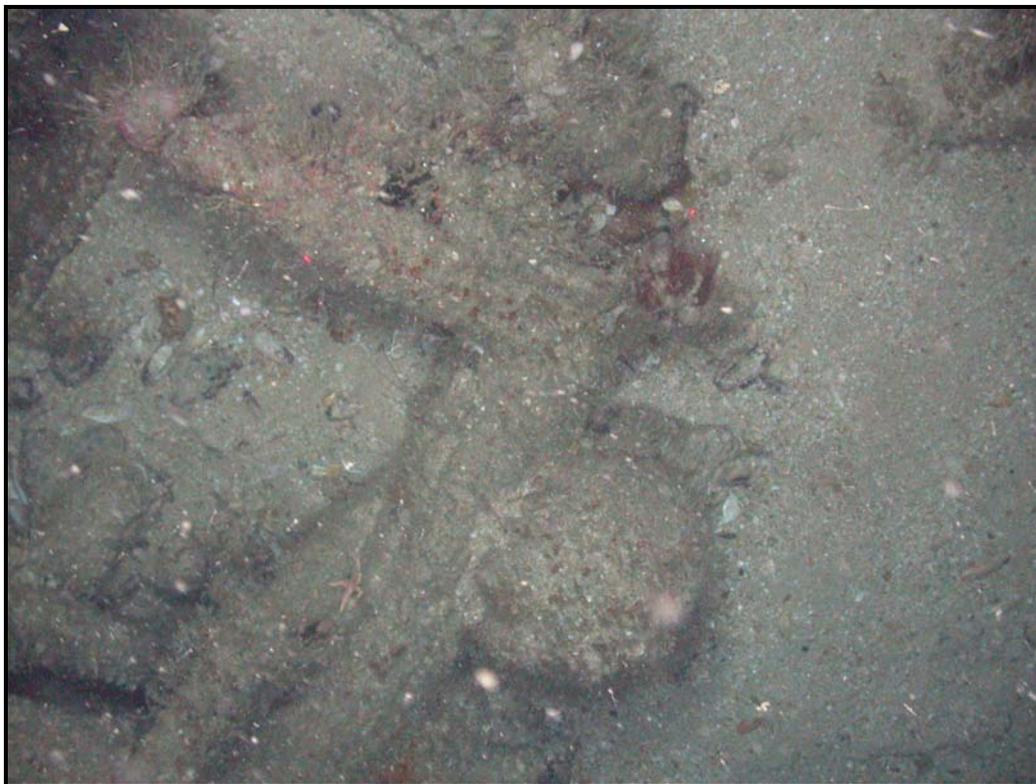
In addition to the seven cannon, the site contained shot, gun truck wheels and brass tracks for the gun carriages. Many of the brass tracks have been recovered. Two shot have been recovered. One conical projectile was inside the barrel of the 7-inch rifle. A shell for a 32-pounder was recovered from the stern forward of the propeller. That shot was attached to a wood sabot and had been packed in a wood box for storage. Additional round shot have been observed forward of the boilers and in the vicinity of the aft pivot gun, one possibly from USS *Kearsarge* (Figure 30).

**Figure 30. Round shot or shell lying adjacent to an iron knee.**

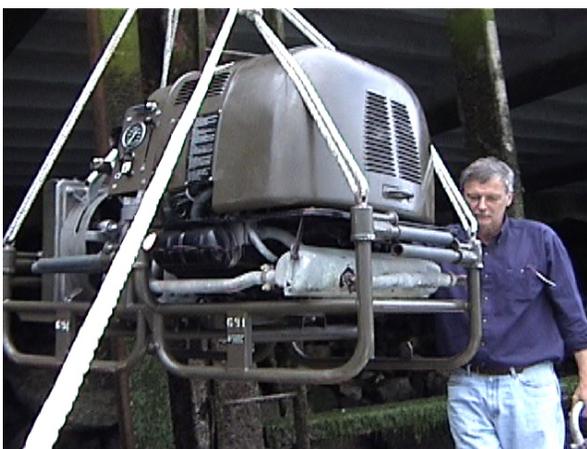
**Figure 36. Loading air compressor.**

With the grids assembled and positioned, the first attempt at excavation was made on 4 June. Excavation was to be carried out using airlifts powered by a rotary compressor aboard the American research vessel *Enrica* (Figure 36). The compressor was powered by a hydraulic system attached to the *Enrica's* diesel engine. That design eliminated the more dangerous gasoline engine that took up most of the space on the *Enrica's* aft deck. Unfortunately, virtually every component of the new and untested compressor system failed during the project. Due to the lack of time to assemble and test the compressor prior to the initiation of fieldwork those failures ultimately eliminated any possibility of conducting the proposed excavation in the stern. Archaeologists spent much of every day during the first dive period attempting to repair and redesign the system and invaluable research time was lost.

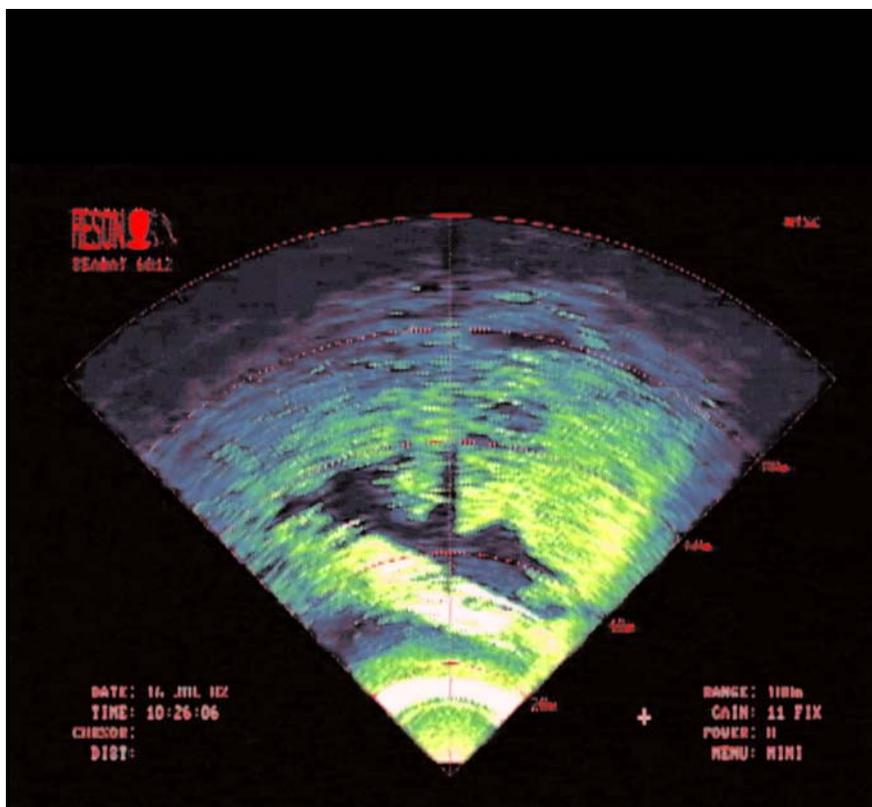
Figure 42. ROV sonar image of the wreck site.

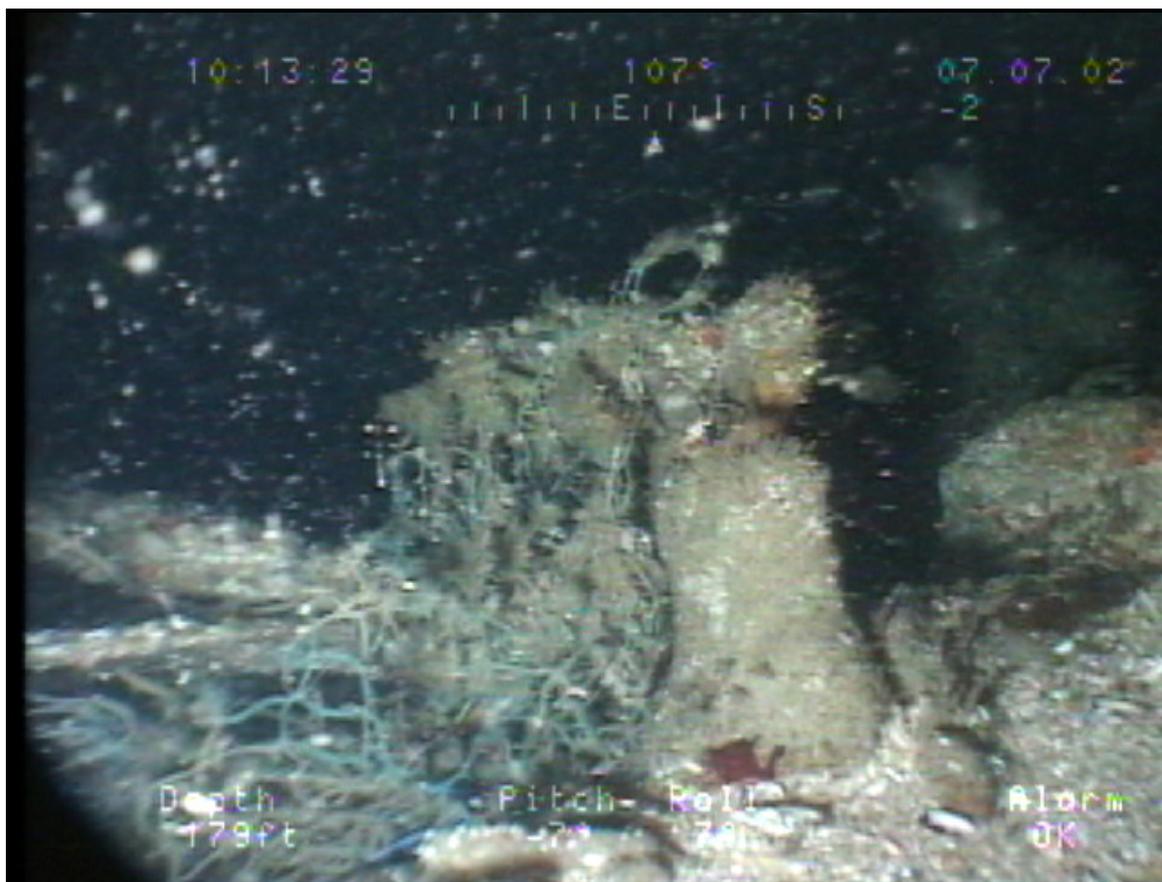
**Figure 45.** Fishing nets fouled on machinery on the *CSS Alabama*.
