## **Archaeological Investigation and Remote Operated Vehicle Documentation: Confederate Commerce Raider *CSS Alabama* - 2002**

April 1, 2004

**Gordon P. Watts, Jr., Ph.D.  
Institute for International Maritime Research, Inc.  
P. O. Box 2494  
Washington, North Carolina 27889**

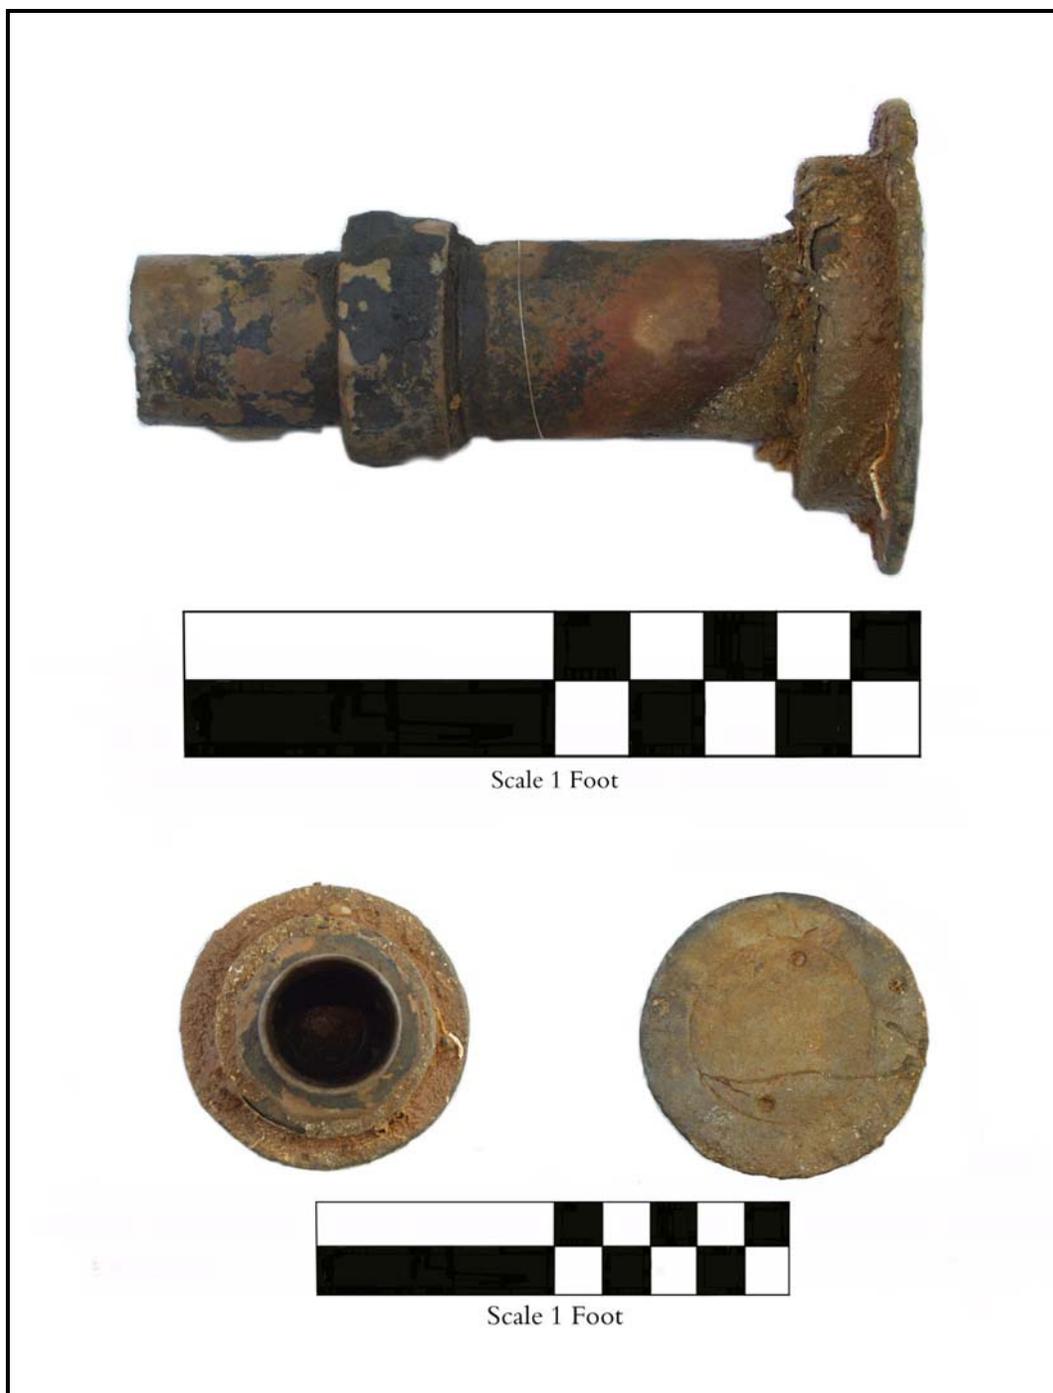
**Figure 46. ALS-300 Fill pipe, deck flange and cap.**

the lid for a spanner. The multi-component artifact is made up of five different pieces. The lid is screwed into the deck plate and the deck plate is screwed onto a short pipe nipple. The pipe nipple is connected to a broken section of pipe by a compression collar. All of the components appear to be fashioned from brass. More detailed information will be available after cleaning.

Length (max):	11.8 inches	29.9 cm
Diameter of deck flange:	7.3 inches	18.5 cm
Diameter of cap:	4.6 inches	11.6 cm
Diameter of collar:	3.8 inches	9.7 cm

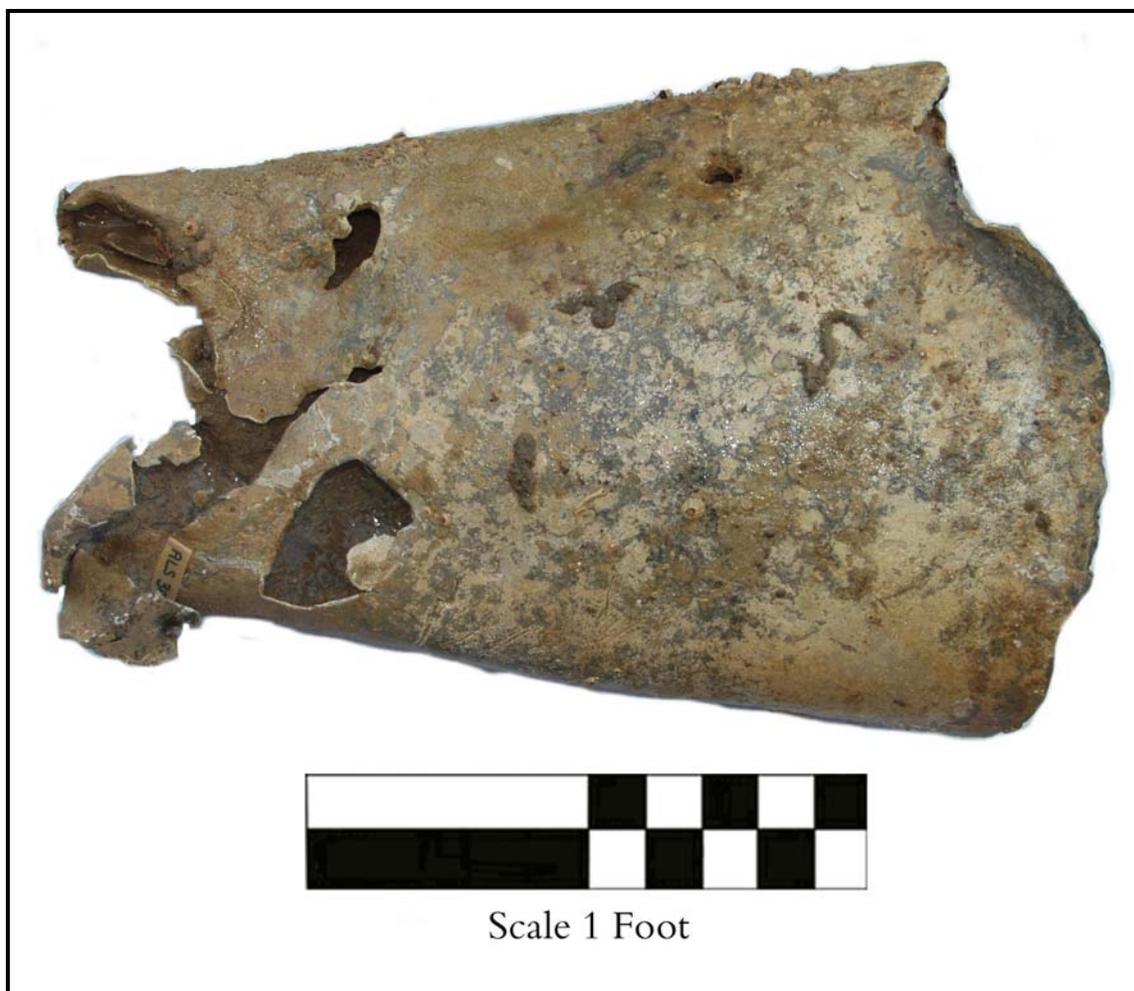
**Figure 47. ALS 301 Lead sheathing for port light aperture.**

Artifact ALS-301 is the lead sheathing for one of the conical port light apertures cut through the CSS *Alabama's* hull. The sheathing prevented water from entering the hull between the planking and ceiling and provided a more finished appearance. The brass frame and glass lens fitted inside the smaller outboard end of the sheathing is missing, and the outboard end of the artifact is heavily damaged.

Length (max):	21.6 inches	55.0 cm
Diameter of inboard end:	15.6 inches	39.5 cm
Diameter of outboard end:	10.6 inches	2.7 cm

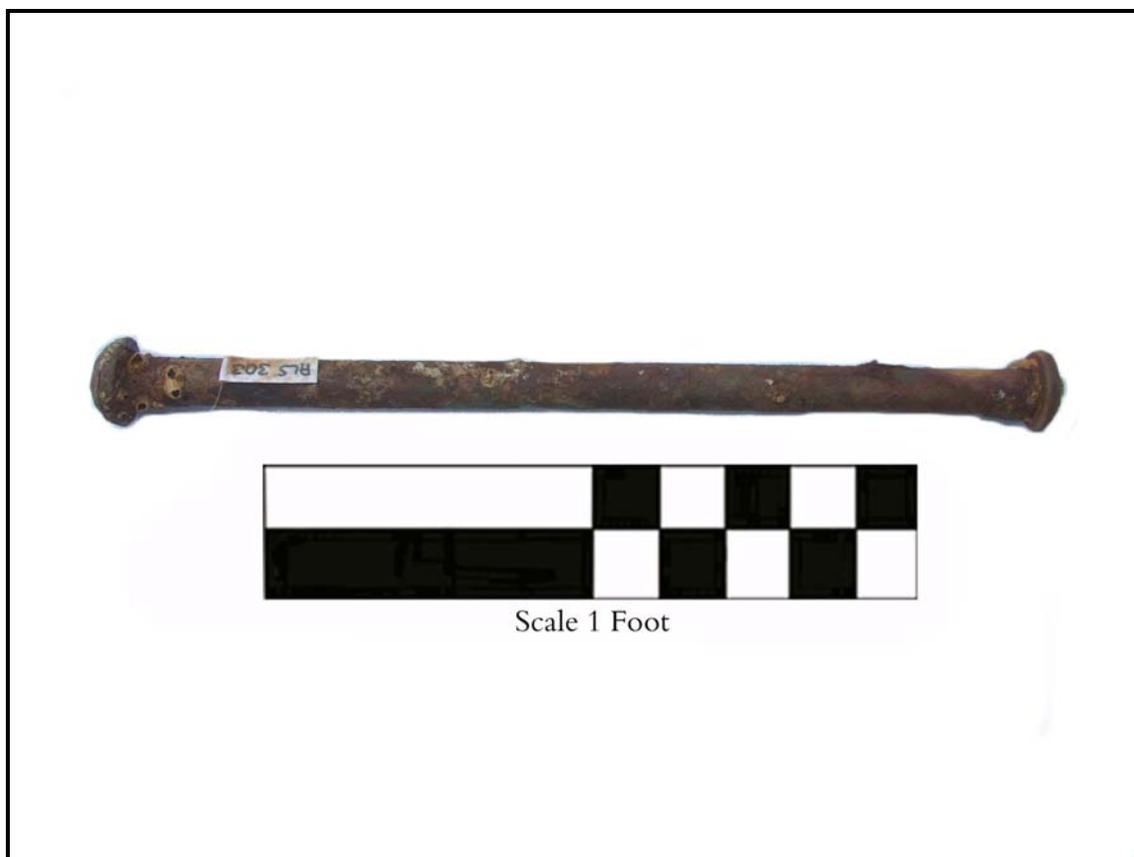
**Figure 48. ALS-303 Fastener with rove.**

Length (max):	18.1 inches	46.0 cm
Diameter of the pin:	0.9 inches	2.4 cm
Diameter of the head:	1.5 inches	3.8 cm
Diameter of the rove:	1.6 inches	4.2 cm

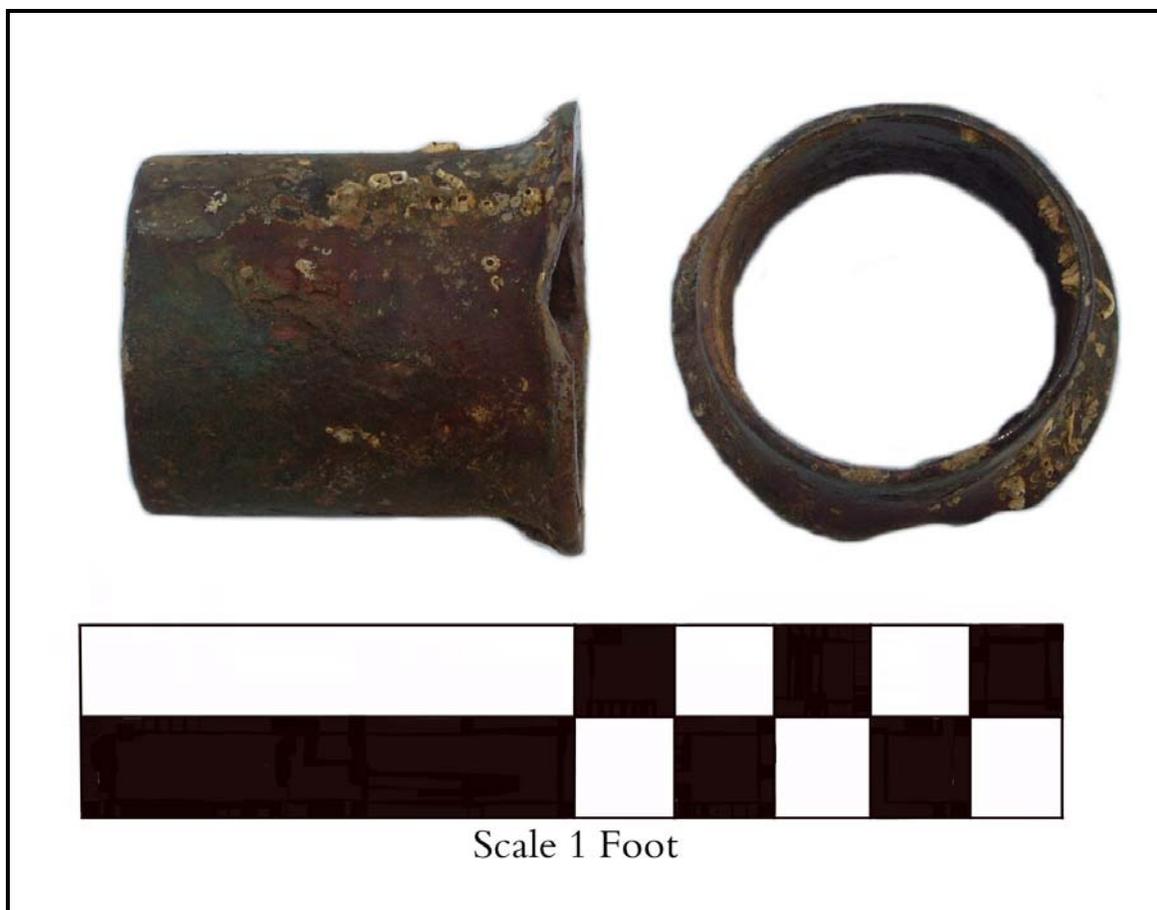
**Figure 49. ALS-302 Bronze sleeve.**

Length (max):	5.1 inches	12.9 cm
Diameter (max):	5.2 inches	13.3 cm
Diameter (min):	4.1 inches	10.5 cm
Thickness of walls:	0.2 inches	0.4 cm
Flange width:	0.8 inches	2.0 cm
Inside diameter:	3.9 inches	9.9 cm

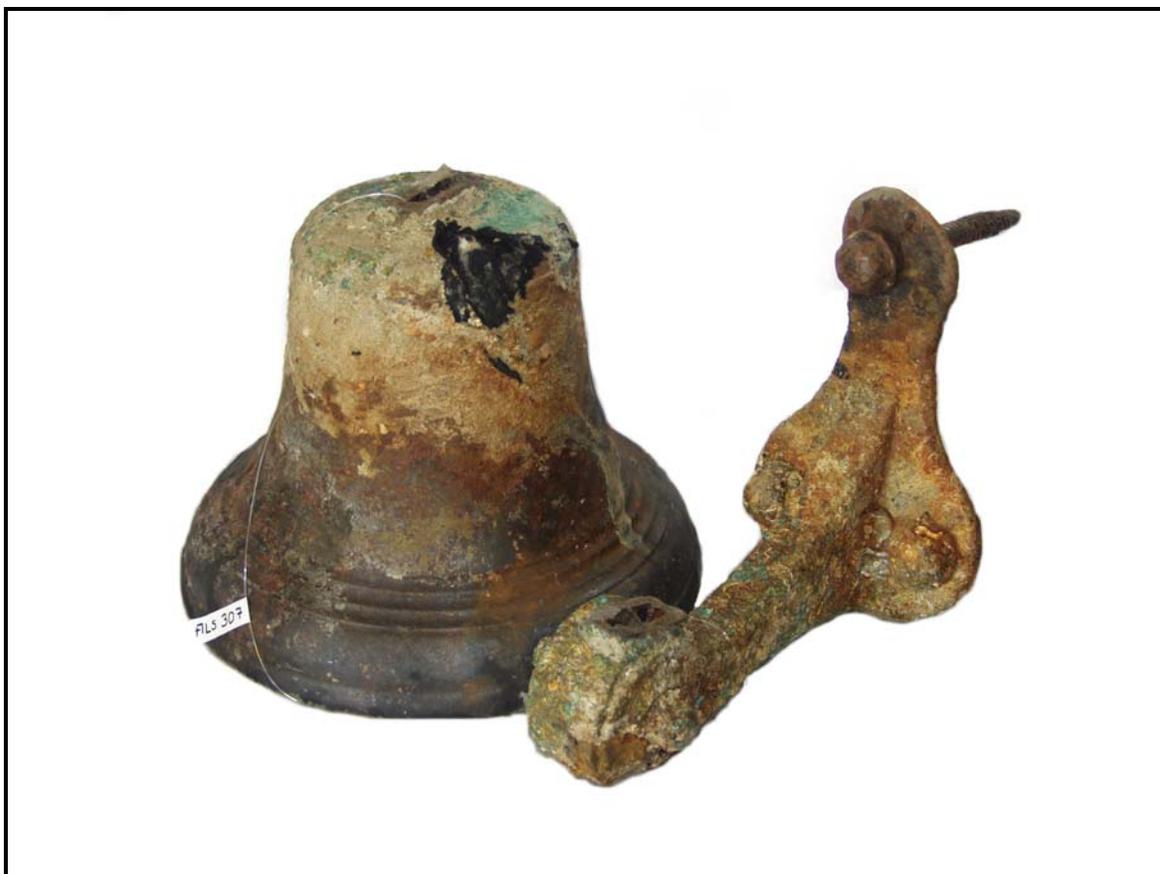
**Figure 53. ALS-307 Bell.**

ALS-307 is the CSS *Alabama's* bell. The CSS *Alabama's* bell appears to be cast in bronze. The mounting lug on top of the head is broken off and remains attached to the mounting bracket (ALS-308). The head of the bell is virtually flat with one reinforce inside the shoulder. Below the shoulder the bell walls flare slightly to the waist approximately half the distance to the lip. Below that point the flare is more exaggerated. Three reinforces decorate the bell immediately above the sound bow and the lip has a flat facet on the exterior. The clapper is missing.

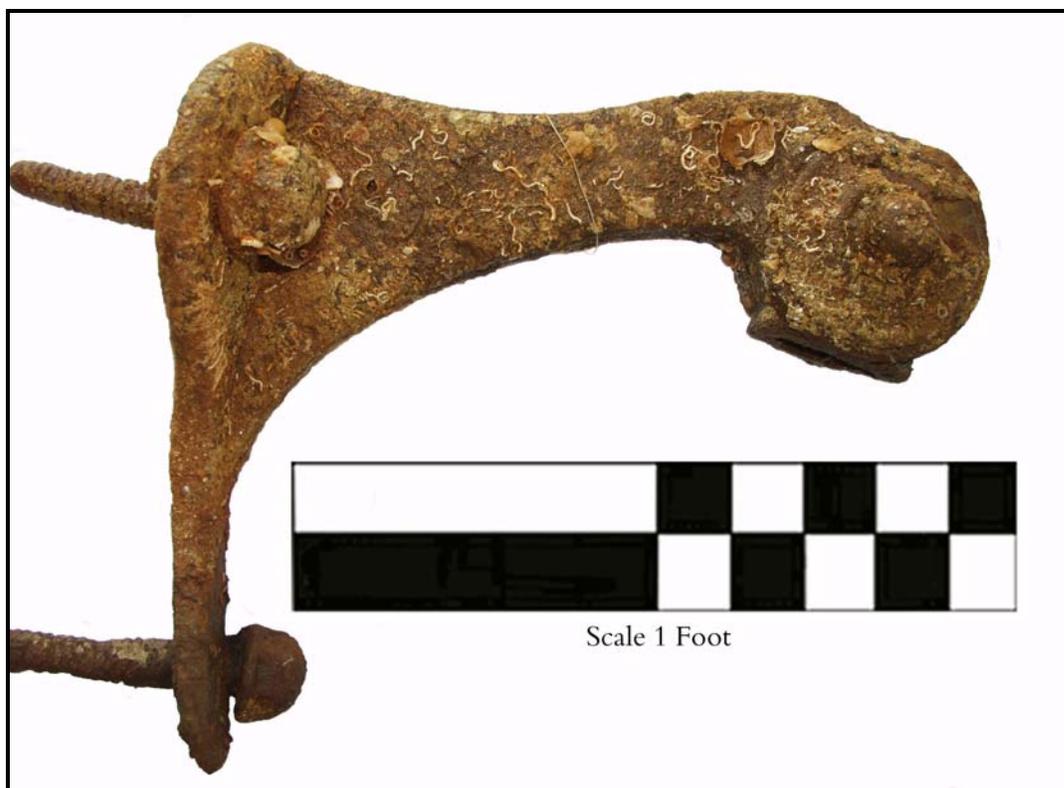
**Figure 54. ALS308 Bell Bracket.**

Artifact ALS-308 includes the bracket, mounting screws and remains of the bell flange. The base of the bracket is "T" shaped and vertically concave to fit the foremast of the *CSS Alabama*. Three pan-head lag bolts were employed to attach the bracket to the mast. The bracket arm is contoured, and the end is decorated with a concentric design centered on the hole for attaching the bell. A stud holds the broken bell head lug and two cap nuts secure the stud. All of the components appear to be bronze. More detailed information will be available after cleaning.

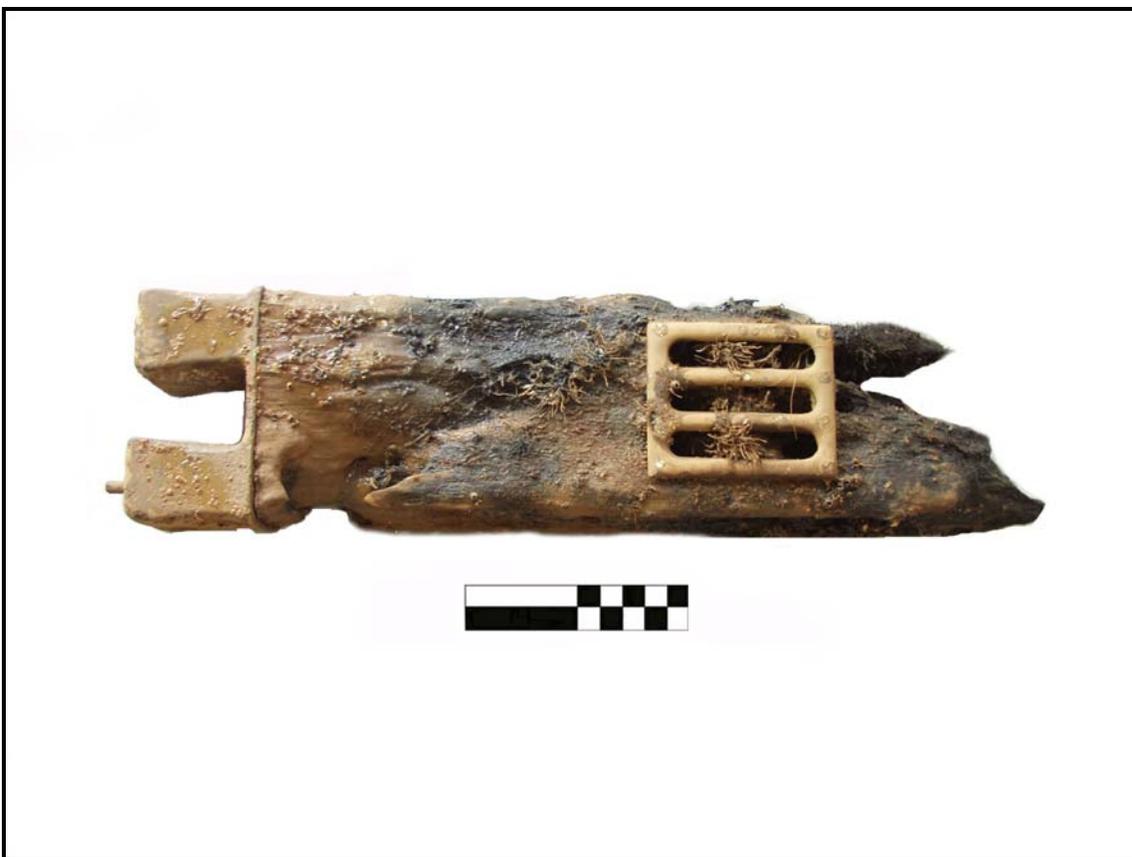
**Figure 55. ALS-309 Knighthead.**

Artifact ALS-309 is a knighthead. The brass cap and remaining wood are 49 inches in length. The dimensions of the wood are 11.6 inches in width and 6.1 inches in thickness. However, the base of the brass cap measures 12.5 inches by 6.5 inches and suggests the original dimensions. The brass cap measures 6.8 inches in height and the top of each head measures 4.5 by 6.2 inches. One of the heads has a 1.8-inch long .7-inch diameter bolt extending from the center. Near the broken end of the beam, a brass three-sheave fairing 9.5 inches high and 8.1 inches wide remains attached. The remains of three wood sheaves are on their axle bolt. The sides of the knighthead were protected by angle brass drilled and countersunk for mounting screws. Two .7-inch diameter brass pins in the side of the knighthead possibly provide an indication of the location of the pin rail. A second brass fairing was mounted on the side of the knighthead opposite the three-sheave fairing. That fairing measured 6.1 inches in length 3.0 inches in width and was attached by four screws. More detailed information will be available after cleaning.

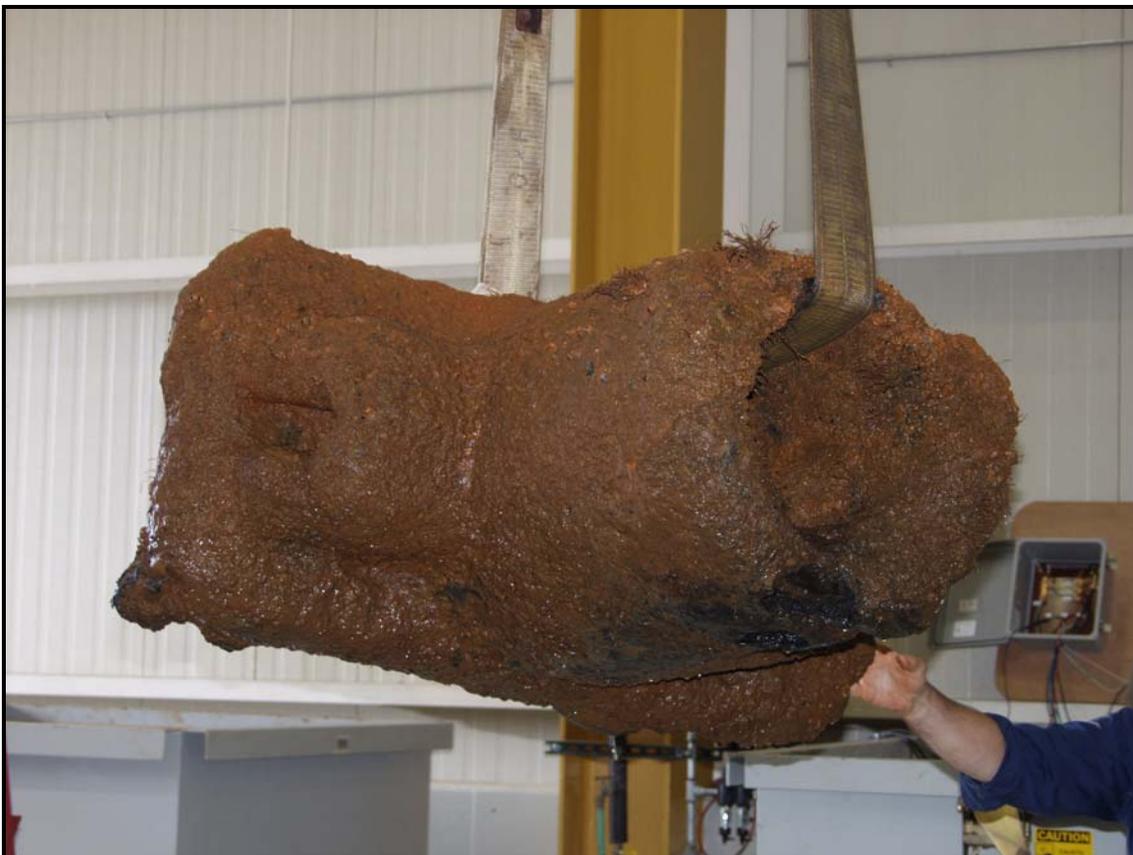
**Figure 56. ALS-310 Cast Iron Riding Bitt.**

Artifact ALS-310 is a cast iron riding bitt. Because of the size and difficulty handling this artifact no measurements were available at the time of report preparation. The base of the bitt is rectangular with rounded corners. A section in the center of the base is recessed approximately .1 inch and two holes for mounting bolts are located near each corner. With the exception of the center area adjacent to the bottom of the bitt cylinder, the base has a lip approximately .1 inch in height. The base is approximately .4 inches thick with rounded sides. The bitt cylinder is approximately 1.8 feet in exterior diameter and 2.5 feet in height. The interior is approximately 1.2 feet in diameter and that opening extends through the base. The forward side of the bitt cylinder was cast with a hollow protrusion approximately .8 feet in height that extends almost to the forward end of the base. The aft side of the bitt cylinder was cast with a second protrusion resembling one end of a cleat. More detailed information will be available after cleaning.

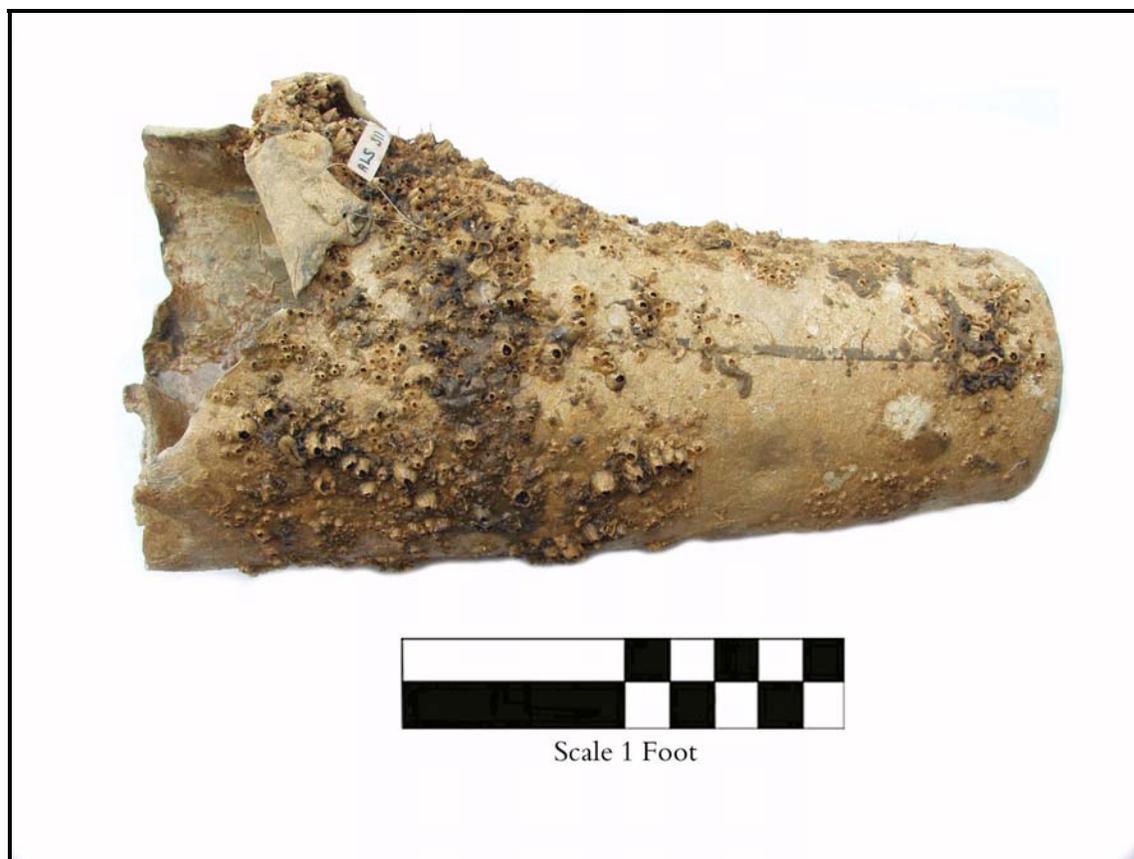
**Figure 57. ALS-311 Port Light.**

Artifact ALS-311 is a port light. Port lights were used to direct light into the lower deck of the ship and to serve as view ports for crewmembers. The glass lens is set in a tapered brass rim. The brass rim has recessed rings at either end. The lead sleeve is formed around the brass rim. The long tapered sleeve served as a through-hull fitting. Remains of both interior and exterior flanges are apparent and would have been secured with tacks. A soldered seam extends down the lead fairing. Additional similar port lights were also recovered during previous campaigns. More detailed information will be available after cleaning.

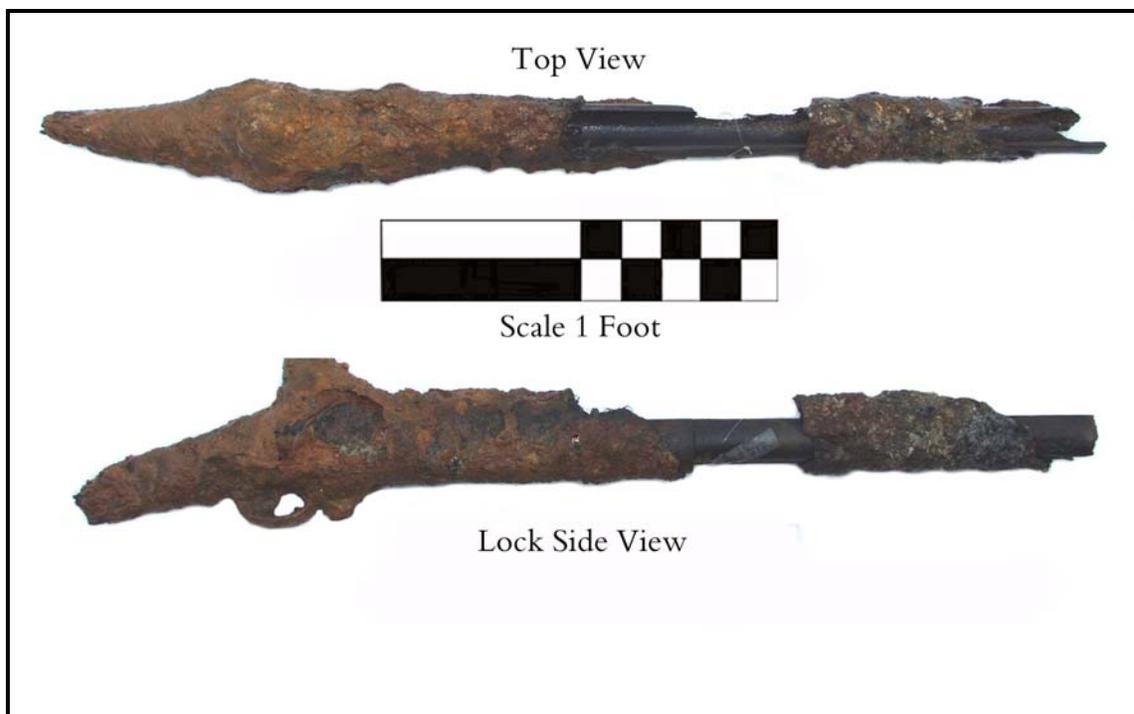
**Figure 58. ALS-312 Rifle fragment.**

Artifact ALS-312 is a fragment of a rifled musket. The stock behind the handgrip and trigger housing is missing, and the fore stock and barrel were broken off during recovery. The configuration of the lock, hammer and trigger guard indicate that the weapon is an Enfield Pattern 1853. Measurements and more detailed information will be available after cleaning.

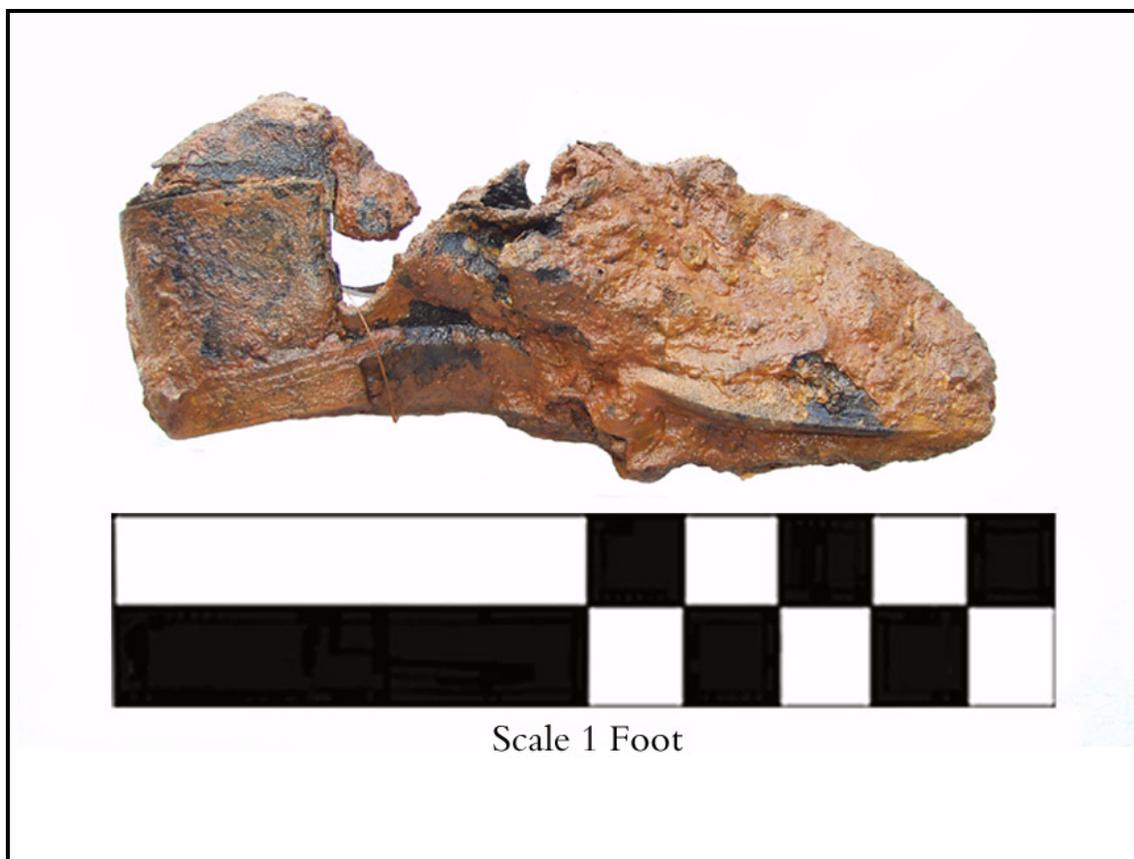
**Figure 59. ALS-313 Shoe or Boot Fragment.**

Artifact ALS-313 is the remaining fragment of a leather shoe or boot. The sole appears to be intact, but only a portion of the heel and upper survives. More detailed information will be available after cleaning.

Sole length:	9.2 inches	23.3 cm
Sole width (max):	3.0 inches	7.5 cm
Heel width:	2.7 inches	6.8 cm
Heel length:	2.3.inches	5.9 cm

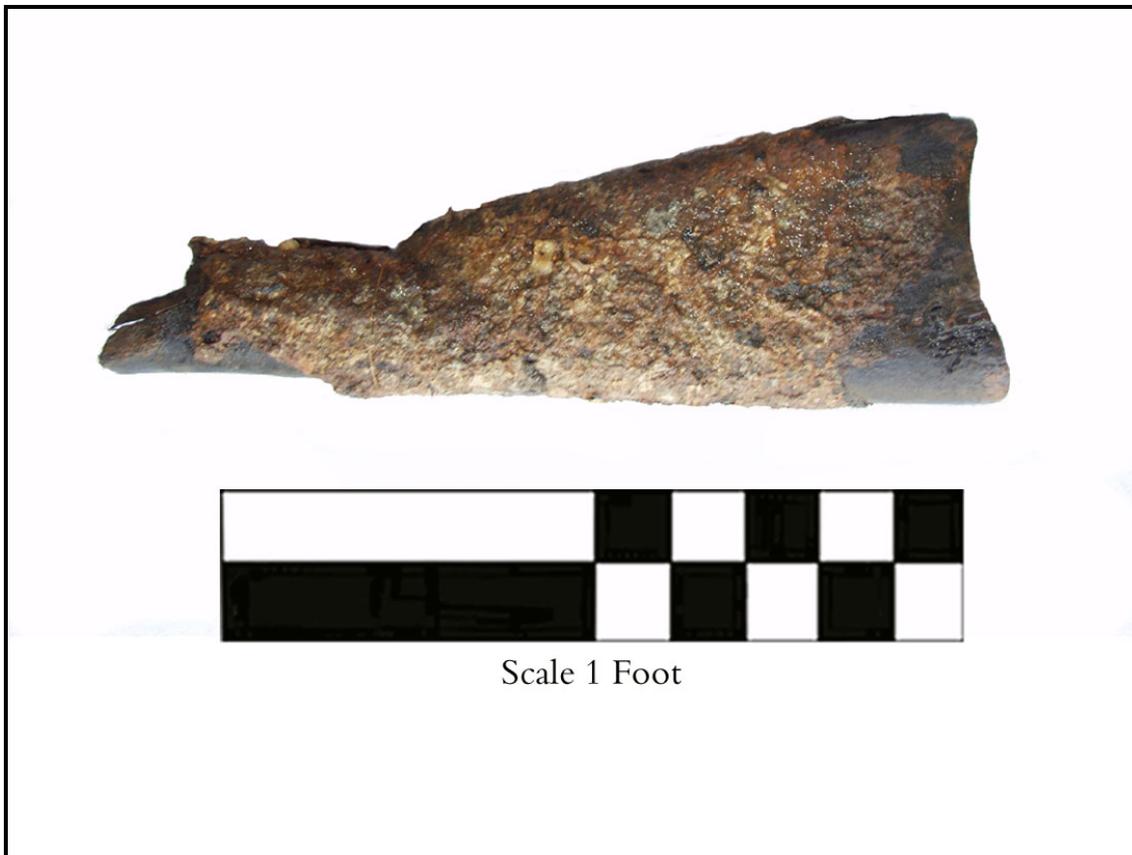
**Figure 60. ALS-314 Rifle Stock Fragment.**

Artifact ALS-314 is a fragment of the stock of a musket. The shape of the stock and the design of the butt plate recess suggest that the weapon was an Enfield Pattern 1853 rifled musket. The butt plate, probably brass, was apparently lost during recovery. More detailed information will be available after cleaning.

Length:	14.2 inches	36.0 cm
Butt Height:	4.5 inches	11.5 cm
Grip Height:	2.3 inches	5.8 cm

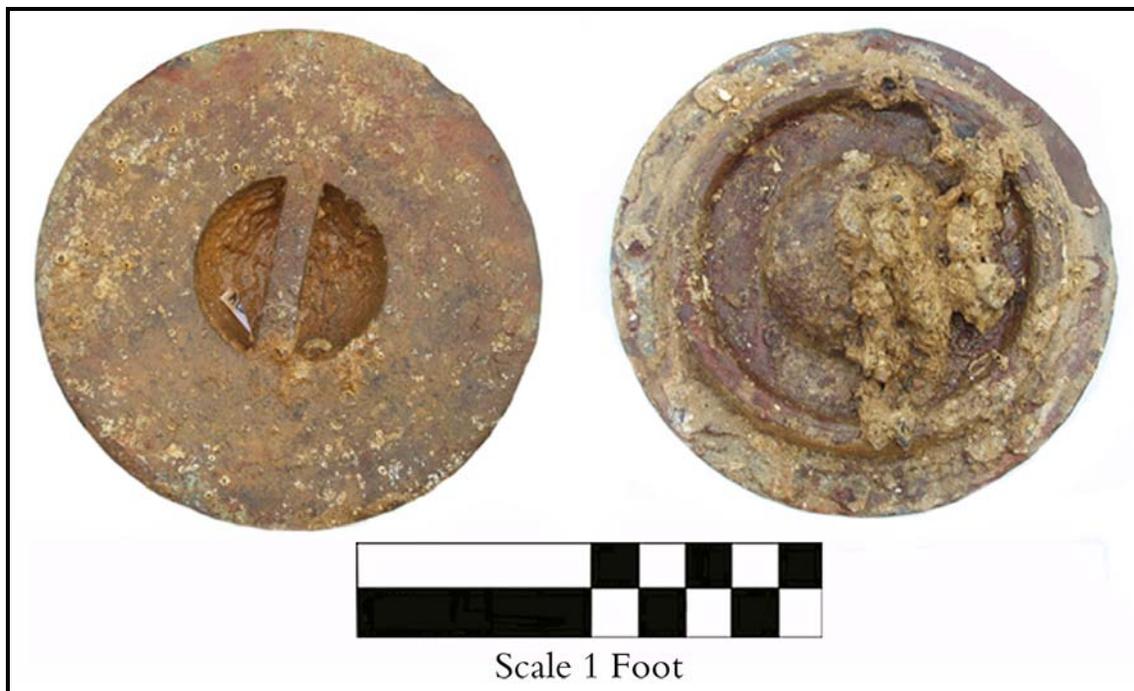
**Figure 61. ALS-315 Deck Plate.**

Artifact ALS-315 is a brass deck plate. The rim is drilled for eight mounting screws/bolts and the interior is threaded for the cover. The cover is threaded to mate with the rim and recessed to accommodate a flush handle. More detailed information will be available after cleaning.

Diameter:	13.1 inches	33.4 cm
Cover diameter:	10.1 inches	25.8 cm
Handle depression diameter:	5.0 inches	12.6 cm
Handle width:	0.9 inches	2.3 cm
Outer rim width:	1.6 inches	4.1 cm

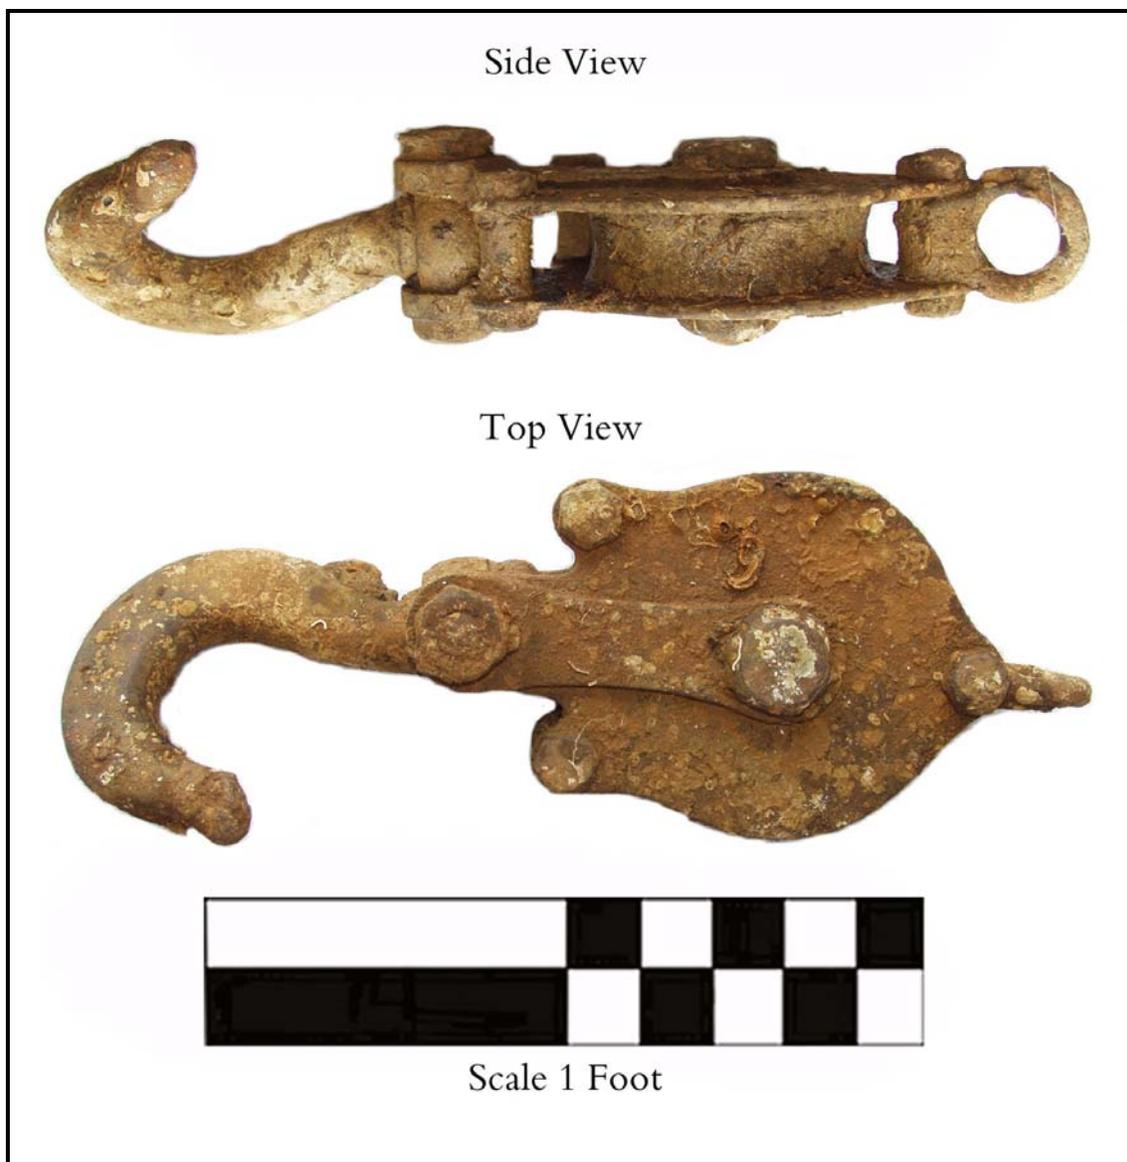
**Figure 62. ALS-316 Gun Truck Block.**

Artifact ALS-316 is a gun truck tackle block. It is likely that the block was used to move and secure one of *Alabama's* large pivot guns. One such block is visible in the photo of Raphael Semmes leaning against the aft pivot gun (**Figure 9**). This particular single-sheave block was hooked to a large eye bolt in the deck. This was coupled with a double-sheave block hooked to the cannon truck to provide mechanical advantage to pivot the cannon. One of the upper double-sheave blocks was recovered from the site in 1991 and a single-sheave block was recovered in 2000.

Overall length:	17.0 inches	43.2 cm
Width (max):	5.7 inches	14.6 cm
Hook span:	5.4 inches	13.6 cm
Hook diameter (mid curve):	1.6 inches	4.0 cm
Sheave axle length:	3.3 inches	8.4 cm
Sheave width:	1.3 inches	3.3 cm
Sheave diameter:	4.2 inches	10.8 cm

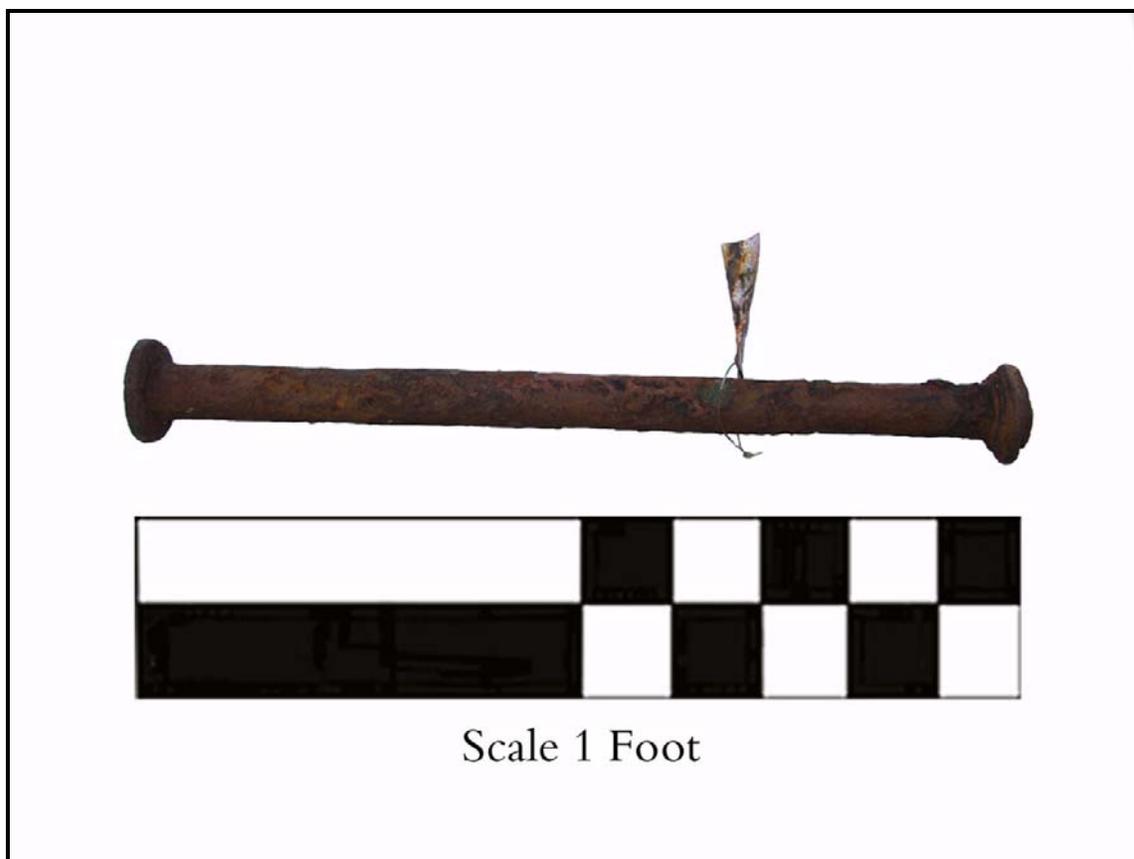
**Figure 63. ALS-317 Copper Fastener.**

Artifact ALS-317 is a copper fastener. One end of the fastener has been peened over a rove and the opposite end has a round head. The overall length is 12.1 inches suggesting that it was used in fastening the upper hull structure above the weather deck. The CSS *Alabama's* contract called for 3/4-inch copper bolts to fasten much of the hull.

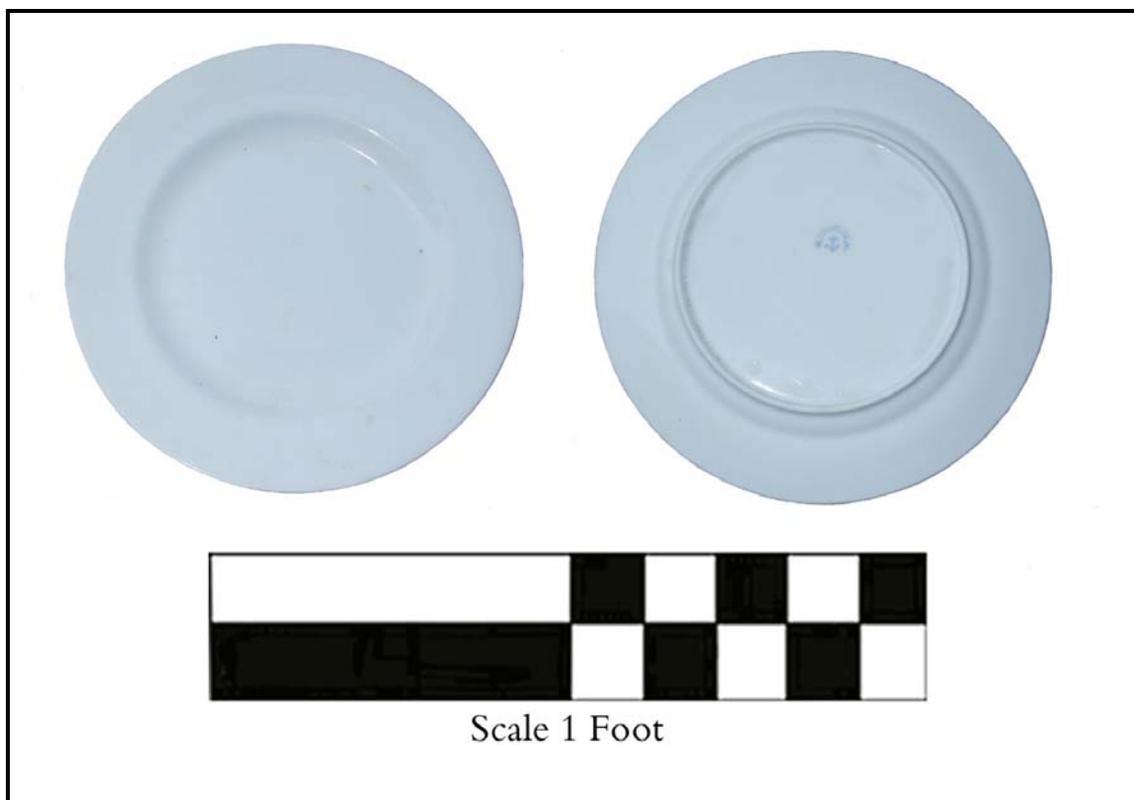
**Figure 64. ALS-318 Ironstone Plate.**

Artifact ALS-318 is a white ironstone plate. The undecorated style does not match any of the other styles recovered from the CSS *Alabama*. The “Davenport” maker’s mark on the bottom confirms its manufacturer. The anchor suggests one of Davenport’s marine wares. It is possible that the plate was the personal property of one of the *Alabama*’s officers, or was taken from a prize vessel by a crewmember.

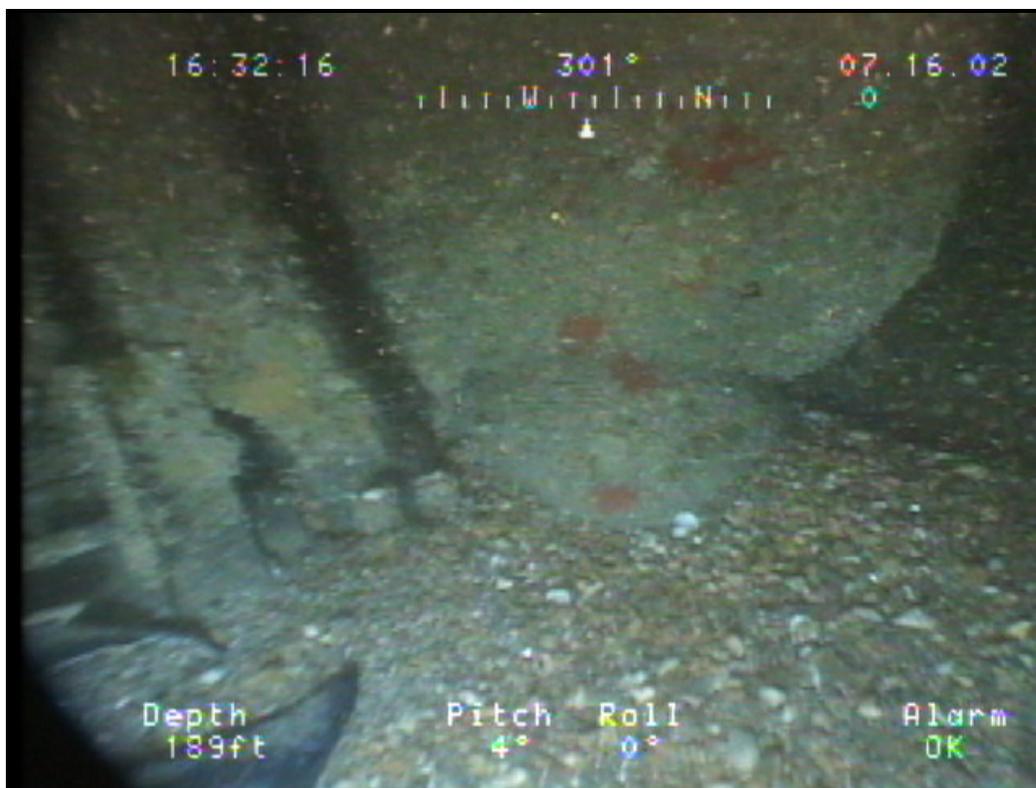
**Figure 65. Forward base of the lifting frame and propeller hub.**

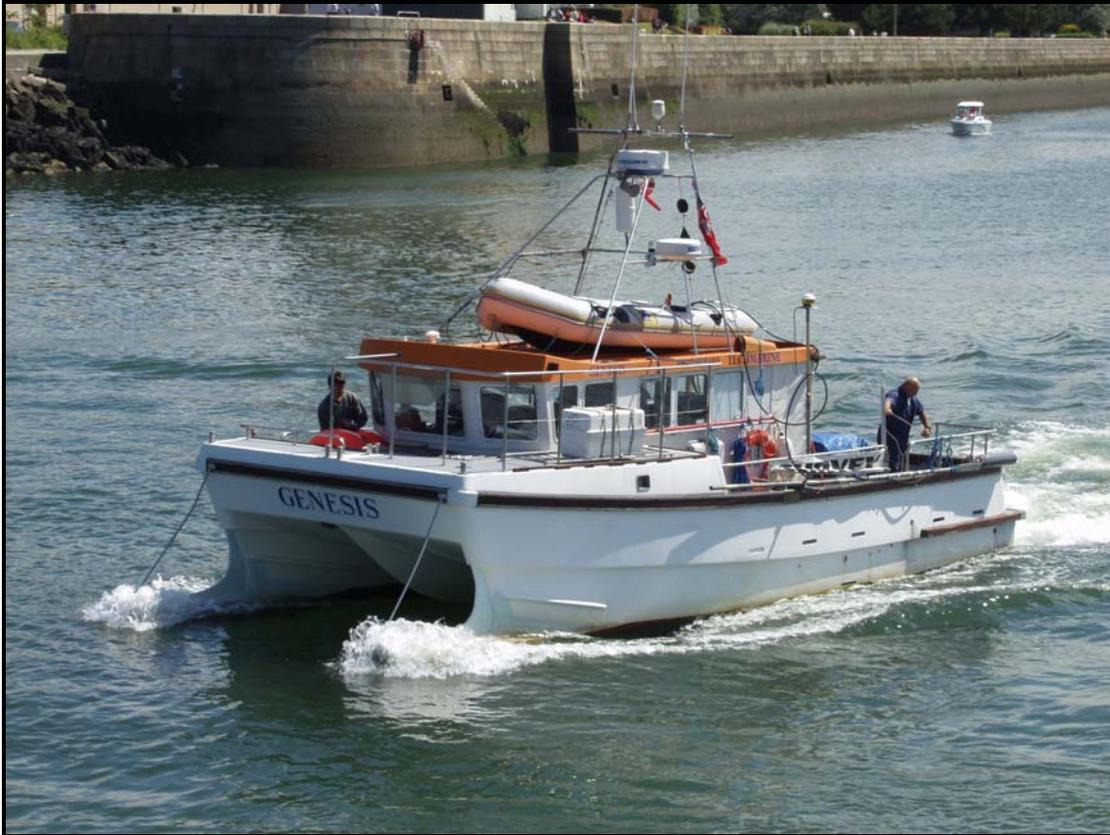
### **Survey Vessel *Genesis***

Tech Marine Service of Great Yarmouth, UK was contracted by NHC to provide the survey vessel *Genesis* to support ROV activities on the CSS Alabama. The 10-ton Catamaran, is capable of cruising at a speed of 20-25 knots and has a fuel range of 300 nautical miles. Bridge equipment on the vessel included an Icom IC-M56 VHF radio, Kelvin Hughes compact VHF radio, Furuno 4-tone daylight display radar, Cetrek autopilot, Trimble Navtrac XL GPS, JMC V-103 color depth sounder, Cetrek Profish 12 chart plotter, and magnetic compass. The aft deck area (3-x-4.9 meters) was open to permit launch and recovery operations. Aft deck equipment included a 400 Kgs Hi-Ab crane with winch to provide a safe and effective means of launching and recovering the ROV (Schmidt 2003).

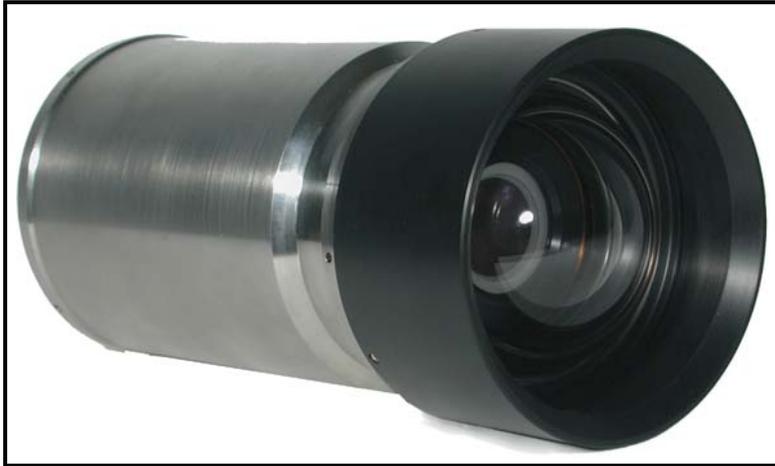
**Scorpio Plus Digital Still TV Camera:**

This latest addition to our product line is a professional digital still color TV camera that uses a 3.34 mega-pixel CCD to provide ultrahigh definition (2.048 x 1.536 pixel) still images. "Through the lens" color video output not only allows the operator to accurately frame still images, but it also can be used for video documentation. This camera features a 4 X Zoom lens (38mm to 115mm in 35mm format), the ability to download digital images in USB format without opening the camera, and corrected optics that virtually eliminates geometric and chromatic distortion. The Scorpio is perfect for applications involving underwater documentation, inspection in restricted access areas, and marine archaeology.

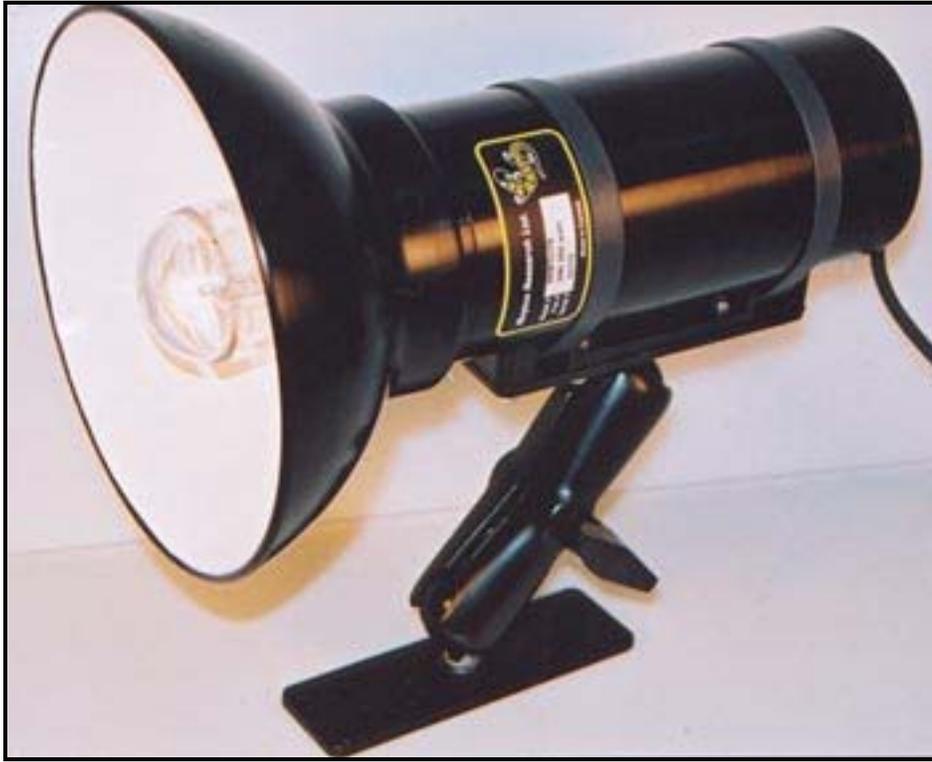
The NEWTLITE 200W is equipped standard with a 200W HMI osram hot-restrikable lamp. The HMI lamp delivers abundant light at 5600 degrees K for maximum color resolution. To minimize the weight of the system and support versatile mounting arrangements, the ballast system has been integrated into the light head. The NEWTLITE uses a combination electronic ballast and light head. This combination is lightweight and eliminates the multiple failure points associated with the extra cabling and bulkheads required for remotely ballasted systems. The NEWTLITE 200W supports HMI, HID, MSR, and CDM bulbs. The ballast also has the ability to be hot trimmed down as low as 100W. The NEWTLITE boasts 85% efficiency and is capable of operating from a 120 or 240 VAC, 250 VDC, or 12/24 VDC with suitable inverter.

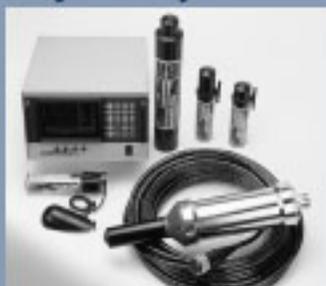
## Trackpoint II Plus Acoustic Tracking & Navigation System

For over 15 years, ORE's family of Trackpoint Systems have been providing customers with highly reliable, ultrashort baseline, acoustic tracking data. ORE's high accuracy Trackpoint II Plus continues this legacy offering the industry a tremendous value at a reasonable price.

The Trackpoint II Plus is the ideal tool for a wide array of subsea navigation and relocation tasks. Target types consist of transponders, responders or free running plagers.
