## **Archaeological Investigation and Remote Operated Vehicle Documentation: Confederate Commerce Raider *CSS Alabama* - 2002**

April 1, 2004

**Gordon P. Watts, Jr., Ph.D.  
Institute for International Maritime Research, Inc.  
P. O. Box 2494  
Washington, North Carolina 27889**

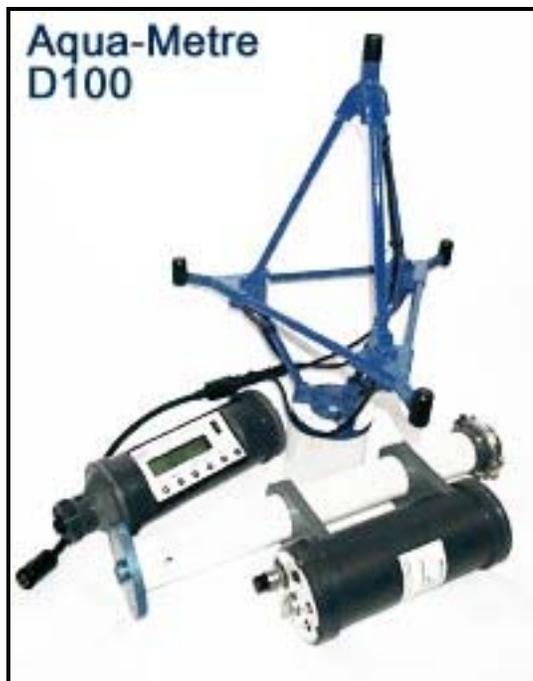
Weight	Base < 2.5 Kg	Pointer < 1.5 Kg
Dimensions	Base housing and mast head: 20 x 11 cm (height x diameter)	
	Interferometric frame : 20 x 30 cm (height x max. diameter)	
	Pointer: 22 x 8 cm (height x diameter)	
Materials	Base: PVC & glass fiber	
	Interferometric frame: glass fiber & aluminium (AGS)	
	Pointer: PVC & Polycarbonate	
Range	Radius up to 100 m (up to 130 m if good acoustic conditions)	
Resolution	Eadial distance : 2 mm – Angles : 0.01° (both azimuth and elevation)	
Accuracy	Distance radiale: +/- 2 cm up to 50 meters, +/- 4 cm up to 100 meters	
	Angles : +/- 0.1 ° (both azimuth and elevation)	
Measurment rate	2 seconds per point	
Memory depth	> 3000 points (data retention > 10 ans)	
Autonomy	> 8 hours in active mode (Base and Pointer)	
Charge adaptater	230 to 250 VAC (other tension on demand), charge duration < 12 hours	
Temperature range	0°C to 40°C	system operational
	0°C to 40°C	batteries charge in progress
