Energy Efficiency Alternatives for Historic Buildings in Extreme Cold Weather Climates

Case Study: Ladd Field, Fairbanks, Alaska

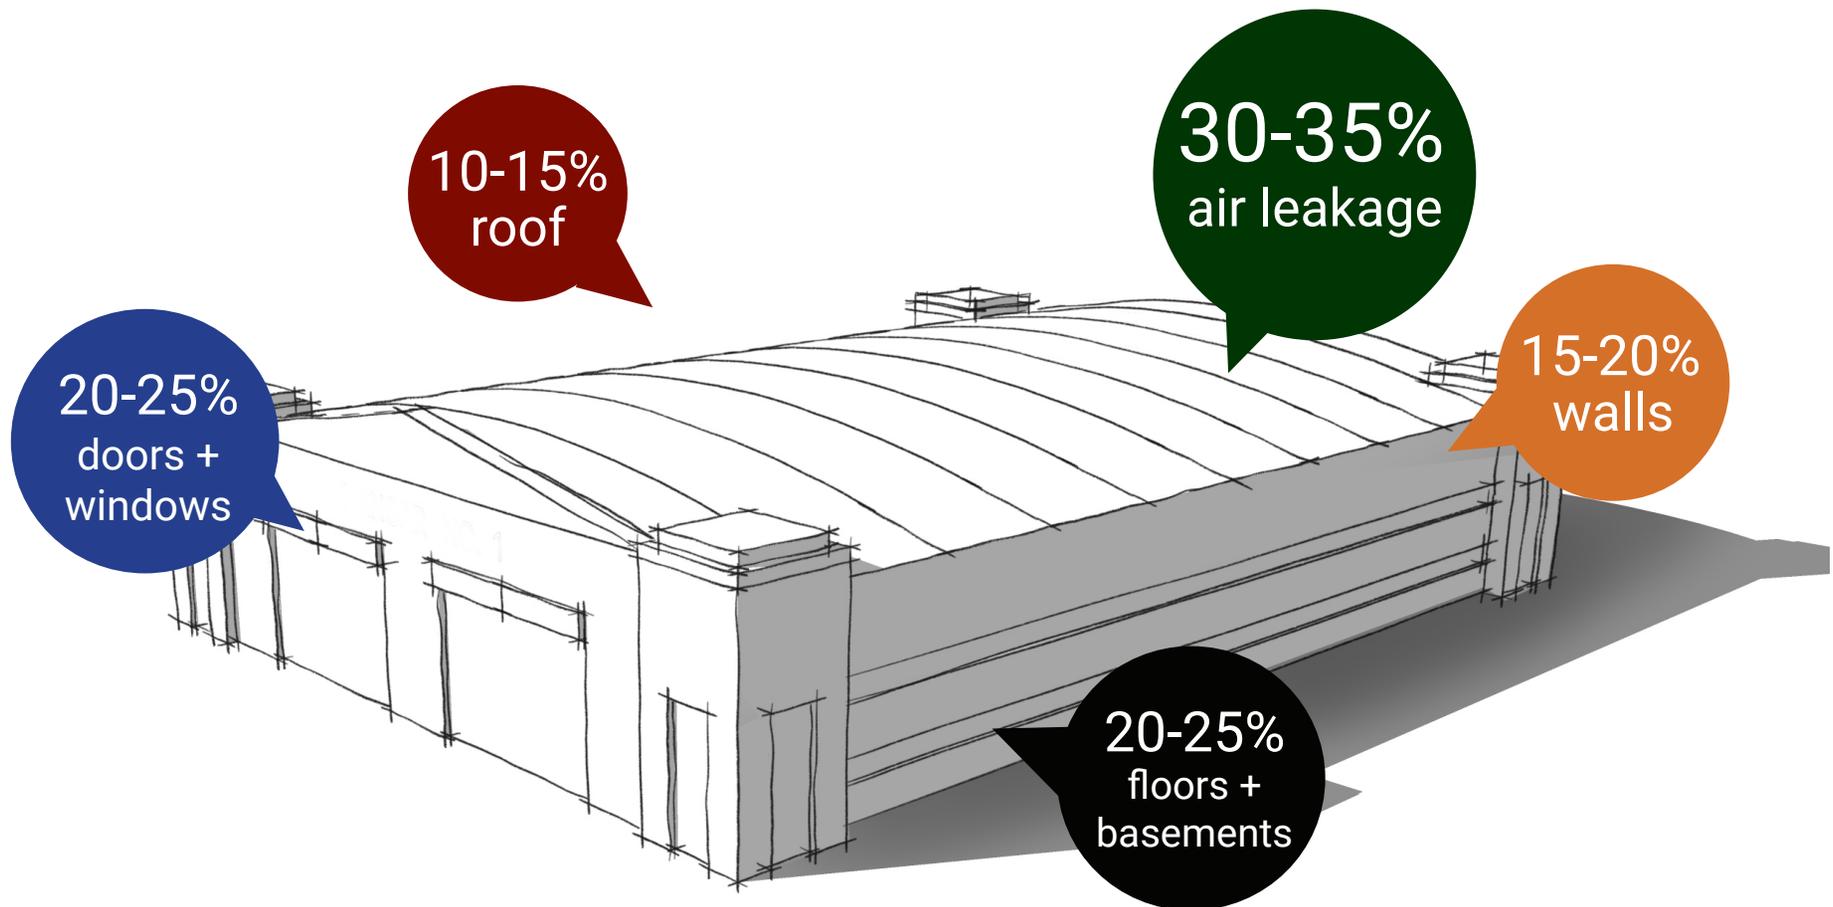
In cold climates, space heating generally makes up the biggest chunk of energy use. However, some buildings may be better served by reducing electrical or water use.

*Heat loss percentages are estimates from the Alaska Residential Building Manual, Seifert, ed. (2007) and not specific to any building.

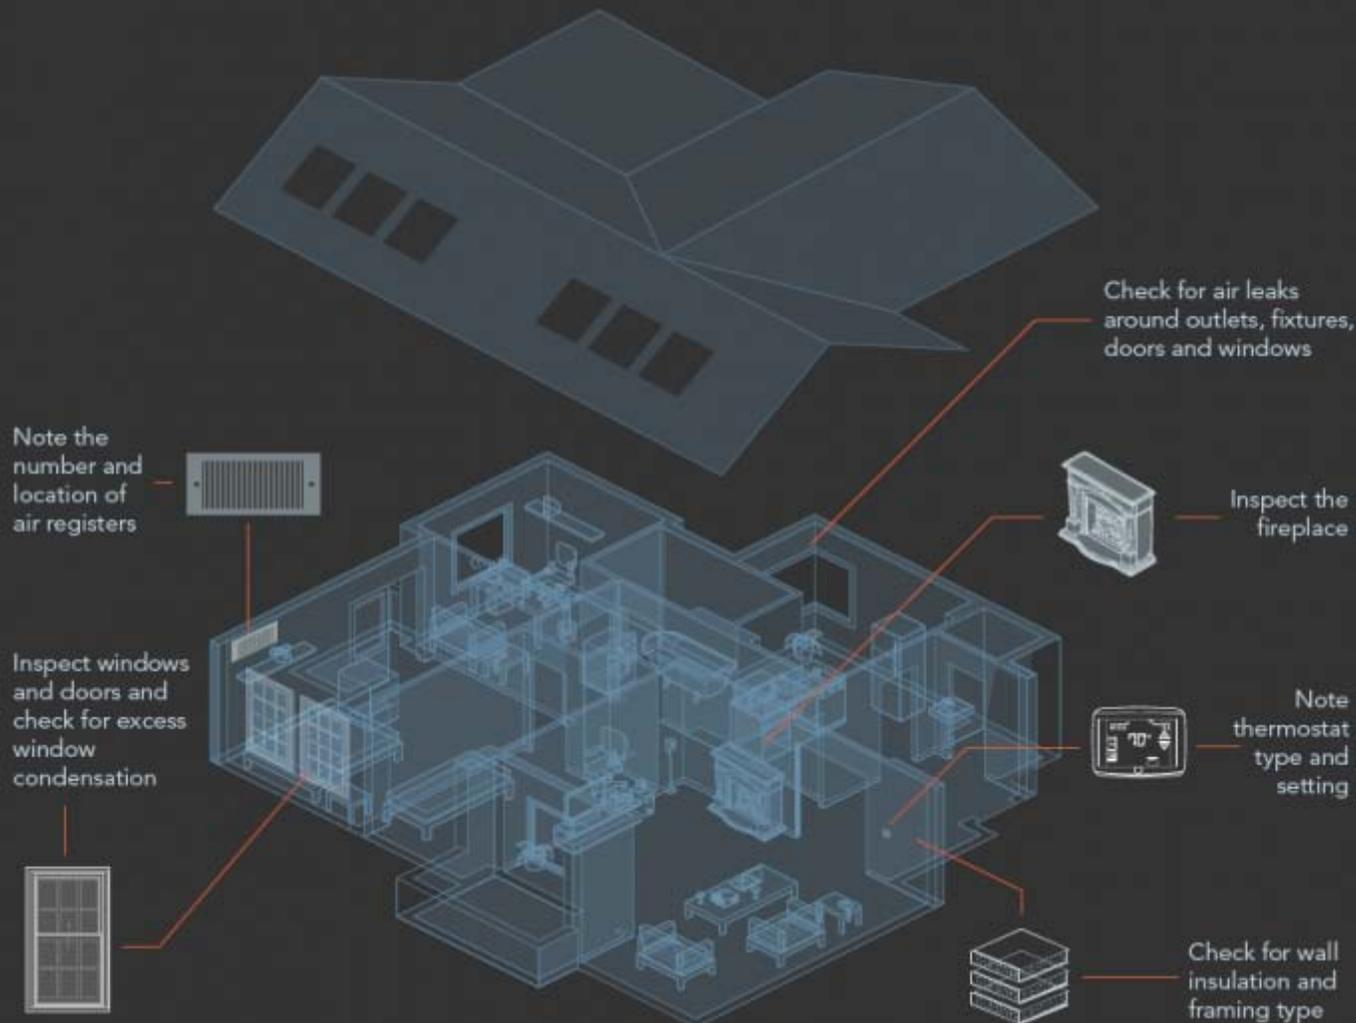
Any building in line for a retrofit should first have an energy audit. An energy audit is a systematic inspection of a building that evaluates the building's current energy use and potential energy saving options.

TESTS PERFORMED

1. Blower door test
2. Infrared Imaging
3. Energy Modeling

INFO PROVIDED

1. Current energy evaluation
2. Air leakage
3. Cold spots
4. Appliance efficiency
5. Recommended improvements + cost-benefit estimates

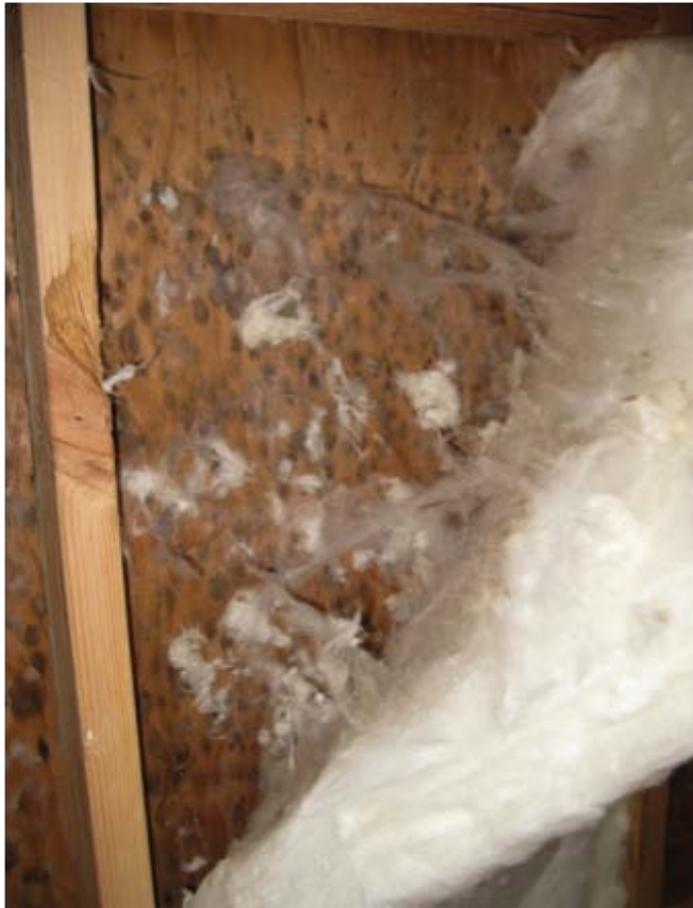
Adding insulation to the walls must follow building science best practices to avoid problems in the building envelope like condensation, mold, and rot (See image on the left.) These guidelines vary by climate.

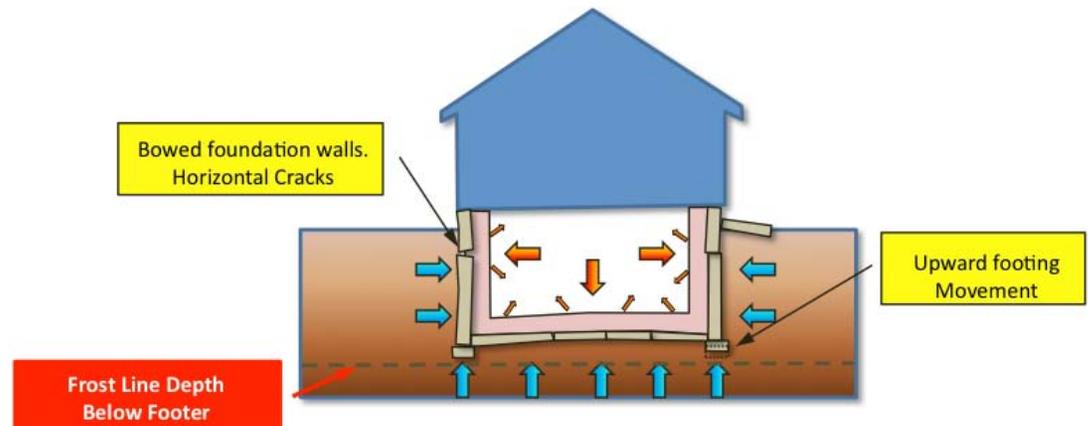
Insulating in and around the foundation requires knowledge of the surrounding soils and building science principles. Applying insulation without understanding the foundation system can lead to moisture concerns in the foundation walls, as well as frost heaving from the surrounding soils. (See below.)

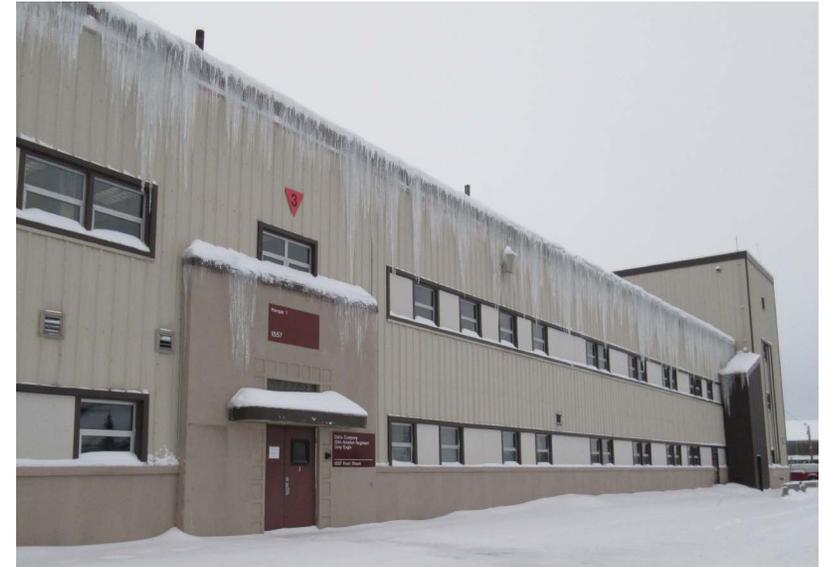
The pictures on the right show the north side of Hangar 1. The infrared image shows heat loss through the building envelope. The yellow colors show the warmest parts of the building. As you can see in the regular picture, the brightest yellow spot is around the fire alarm. These photos suggest that when the alarm was installed, a hole was cut into the wall and was not air sealed. Warm air is leaking out of the hole and heating the outside of the building. This is just one example of the large amount of air leakage from the building (the ice on the roof is another result of air leakage through the ceiling).

Stopping air leakage from the building envelope is often the simplest and most cost-effective energy saving option. In the case of historic buildings, it has the added advantage of not altering the exterior look of the structure.
