# Department of Defense Legacy Resource Management Program

PROJECT 05-239

## **Stabilization and Preservation of DoD-owned Military Fortifications**

Douglas R. Cubbison  
Cultural Resources Manager  
And  
Travis Beckwith  
Architectural Historian  
United States Military Academy  
West Point, New York

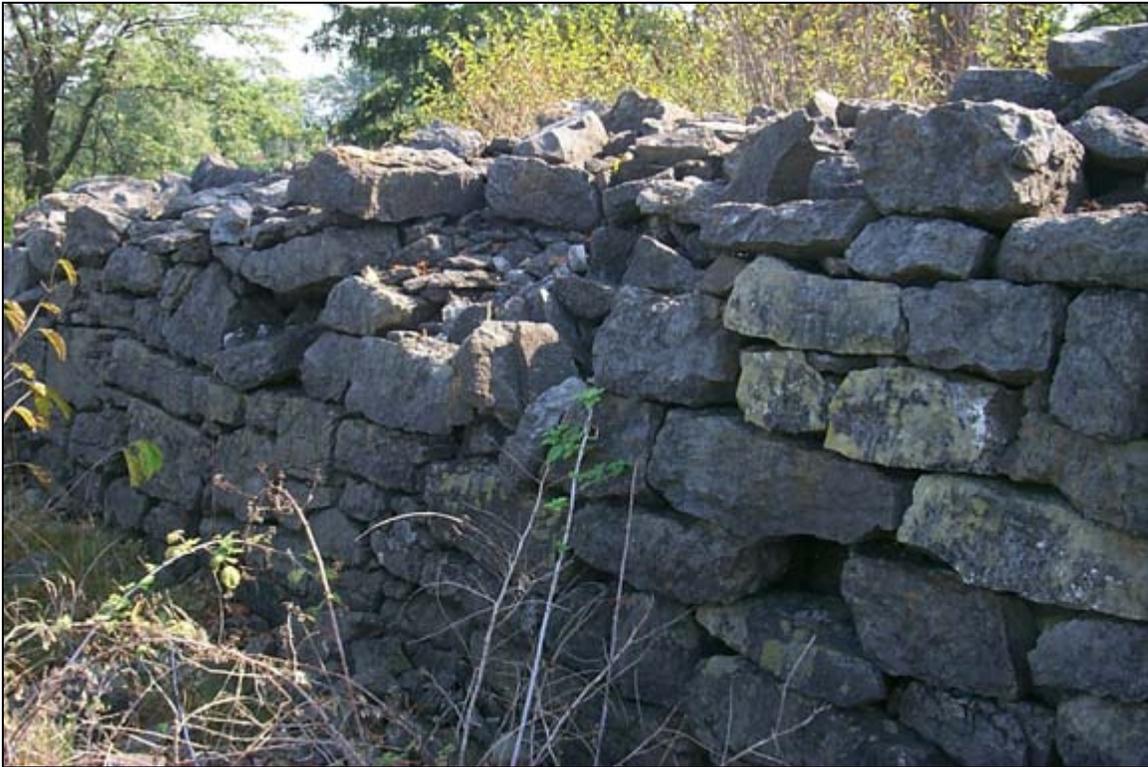
**Photograph 1:** Dry-Laid Field Stone Parapet Wall, 1758 Germain Redoubt, Fort Carillon (Fort Ticonderoga), Essex County, New York  
(Photograph by D.R. Cubbison).

It was only natural that when the Continental Army was formed in 1775, that American soldiers turned to the use of dry-laid stone masonry to construct military fortifications, similar to the redoubt at Fort Carillon that some of these soldiers had seen while serving as Provincials with the British Army during the Seven Years War. Today, numerous examples of this craft survive at the U.S. Military Academy, West Point, New York.

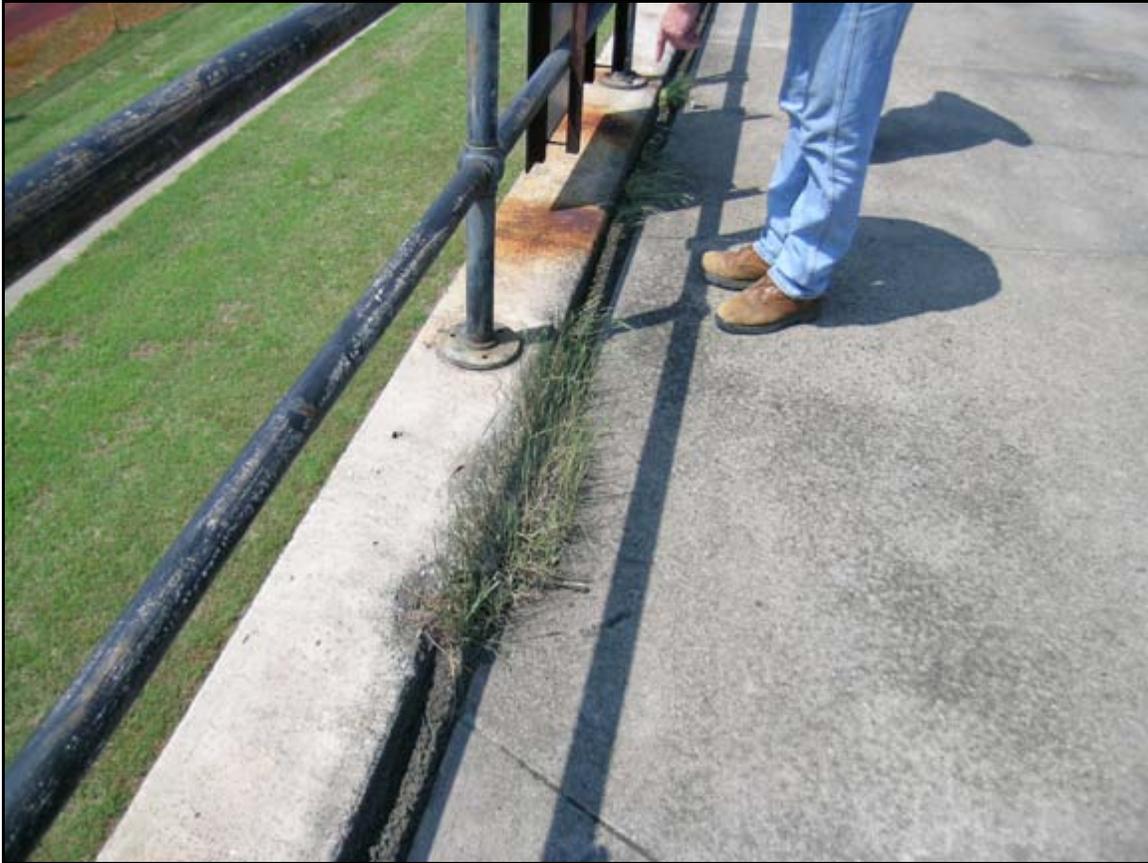
**Photograph 2:** View looking at the drainage gutter on the inland side of Battery DeRussy at Fort Monroe Virginia. Soil and debris completely filled in this gutter significantly affecting the ability of the structure to shed water during periods of precipitation.

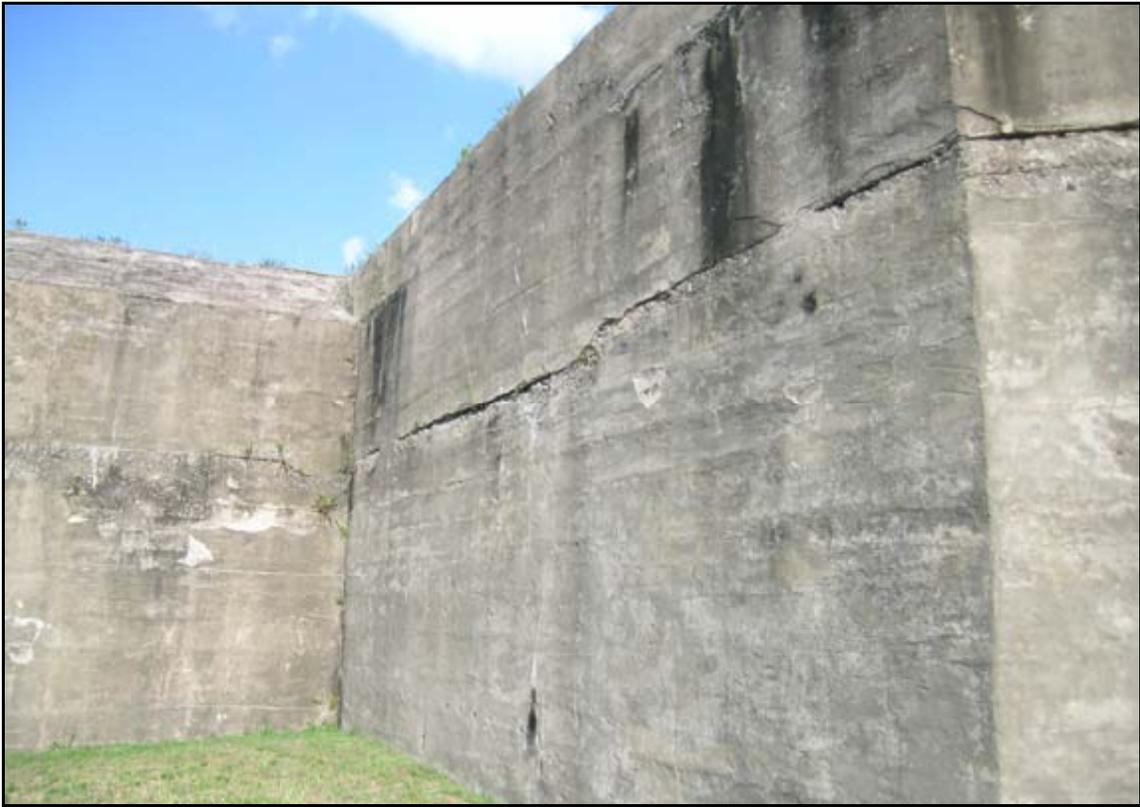
**Photograph 3:** View looking at the seaward side of Battery DeRussy at Fort Monroe, VA. Note the horizontal crack on this exterior wall. This is an example of a cold joint, a condition that occurs when a layer of concrete is poured adjacent to a layer that has been allowed to harden. Cracks such as these allow moisture to infiltrate the structure and cause a great deal of damage. Note the presence of biological growth in some of cracks; this is a clear sign that moisture is present within the exterior walls. This portion of Battery DeRussy was once covered with earth but it was removed in the 1950s to accommodate base housing.

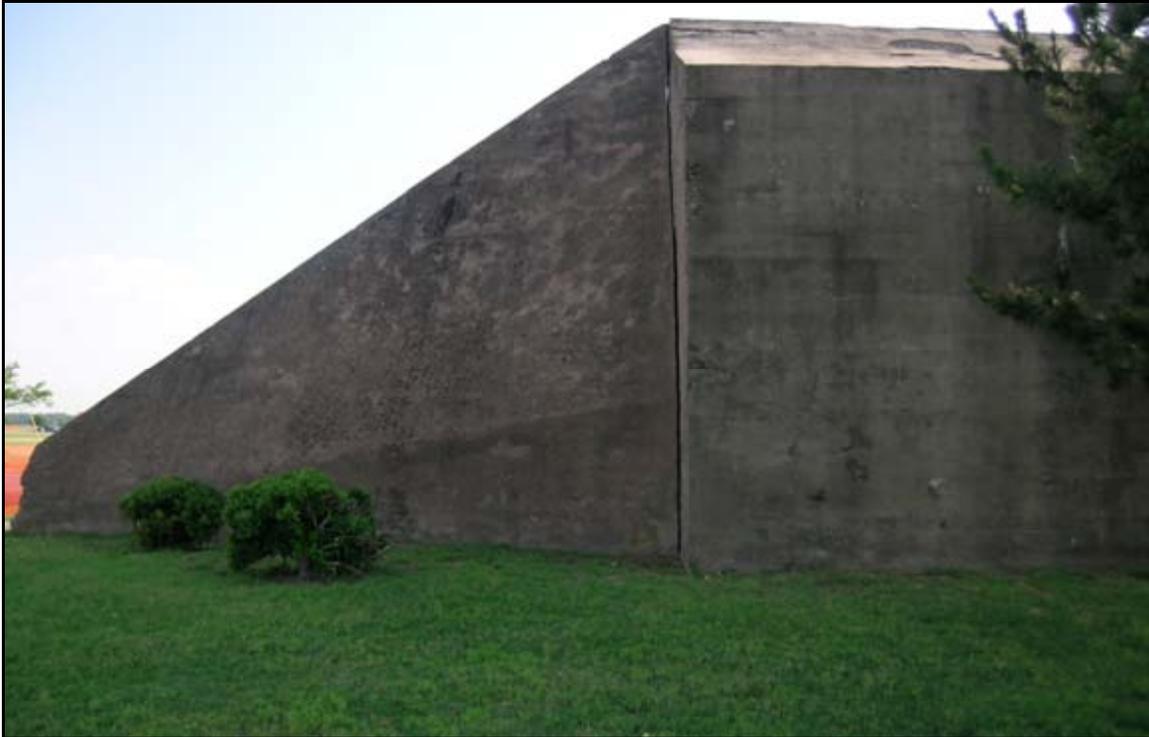
**Photograph 4:** View looking at Battery Church, Fort Monroe, Virginia. These particular sections have completely separated from each other. This may be a result of the use of a plane of weakness in the original design of the battery. A plane of weakness creates a joint between two adjacent sections of concrete that is designed to fail. This allows engineers to prevent unwanted cracks in concrete structures by allowing sections to settle independently of each other.

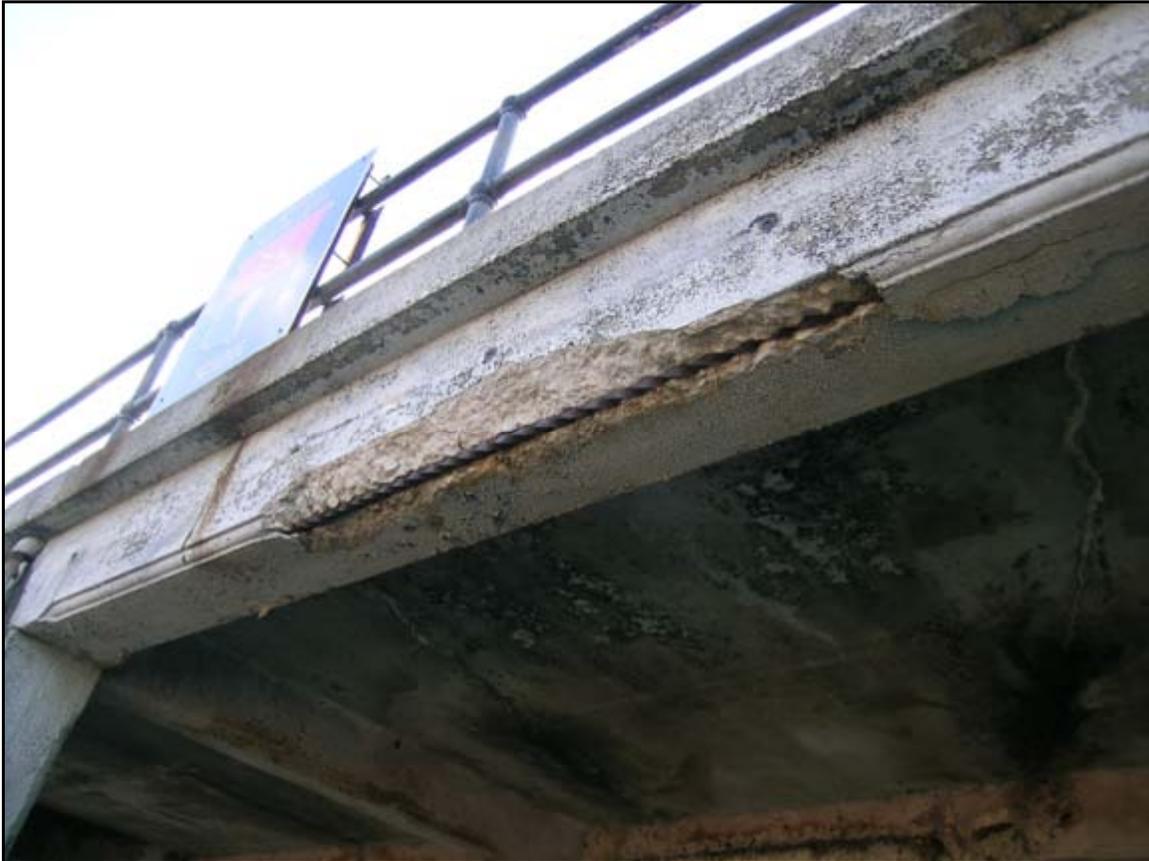
**Photograph 5:** View looking at Battery DeRussy, Fort Monroe, Virginia. This particular portion of the concrete spalled off and exposed the steel reinforcement beam embedded in the concrete. This condition may have occurred as a result of salts in the concrete rusting the steel. When steel corrodes it expands, which in turn caused the concrete face to spall off the building

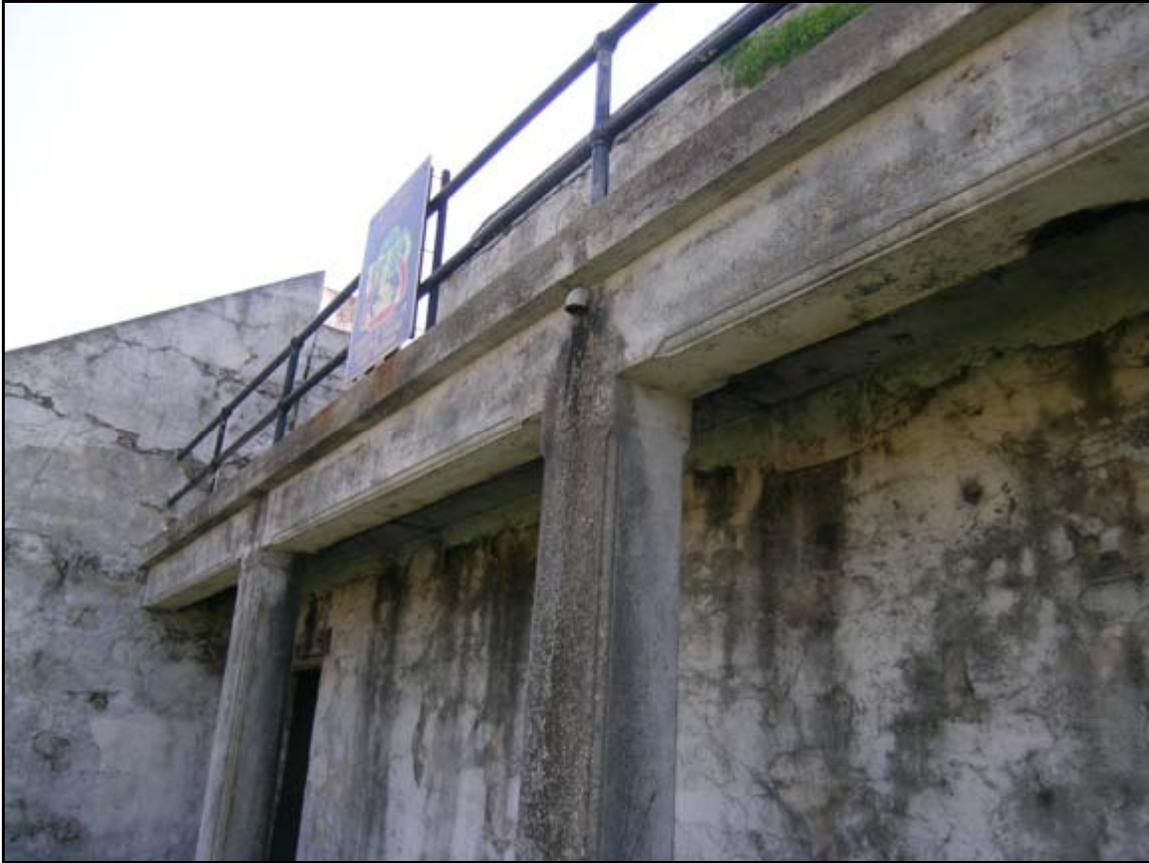
**Photograph 6:** View looking at Battery DeRussy, Fort Monroe, Virginia. This portion of the battery exhibits a number of cracks with varying degrees of severity. Most of these are superficial but should be monitored over time to ensure that they are not adversely affecting the structural stability or allowing moisture to infiltrate the walls. Note that the two leaders and downspouts in the center of the photograph have been entirely removed.

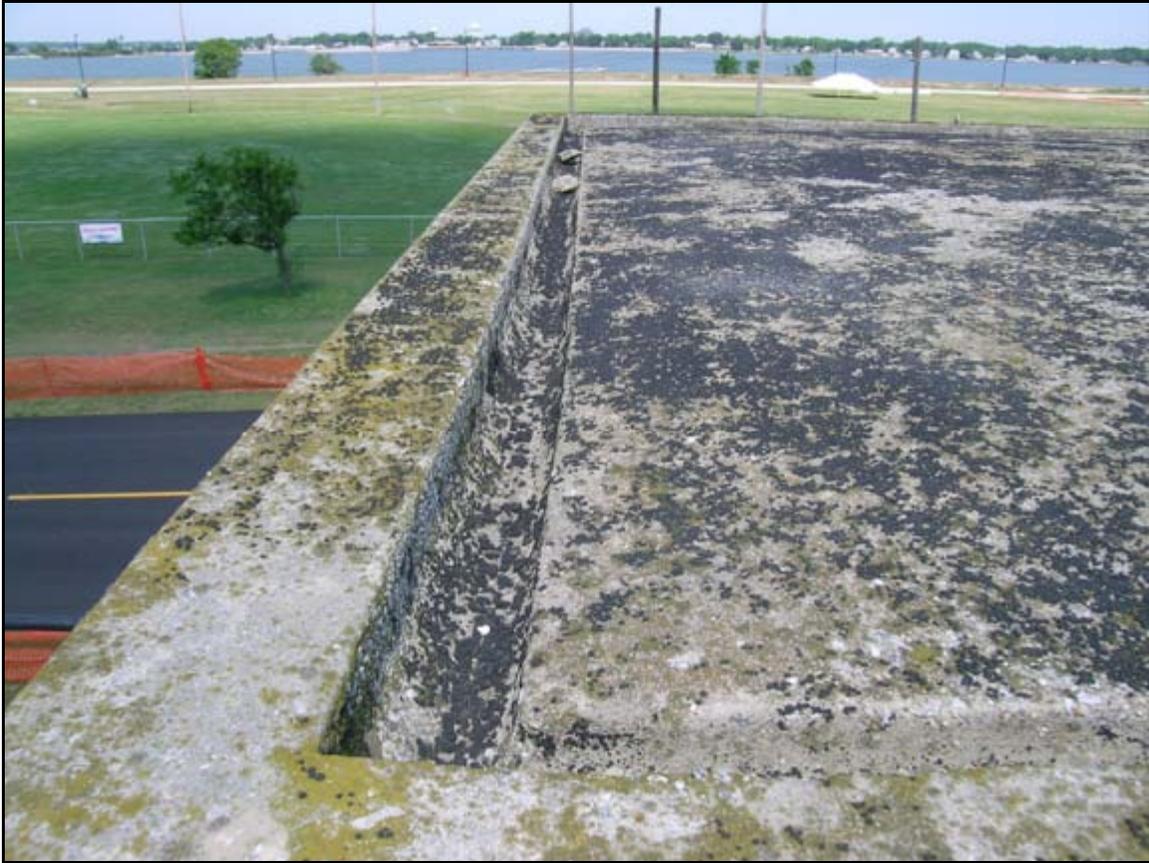
**Photograph 7:** View looking at the top of the observation tower, Battery DeRussy, Fort Monroe, Virginia. This tower exhibits some erosion caused by exposure to weather. Overtime, erosion will wear away the surface layer of concrete and ultimately allow moisture to infiltrate the structure. The black on the roof appears to be tar, which was routinely applied to waterproof the building.  
(Photograph by T. Beckwith, June 2005).

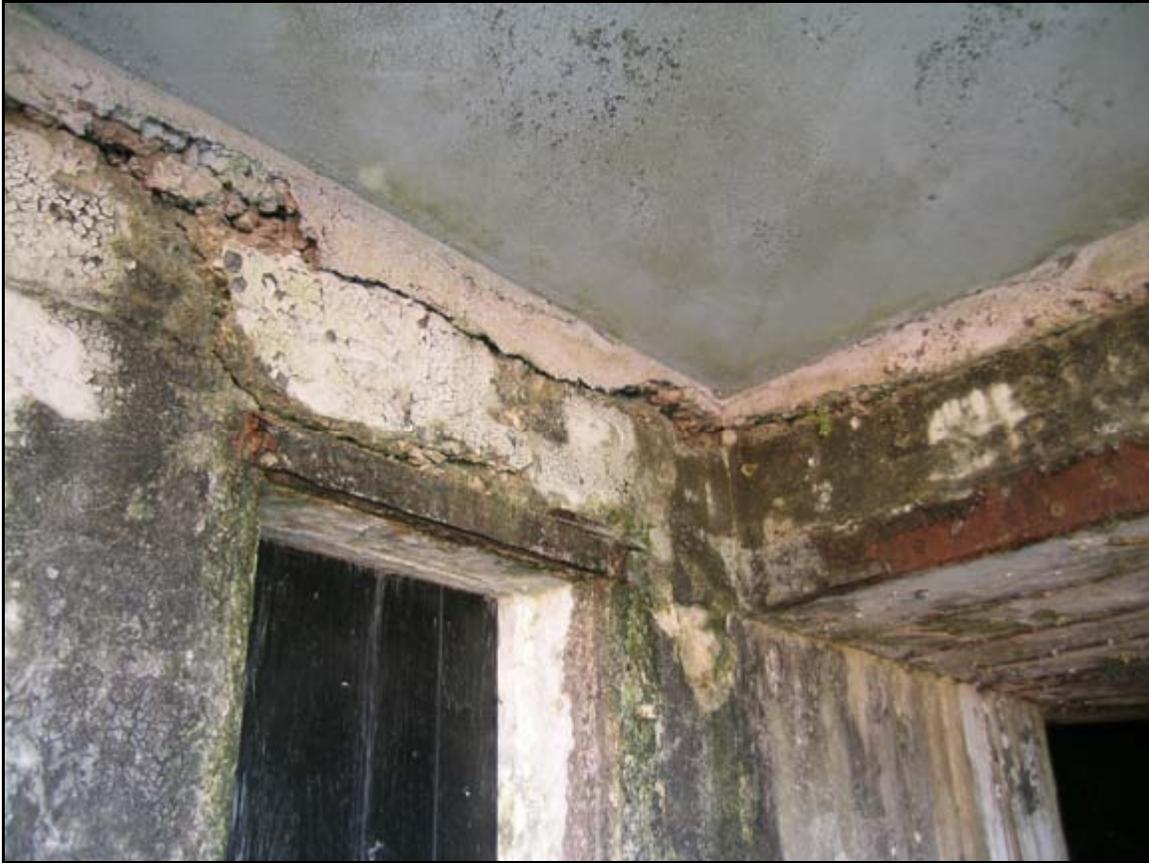
**Photograph 8:** Detailed view looking at the underside of Battery DeRussy, Fort Monroe, Virginia. This portion of the wall exhibits significant spalling. Spalling can occur for many reasons, in this instance it appears that moisture infiltrated the concrete walls causing the surface layer to fall off. This portion of the building also features a substantial amount of biological growth, clear evidence of a serious moisture problem.

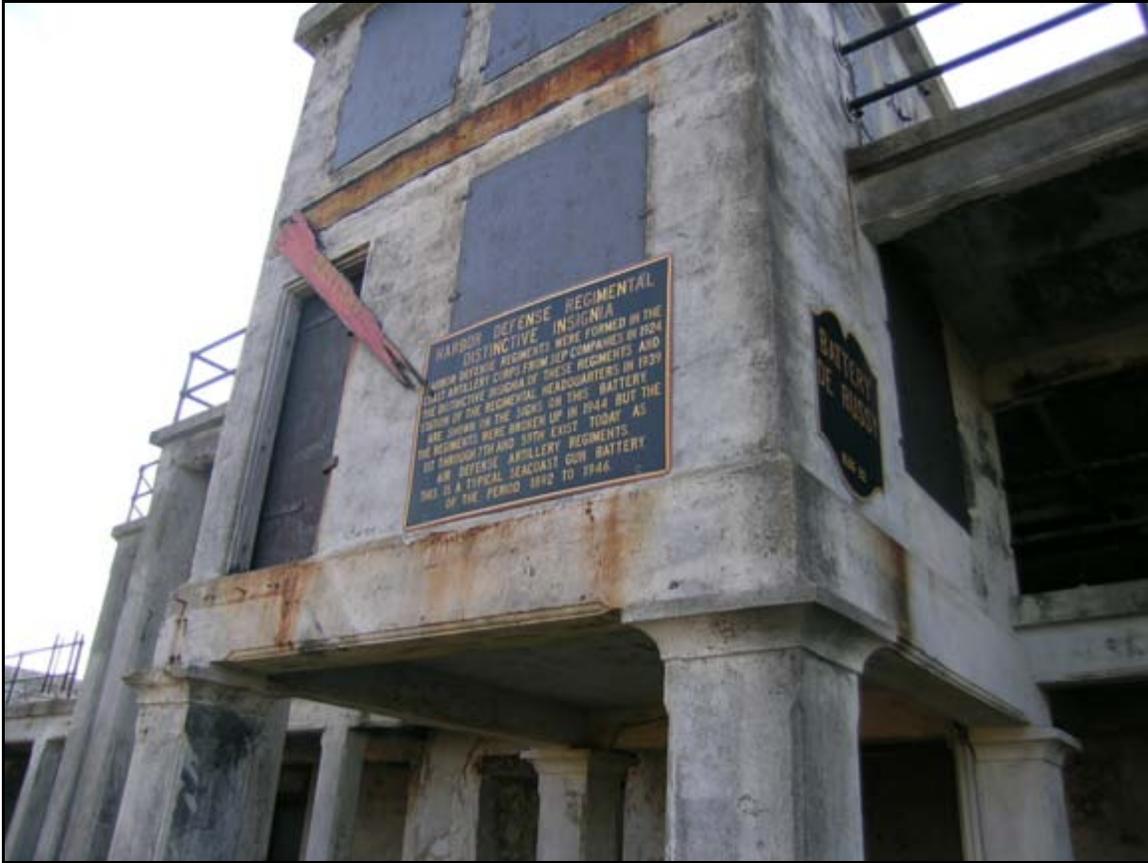
**Photograph 9:** View looking at Battery DeRussy, Fort Monroe, Virginia. These rust stains are likely a result of the metal stairs that once provided access to the tower. Discoloration such as these is generally cosmetic and does not pose a threat to the continued preservation of the structure. Stains however should be scrutinized to ensure that they are not caused by a more serious issue.

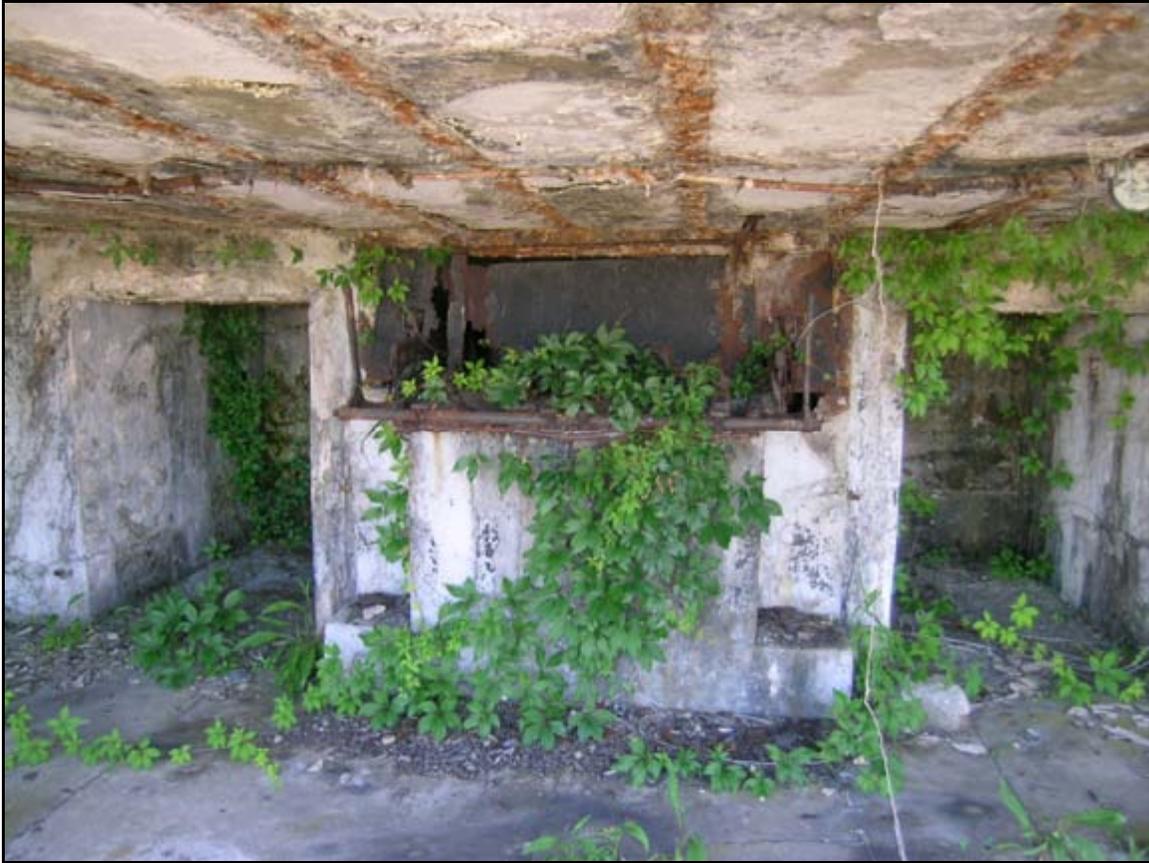
**Photograph 10:** View looking at one of the chain hoist system at Battery DeRussy, Fort Monroe, Virginia. The presence of substantial biological growth, extensive corrosion, and the great amount of spalling that has occurred indicates a significant amount of moisture infiltration. Before any rehabilitation work can begin, the building needs to be allowed to dry out. (Photograph by T. Beckwith, June 2005)

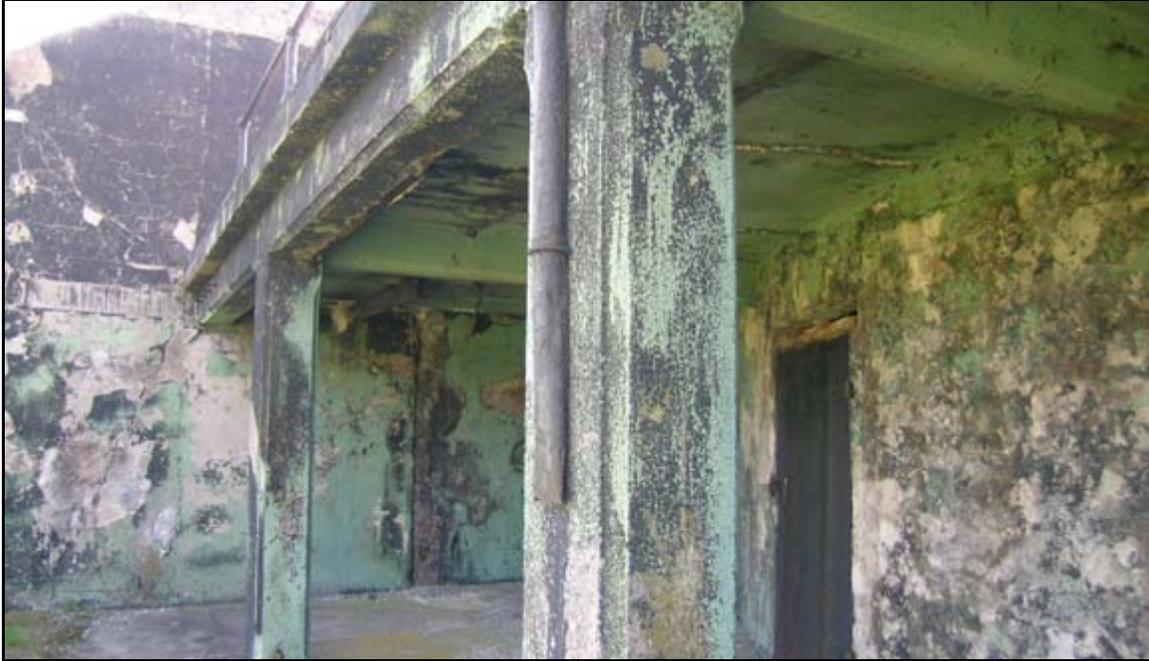
**Photograph 11:** Detailed view of one of the leaders at Battery Parrott, Fort Monroe, Virginia. Many of the downspouts and leaders are missing or severely damaged, which is the case with this particular example. This condition inhibits the drainage system’s ability to guide water away from the foundation of the building.

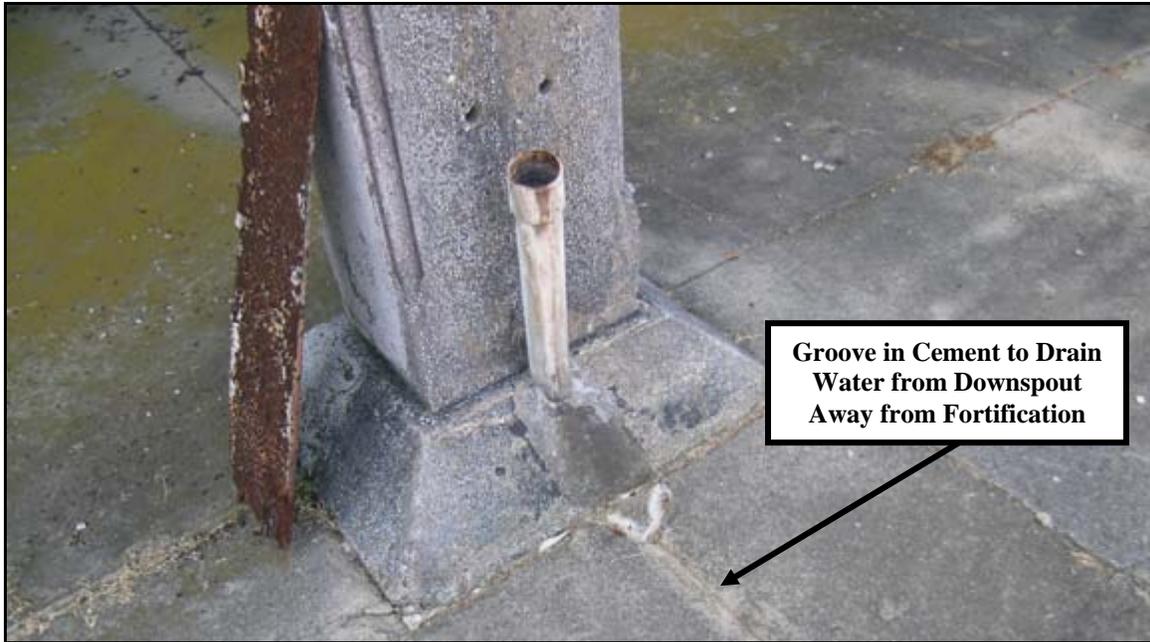
**Photograph 12:** Detailed view of one of the downspouts at Battery DeRussy, Fort Monroe, Virginia. Many of the downspout bases have been filled in with Portland cement. Even if the leaders and downspouts still existed, water would not flow away from the foundation. The concrete needs to be removed to restore the ability of the drainage system to shed moisture. Note the groove in the cement, which is designed to carry water away from the foundation.  
(Photograph by T. Beckwith, June 2005).

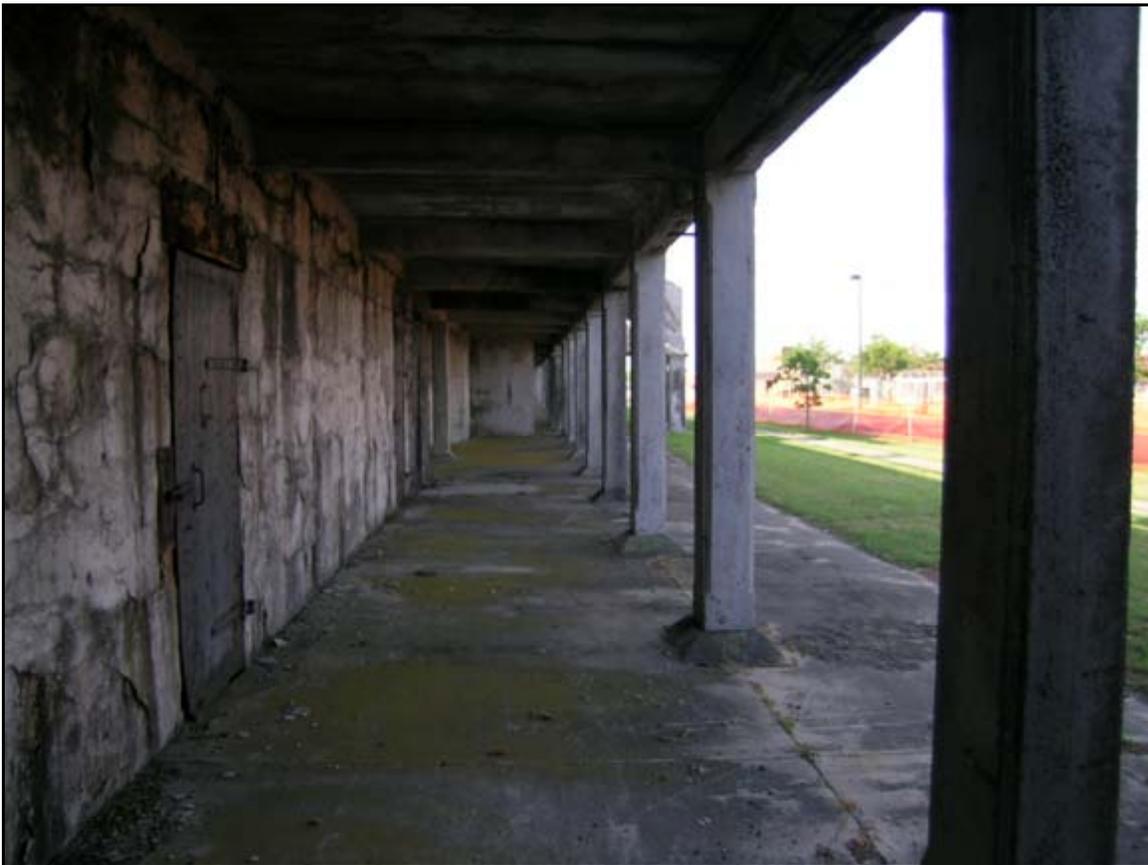
**Photograph 13:** View looking at the exterior of Battery DeRussy, Fort Monroe, Virginia. The doors in the left portion of this photograph prevent adequate air exchange within the battery. These doors should be opened and replaced with grates that will allow air to flow through the battery, while still preventing people from accessing the interior.

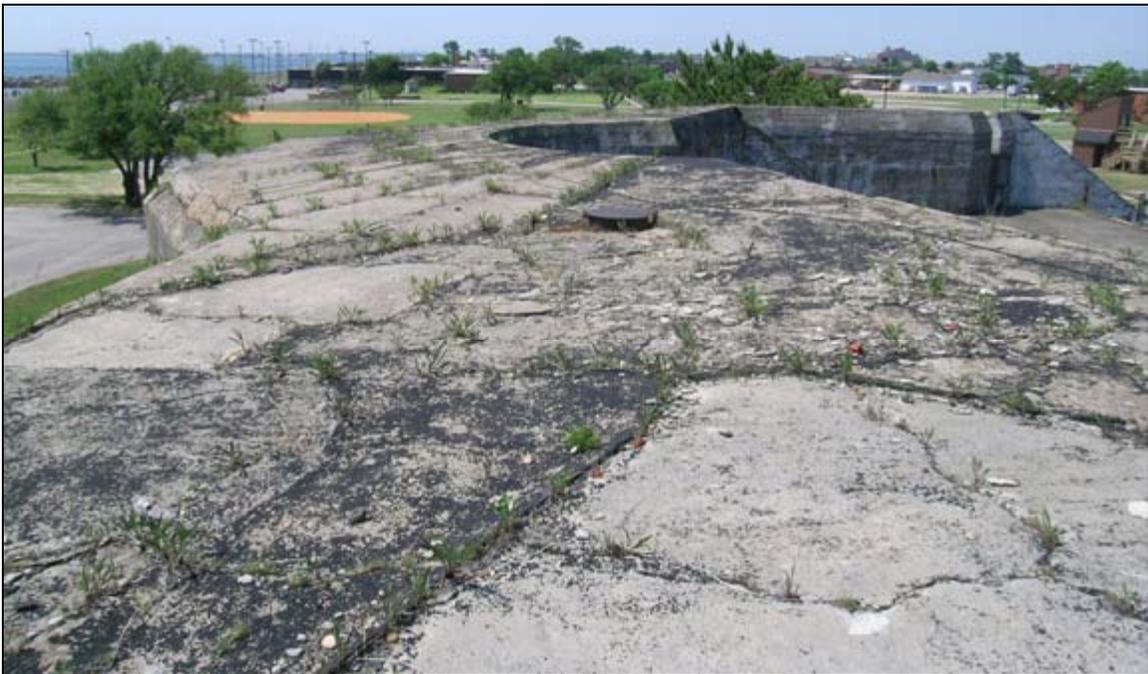
**Photograph 14:** View looking at the roof of Battery DeRussy, Fort Monroe, Virginia. The low pitch of the roof makes it difficult for the structure to shed moisture during periods of high precipitation. Engineers recognized the need for a working drainage system, and stipulated that the gutters, downspouts, and drains be cleaned on a weekly basis. The black substance appears to be tar or asphalt, which was applied to keep moisture from infiltrating the battery. This coating failed and the roof is now exhibiting some cracking. The presence of biological growth in the cracks clearly indicates a significant amount of moisture infiltration into the concrete.

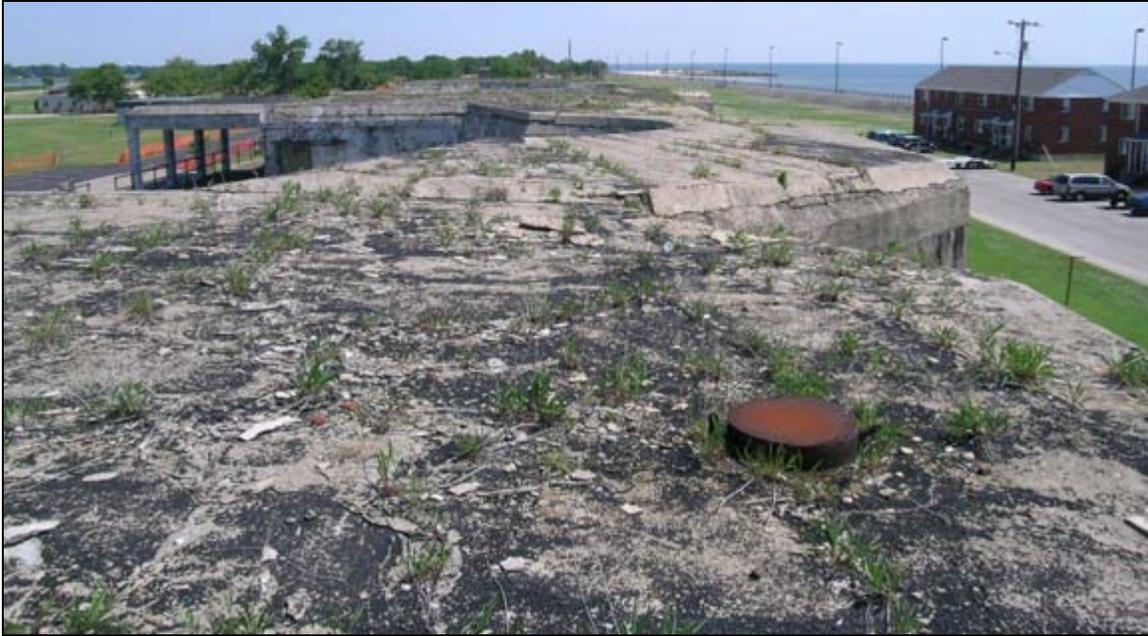
**Photograph 15:** View looking at the roof of Battery DeRussy, Fort Monroe, Virginia. Note how this portion of the roof has deteriorated significantly. Differences in the rate of expansion between the surface layer and the substrate cause the surface layer to disintegrate and become unattached from the substrate. Over time, this allows moisture to pool atop the fortification, exacerbating the problem.

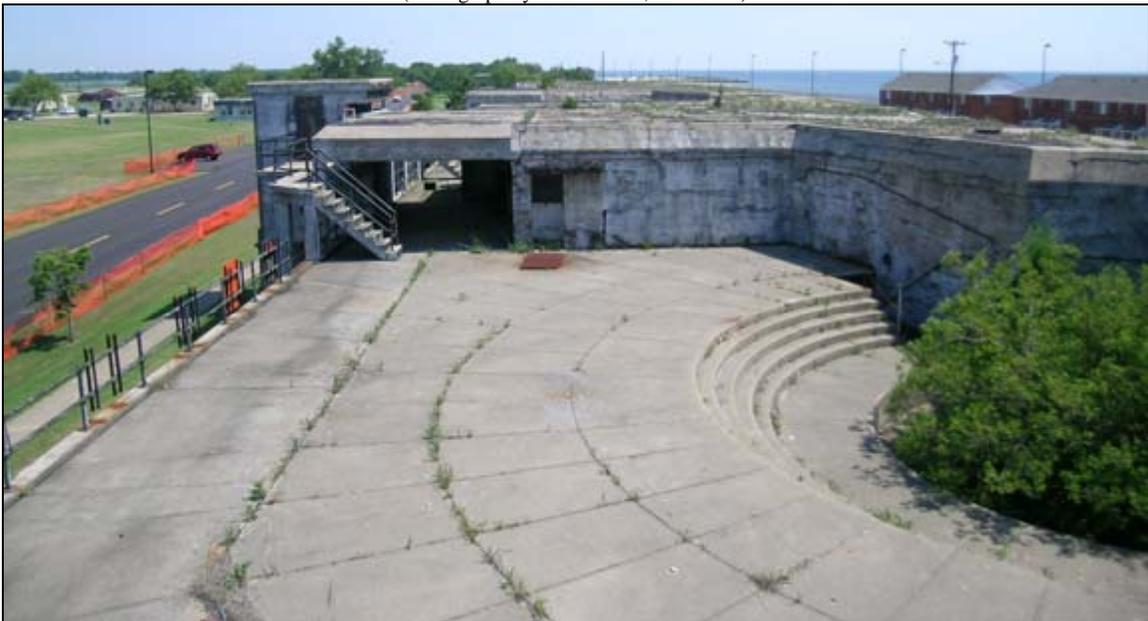
**Photograph 16:** View looking at Battery DeRussy, Fort Monroe, Virginia. The horizontal surfaces surrounding the gun emplacements appear to be in remarkable shape. Although there is some biological growth in the seams, there is very little cracking or erosion of the surfaces. What little vegetation there is in the seams should be removed to facilitate drainage and natural drying.

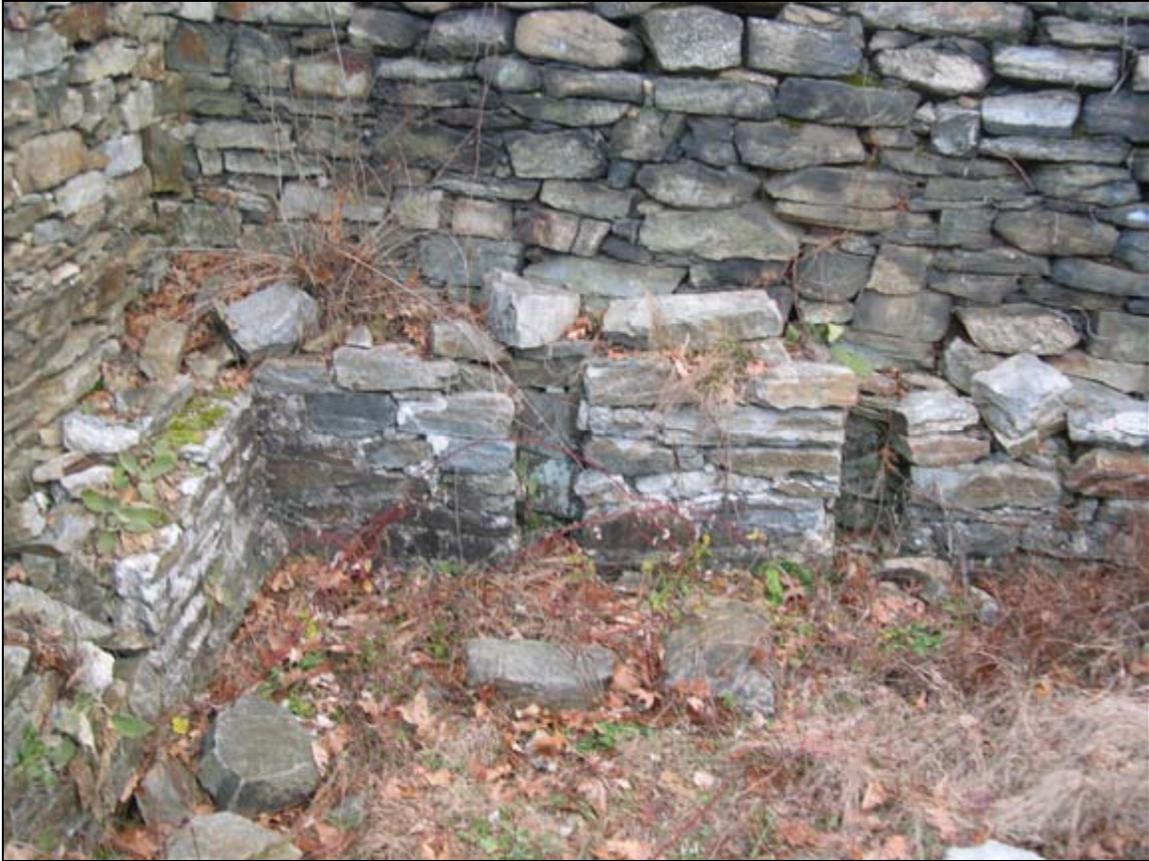
**Photograph 17:** Redoubt Wyllis, Fortress West Point (1778-1783), Dry-Laid Stone Interior Walls, Powder Magazine, U.S. Military Academy, Orange County, New York.  
(Photograph by D.R. Cubbison)

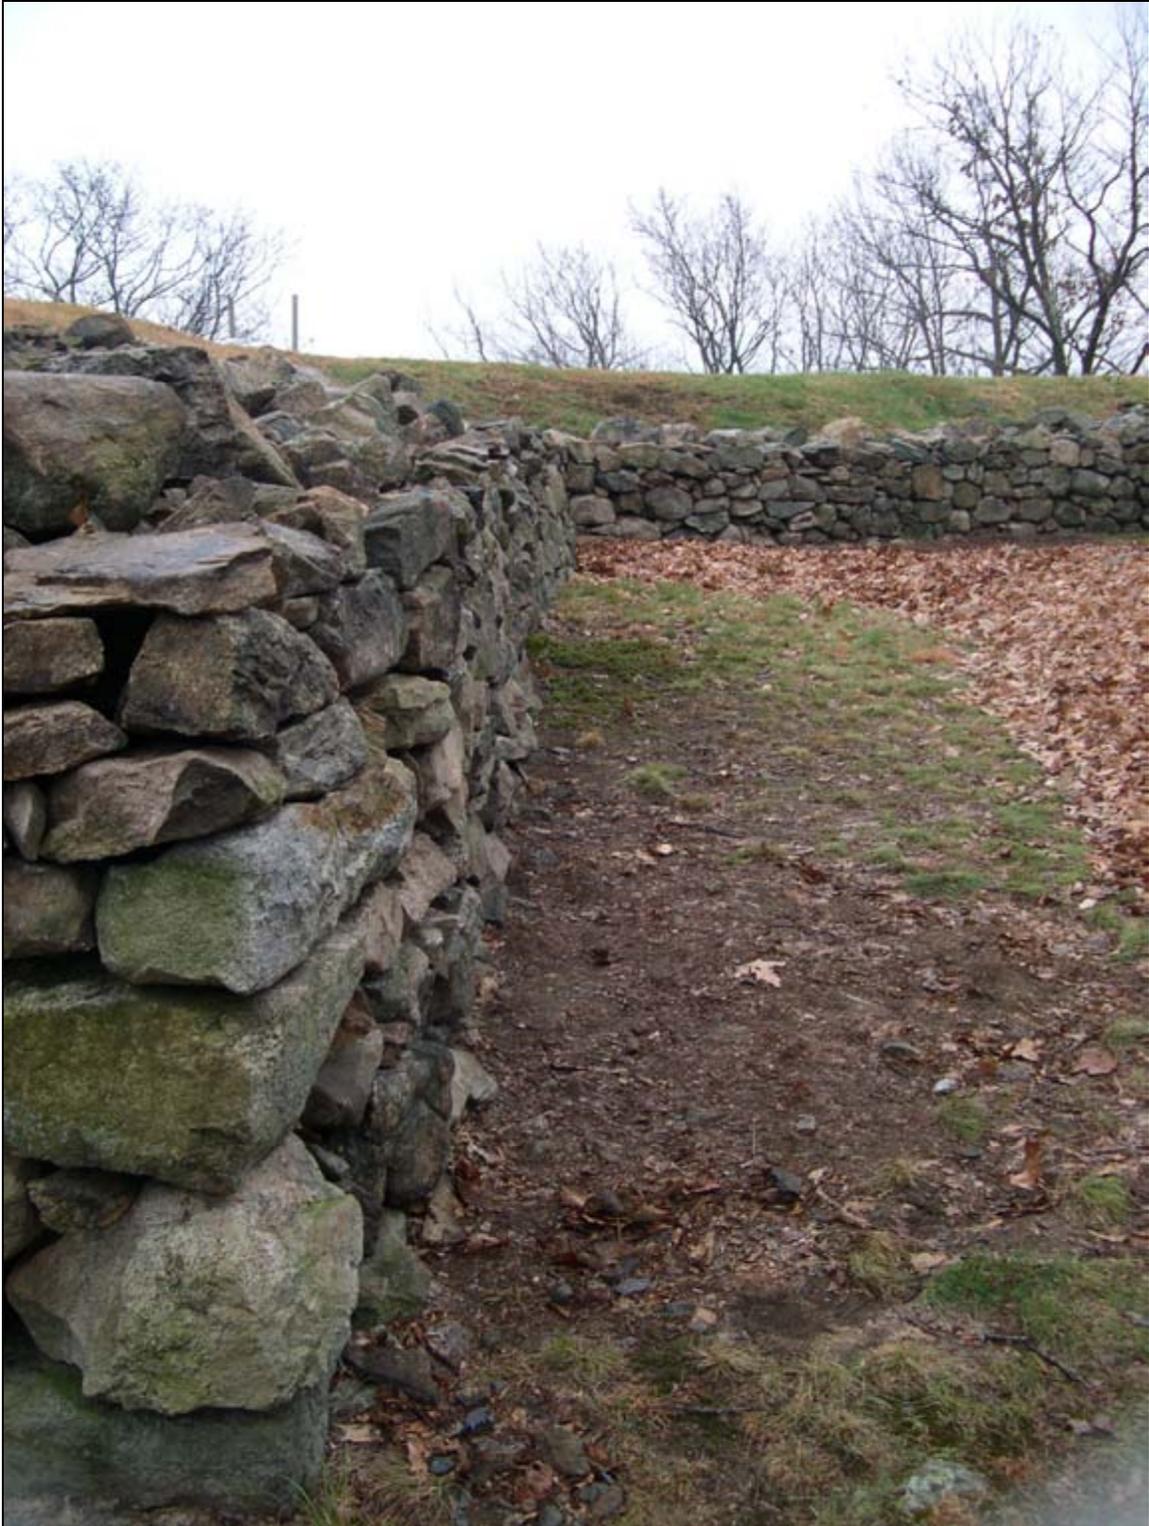
**Photograph 18:** Redoubt Four (1779-1783), Fortress West Point,  
Dry-Laid Stone Walls at West Reentrant Angle.  
(Photograph by D.R. Cubbison)

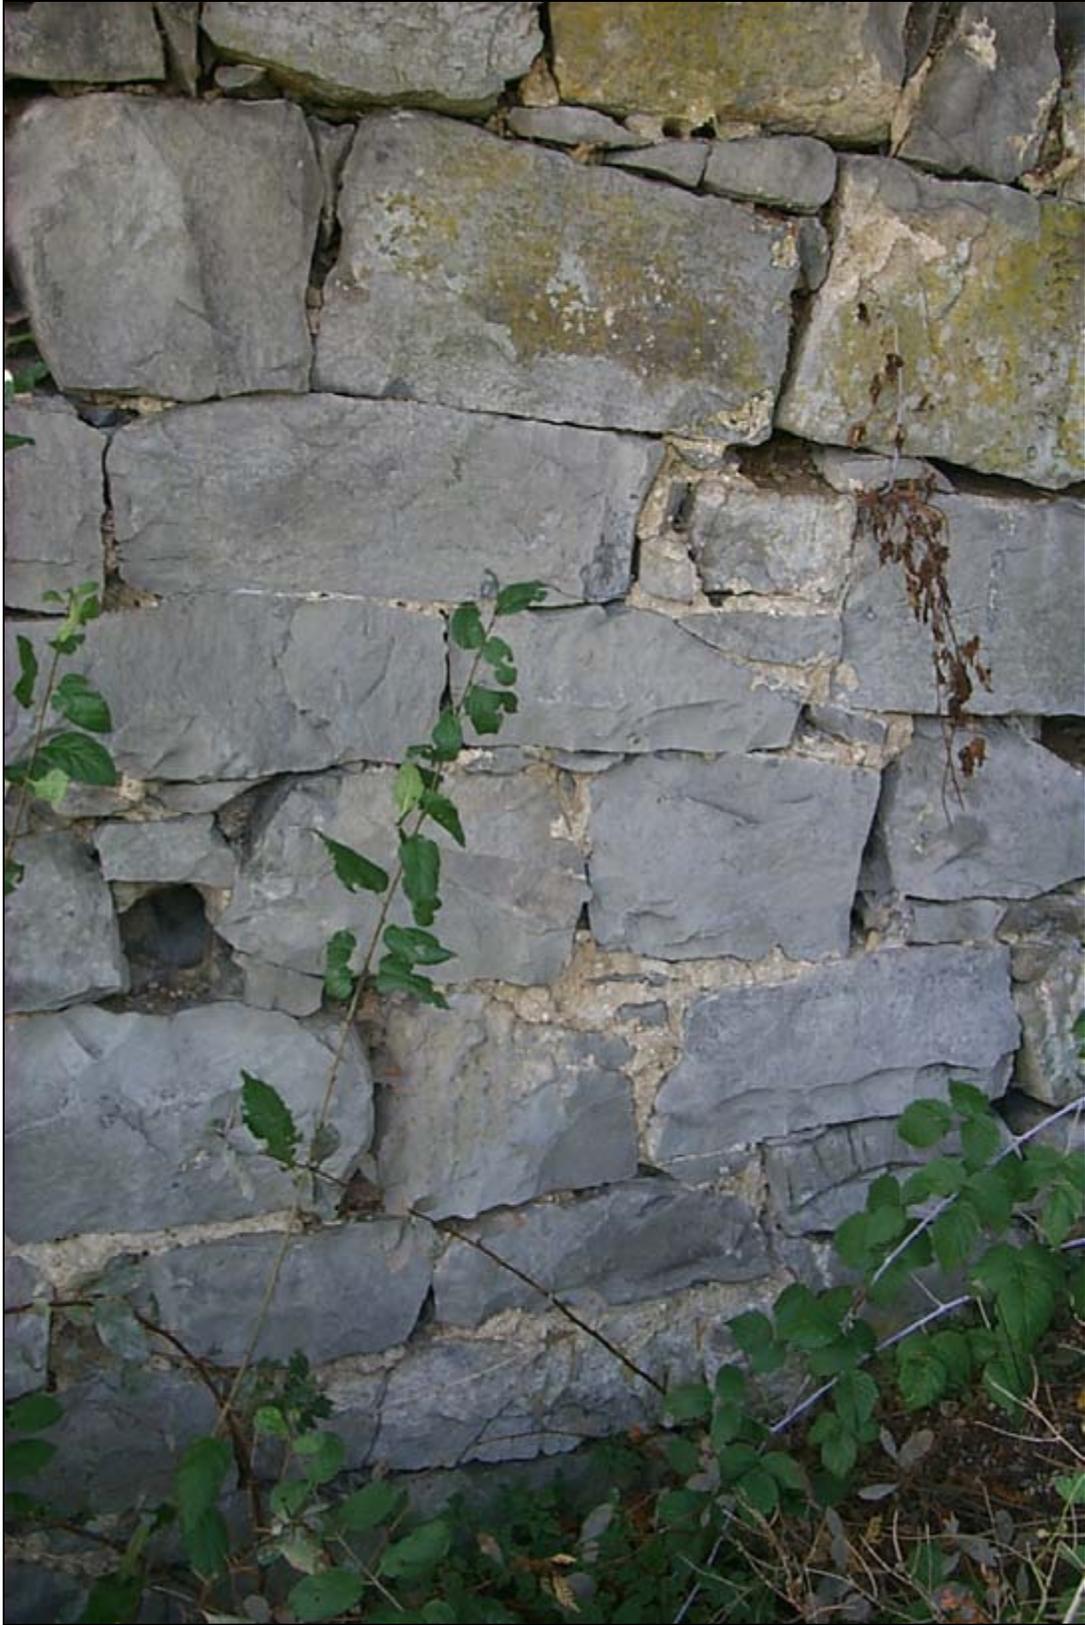
**Photograph 19:** Mortared Parapet Wall, 1756 Grenadier Redoubt, Fort Carillon (Fort Ticonderoga).  
(Photograph by D.R. Cubbison)

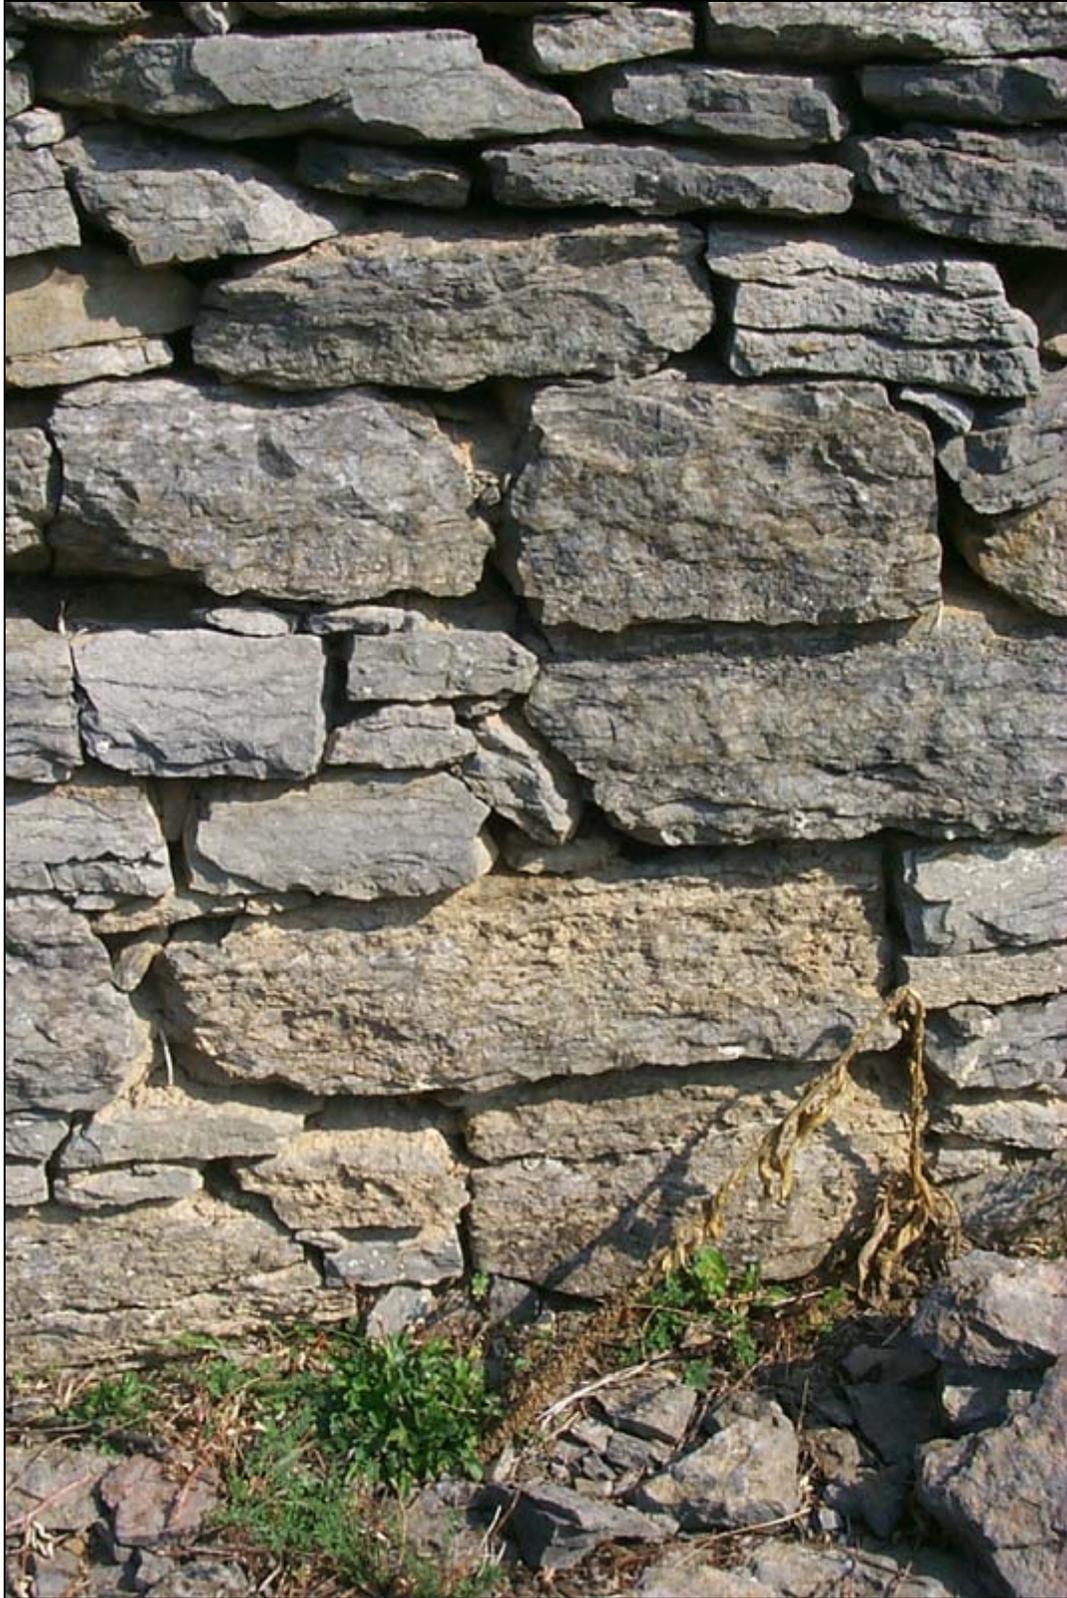
**Photograph 20:** Mortared Stone, 1759 Light Infantry Redoubt,  
Fort Crown Point, Essex County, New York.  
(Photograph by D.R. Cubbison)
