# Department of Defense Legacy Resource Management Program

PROJECT 05-239

## **Stabilization and Preservation of DoD-owned Military Fortifications**

Douglas R. Cubbison  
Cultural Resources Manager  
And  
Travis Beckwith  
Architectural Historian  
United States Military Academy  
West Point, New York

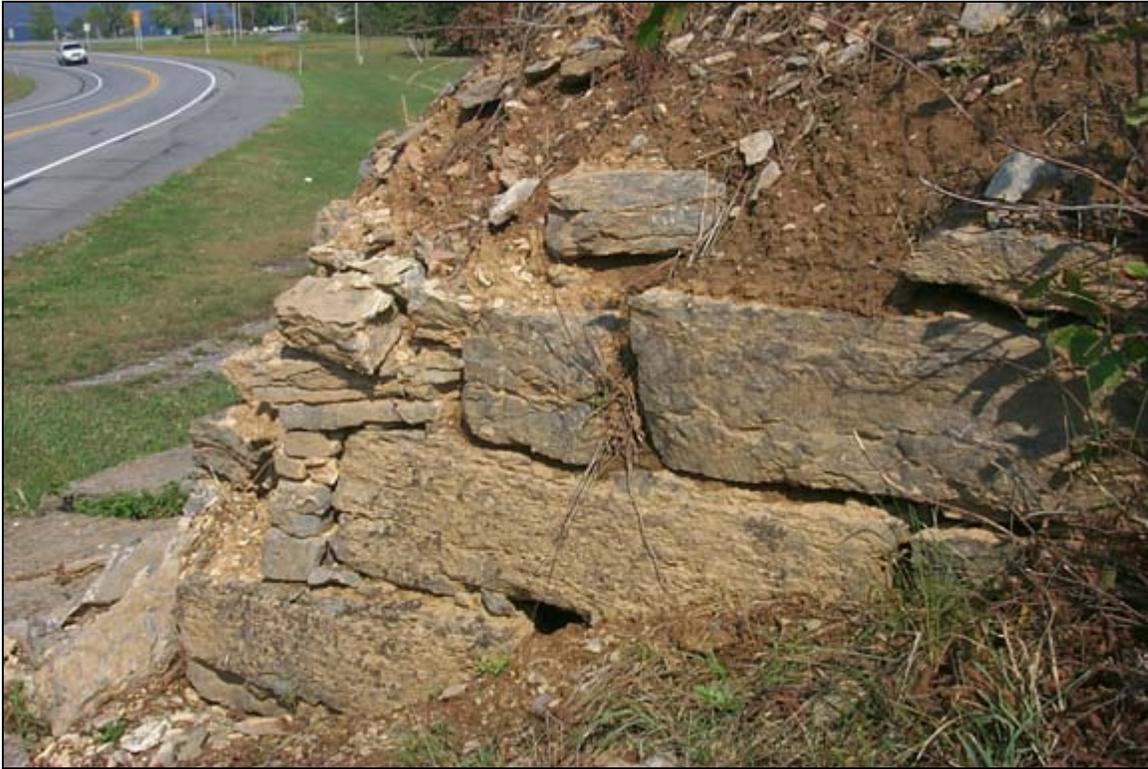
**Photograph 21:** Mortared Stone, 1759 Light Infantry Redoubt, Fort Crown Point.  
(Photograph by D.R. Cubbison)

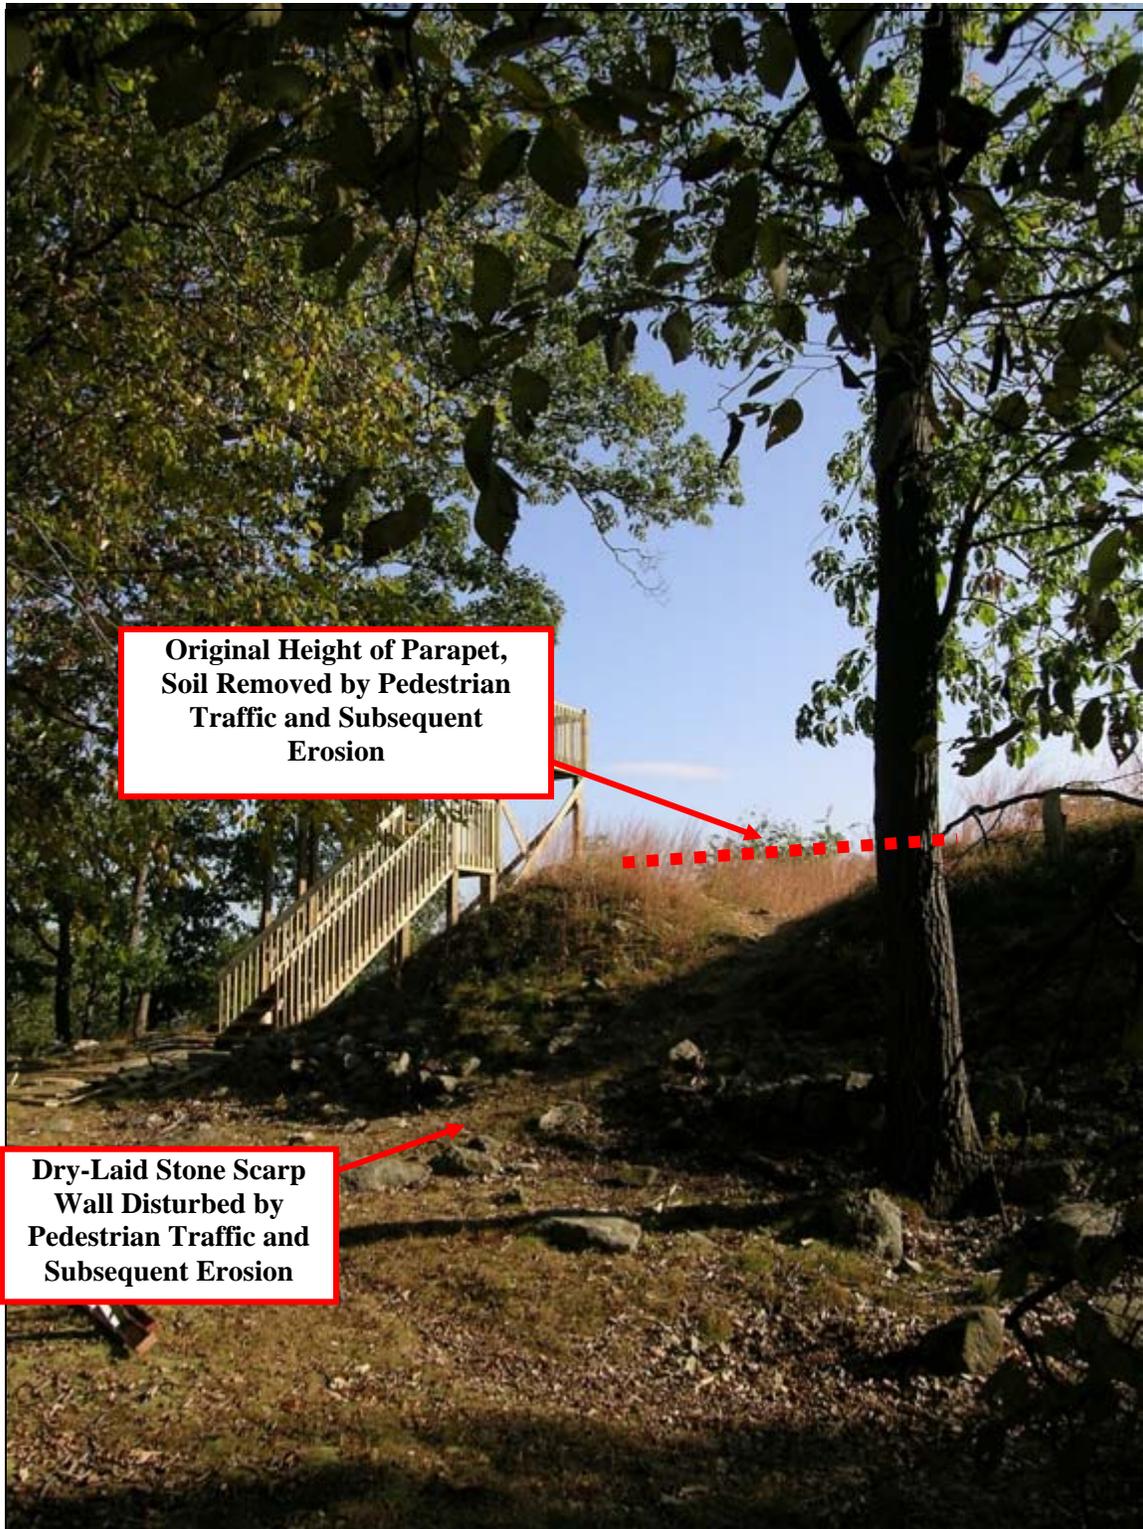
**Original Height of Parapet,  
Soil Removed by Pedestrian  
Traffic and Subsequent  
Erosion**

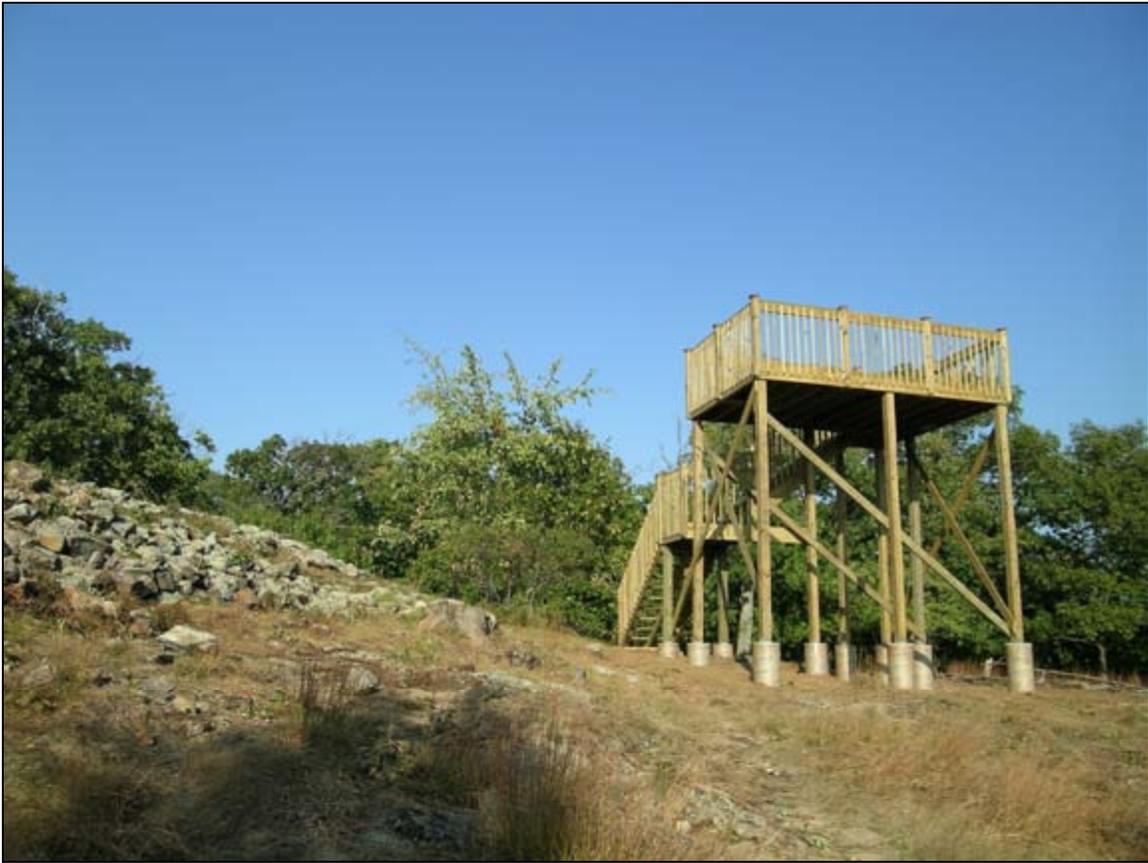
**Photograph 23:** Cadet Academic Project and DoD Demonstration Project, Redoubt No. 1 Viewing Platform, U.S. Military Academy, Orange County, New York. Note how the natural wood colors blend with the surrounding landscape and vegetation.  
(Photograph by D.R. Cubbison, September 2005)

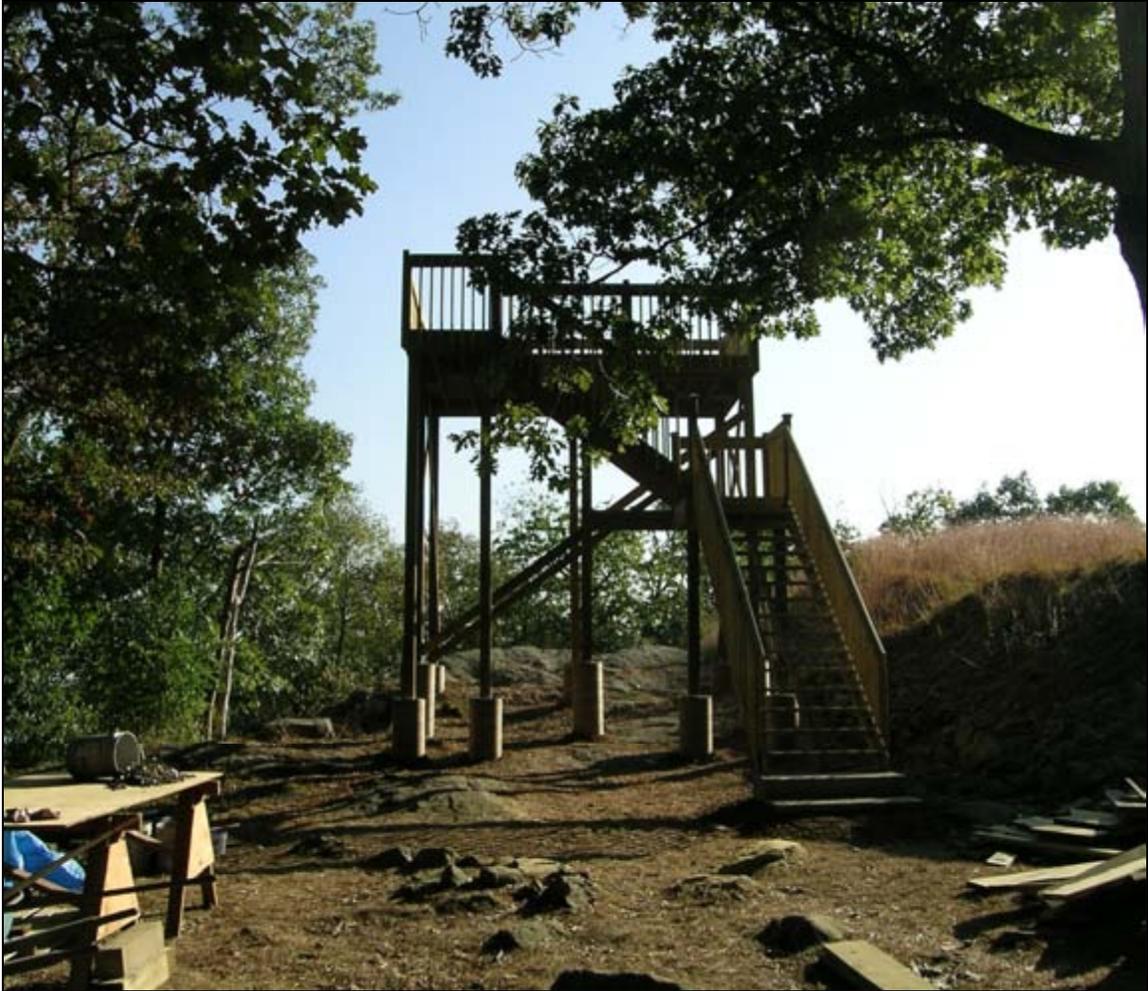
**Photograph 24:** Cadet Academic Project and DoD Demonstration Project, Redoubt No. 2 Viewing Platform, U.S. Military Academy, Orange County, New York. Note how the natural wood colors blend with the surrounding landscape and vegetation.  
(Photograph by D.R. Cubbison, September 2005)

- At-grade foundations to minimize ground disturbance and excavation;
- Unpainted lumber construction to blend with natural landscape;
- Railings and steps designed to provide for pedestrian safety;
- Adequate space provided for installation of interpretive markers and/or similar signage;
- Adequate height to see clearly into the interior of redoubt (Photograph 26);
- Relatively simple design that can be constructed by any general contractor (specialized construction skills are not required);
- Use of standard lumber (specialized materials are not required);
- Twenty-year design standard (service life can be extended through routine maintenance).

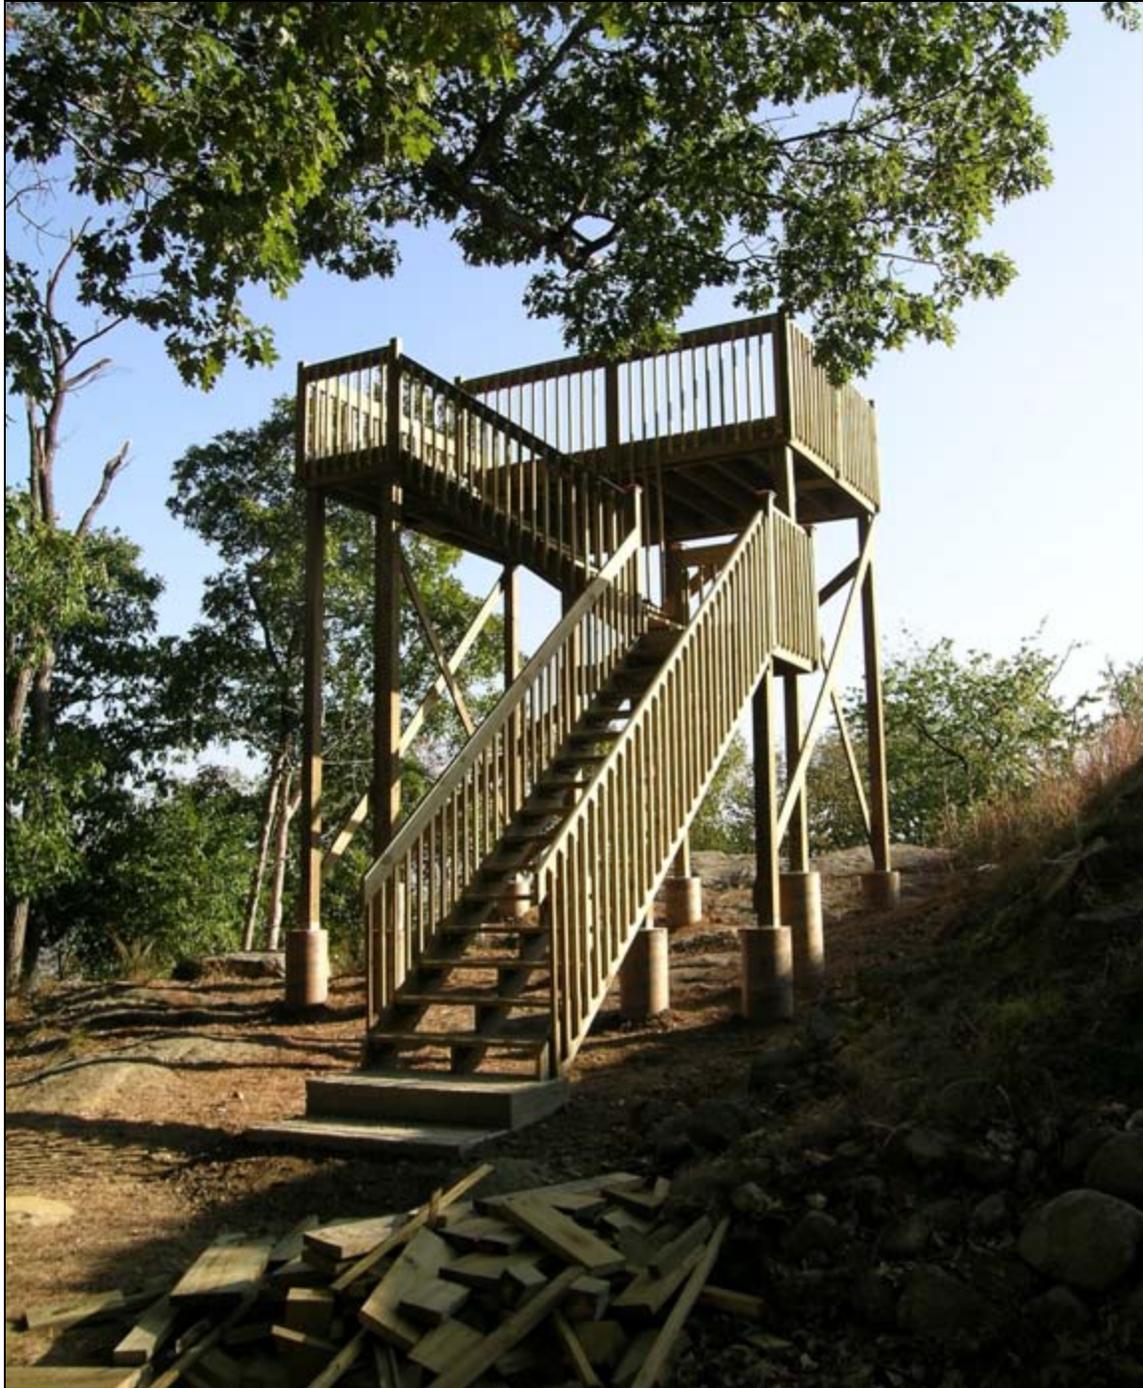
**Photograph 25:** Cadet Academic Project and DoD Demonstration Project, Redoubt No. 2 Viewing Platform, U.S. Military Academy, Orange County, New York. Note how the natural wood colors blend with the surrounding landscape and vegetation.  
(Photograph by D.R. Cubbison, September 2005)

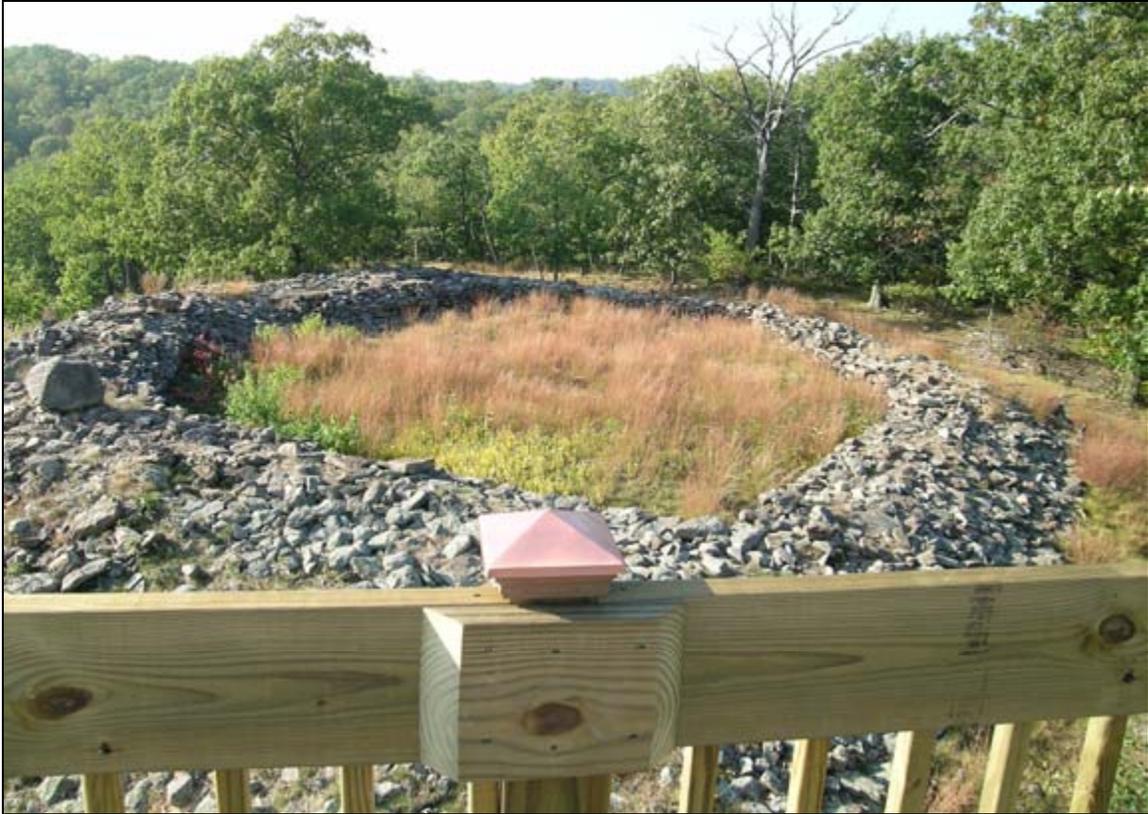
**Photograph 26:** Cadet Academic Project and DoD Demonstration Project, Redoubt No. 1 viewed from new Viewing Platform, U.S. Military Academy, Orange County, New York. The ability of this structure to provide excellent views of the layout of the fortification that cannot be obtained from any other perspective is dramatically demonstrated by this photograph.

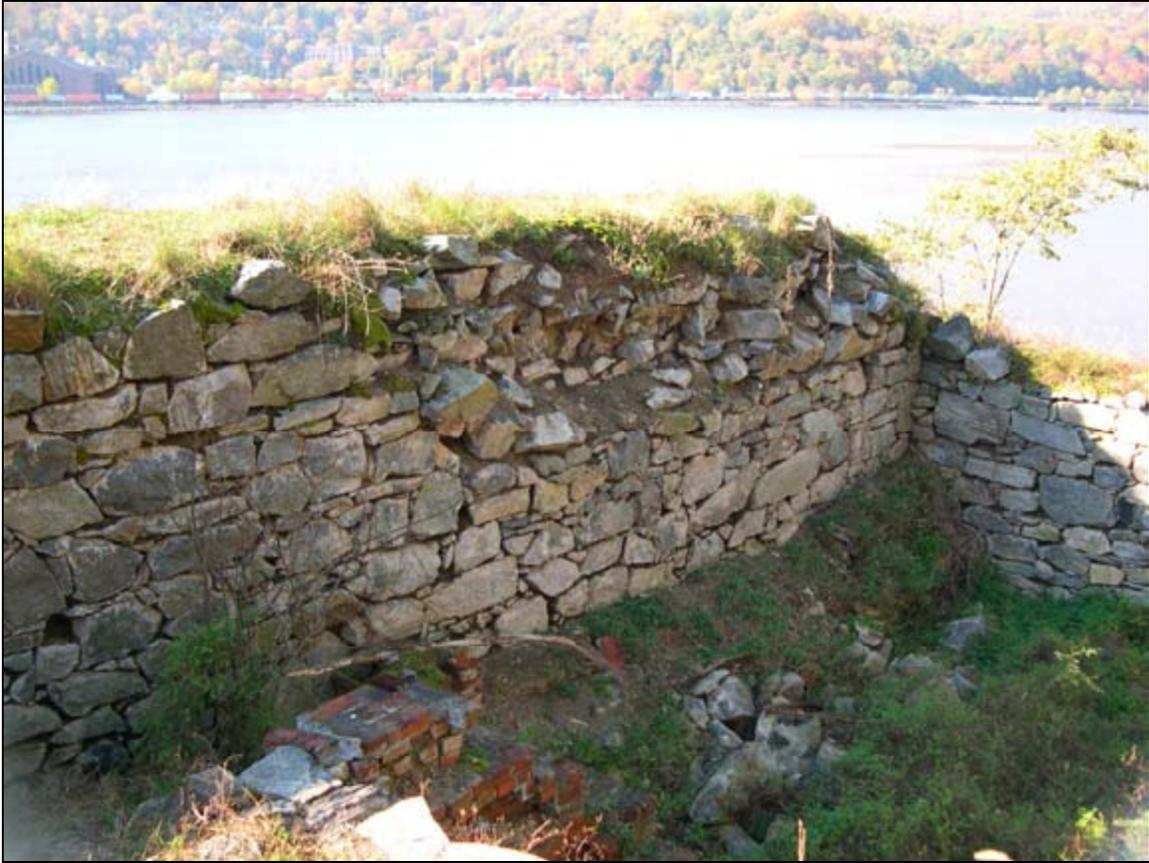
**Photograph 27:** Catastrophic Failure, sixty square foot collapse, Interior of Romans' Powder Magazine,  
Looking Northwest.

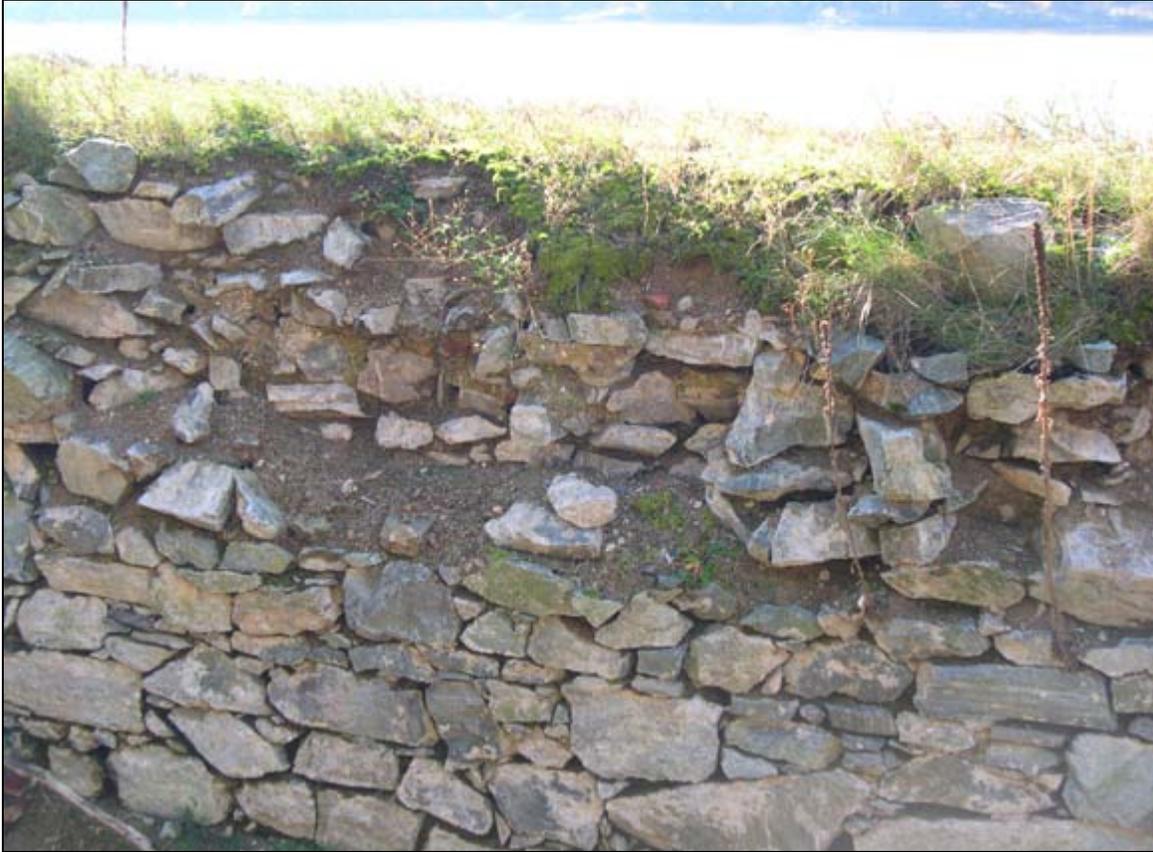
**Photograph 28:** Catastrophic Failure, sixty square foot collapse,  
Interior of Romans' Powder Magazine.  
(D. R. Cubbison, 31 October 2003)

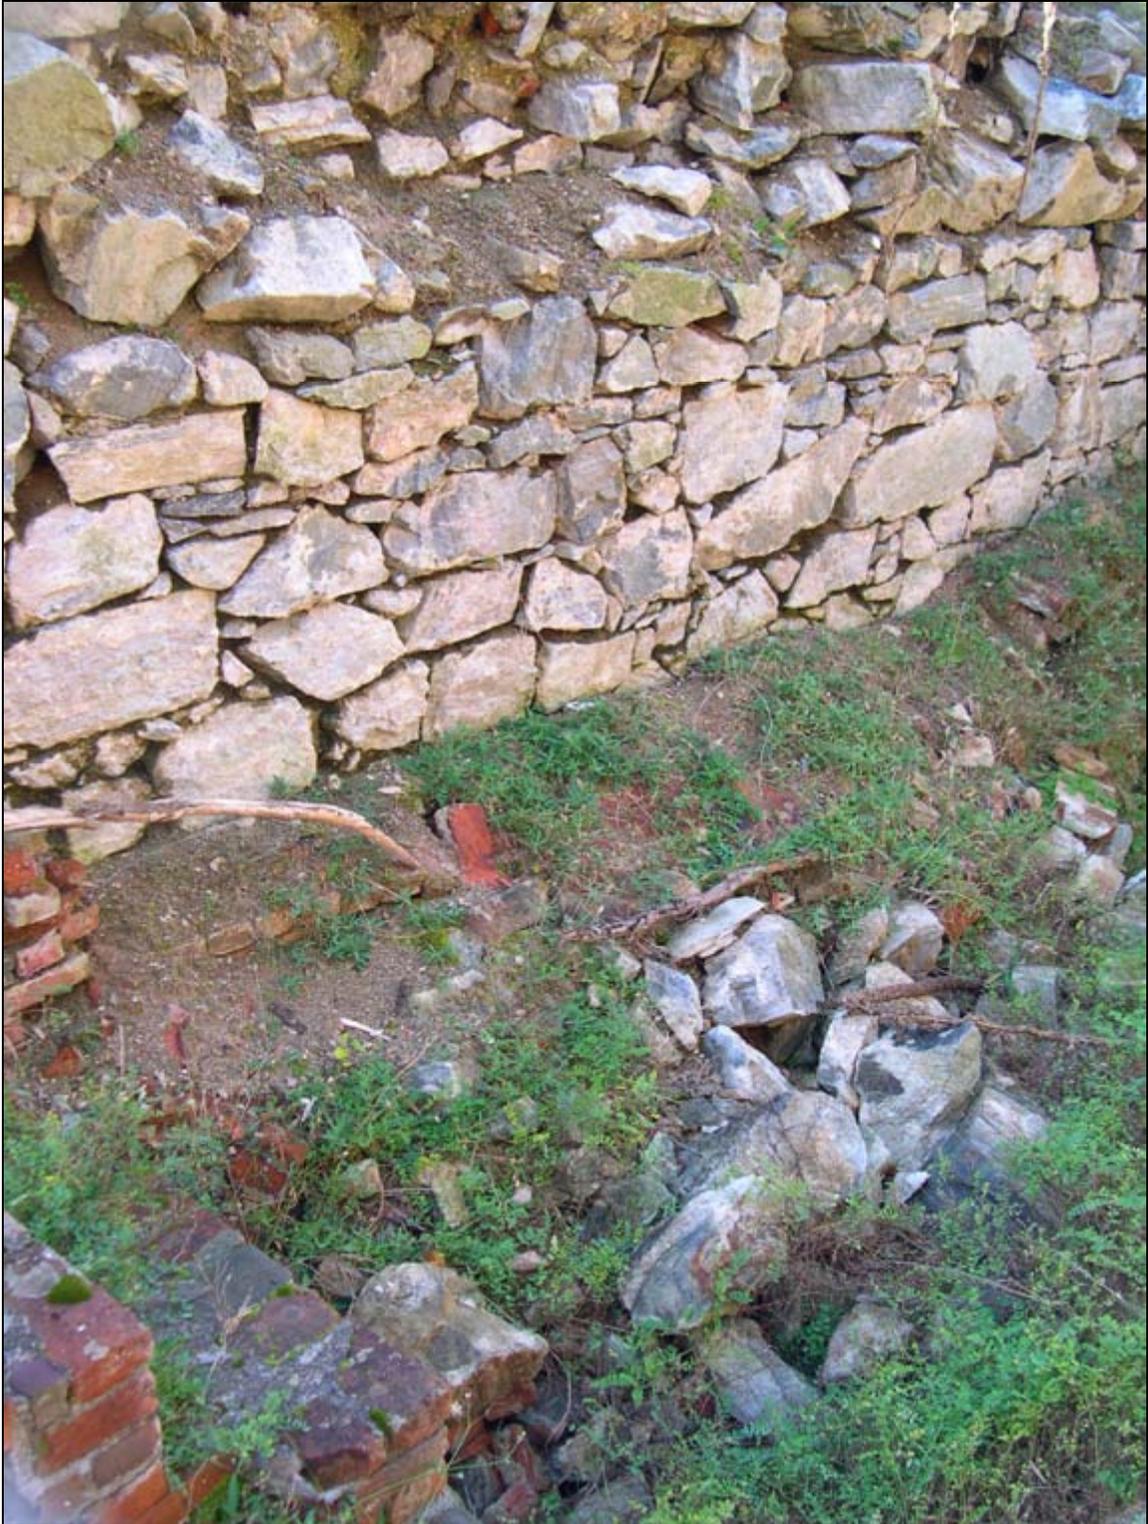
**Photograph 29:** Catastrophic Failure, sixty square foot collapse, Interior of Romans' Powder Magazine.  
(D. R. Cubbison, 31 October 2003)

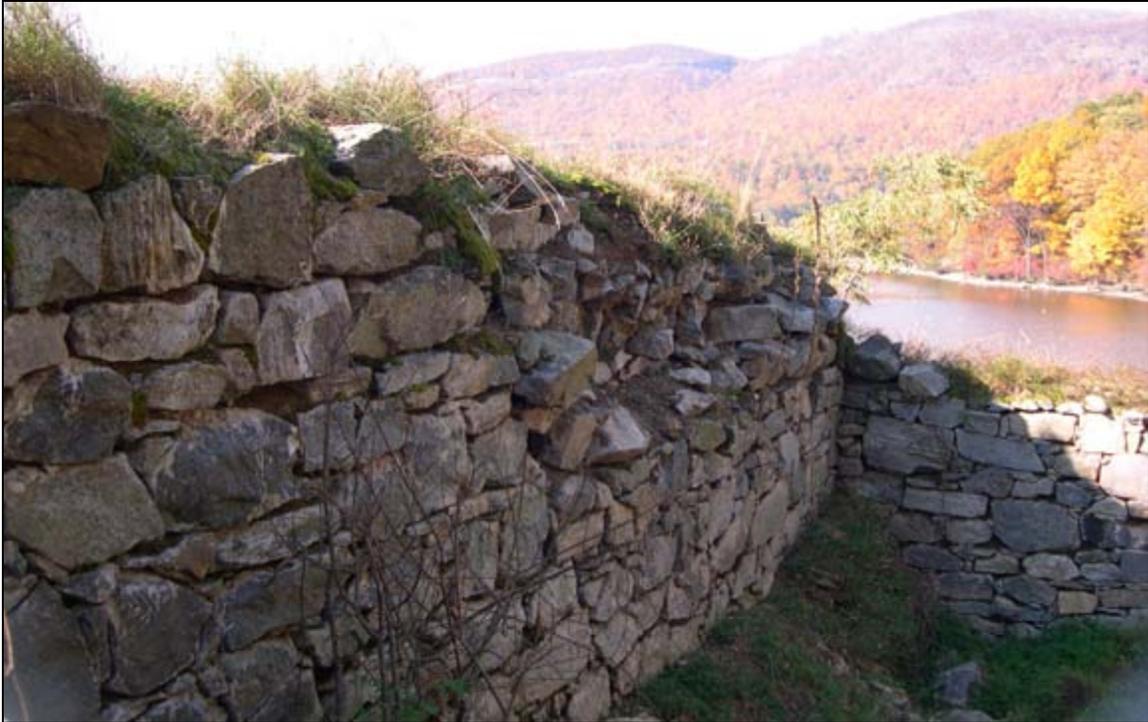
**Photograph 30:** Catastrophic Failure, sixty square foot collapse,  
Interior of Romans' Powder Magazine, Looking North.  
(D. R. Cubbison, 31 October 2003)

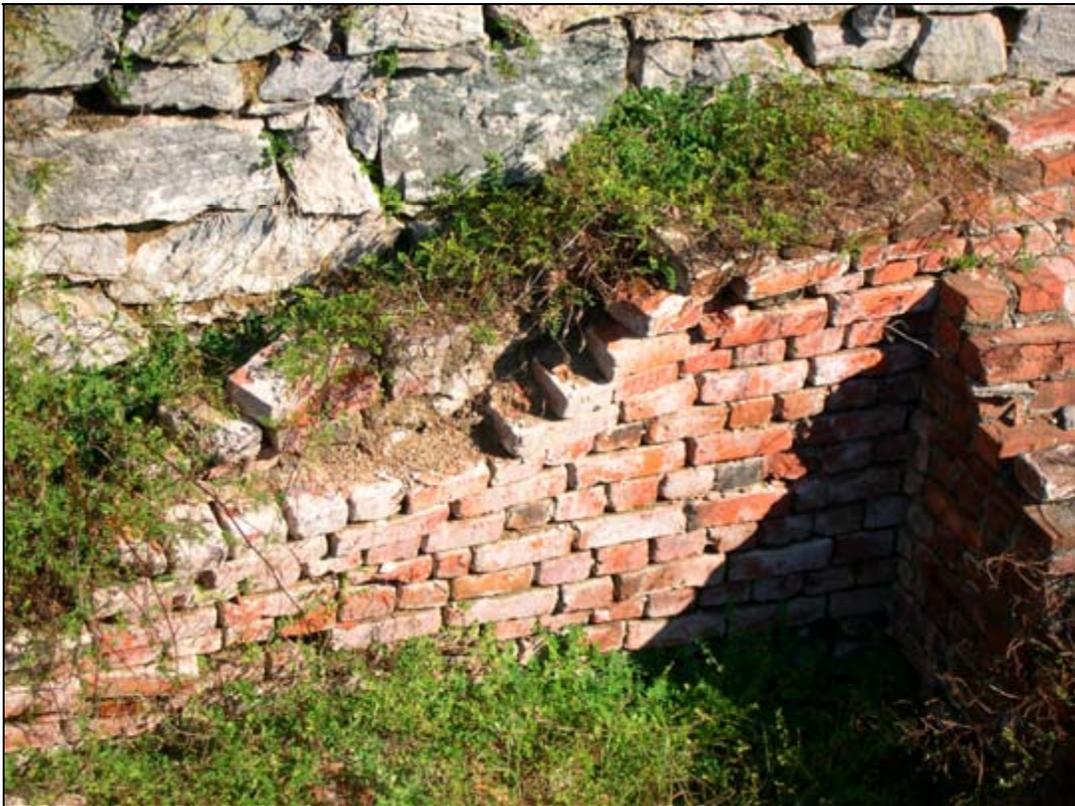
**Photograph 31:** Brick Collapse, Interior of Romans' Powder Magazine, Looking East.  
(D. R. Cubbison, 31 October 2003)

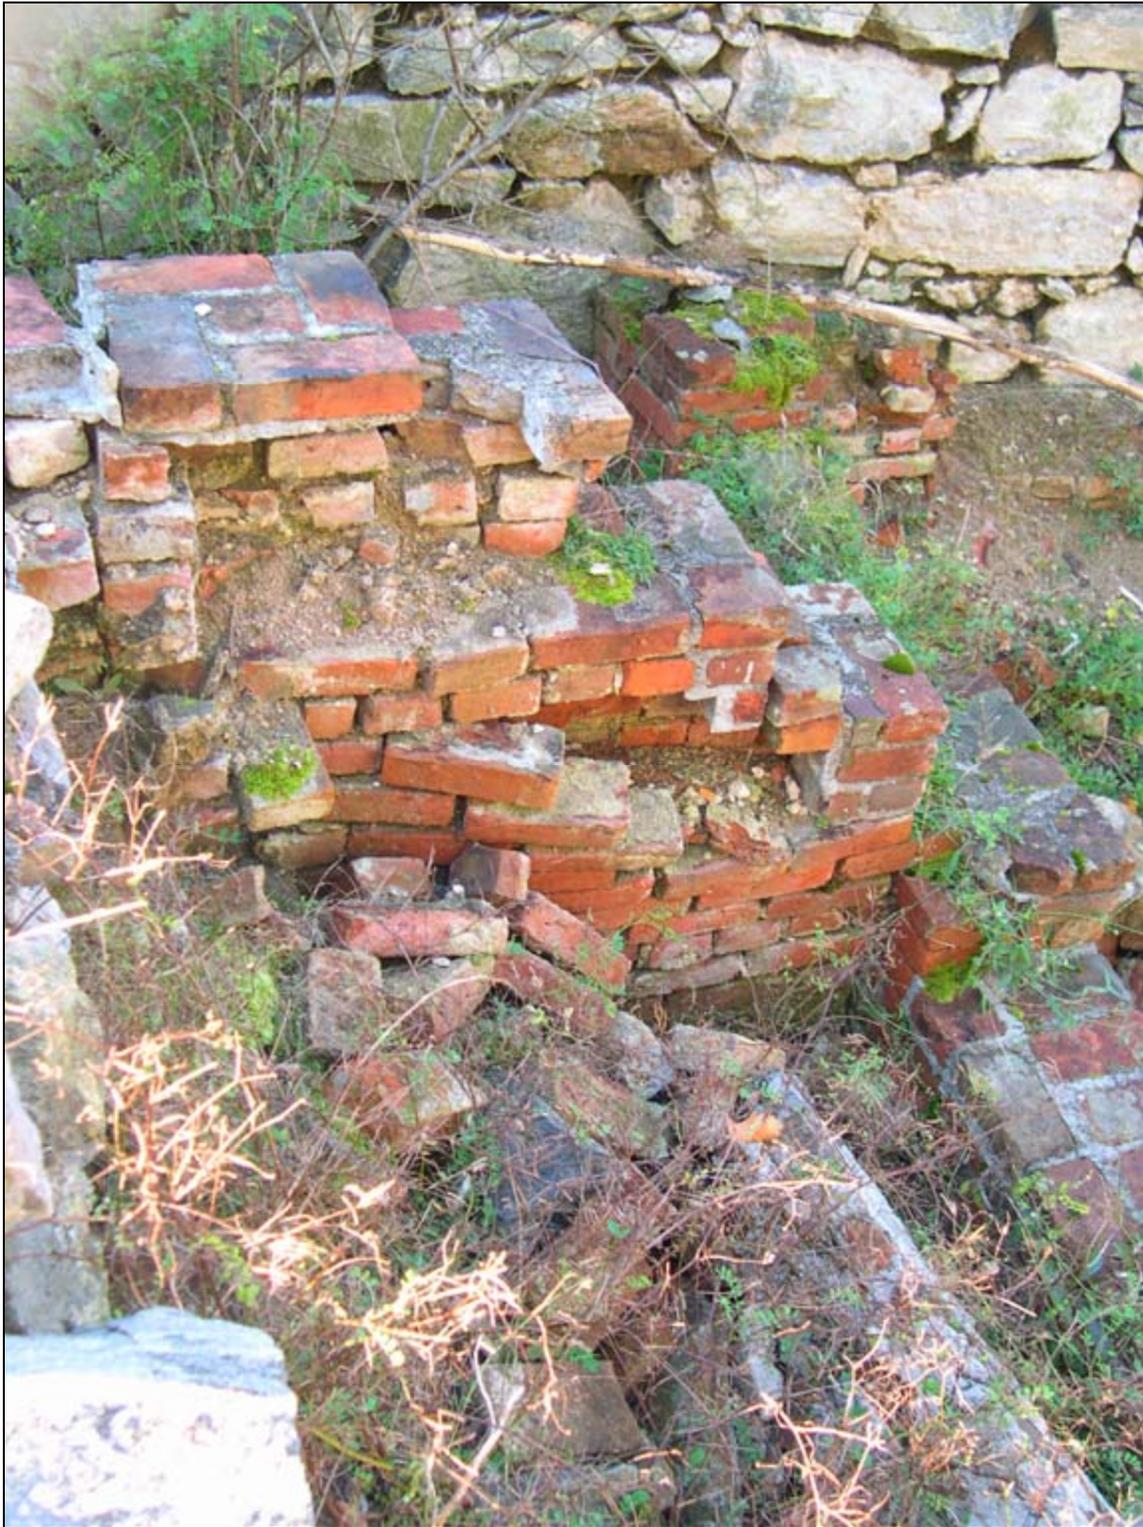
**Photograph 32:** Collapse of Brick Stairs, Interior of Romans' Powder Magazine, West Entrance.  
(D. R. Cubbison, 31 October 2003)

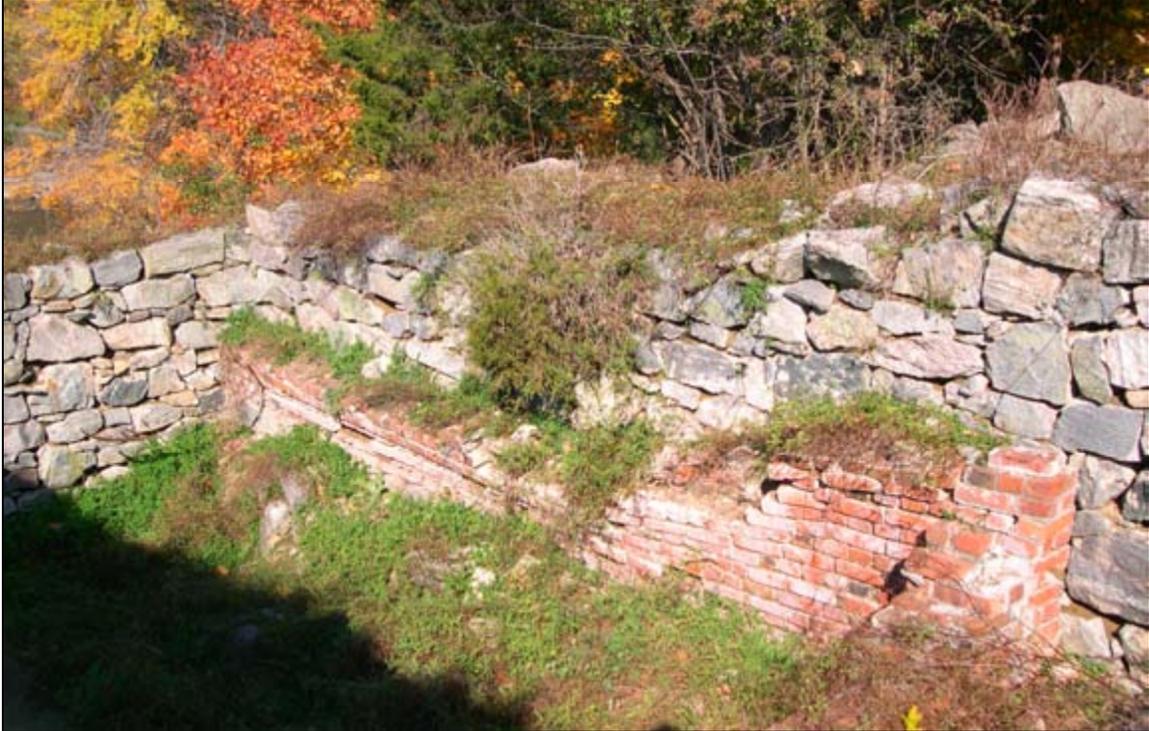
**Photograph 33:** Imminent Failure of Interior Brick Wall,  
Interior of Romans' Powder Magazine, Looking Northeast.  
(D. R. Cubbison, 31 October 2003)

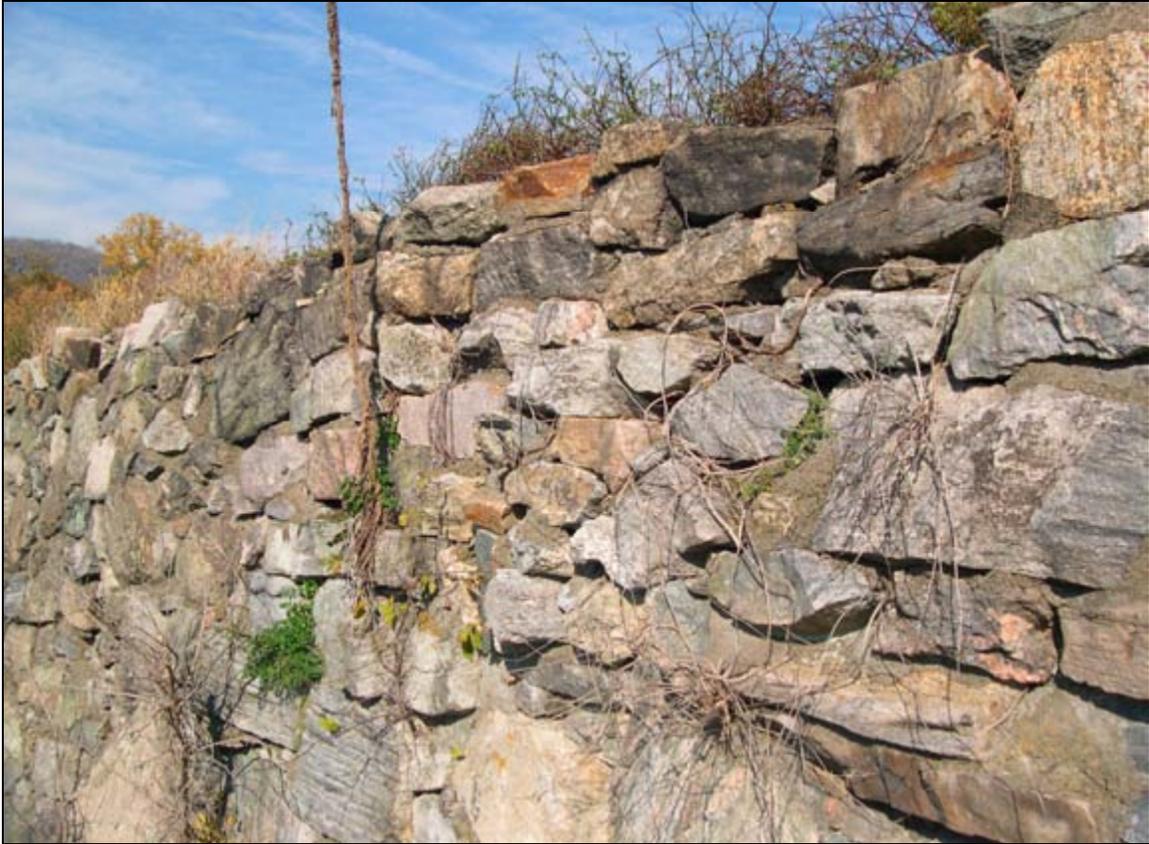
**Photograph 34:** Imminent Failure of Exterior Masonry Parapet Wall, Romans' Powder Magazine.  
(D. R. Cubbison, 31 October 2003)

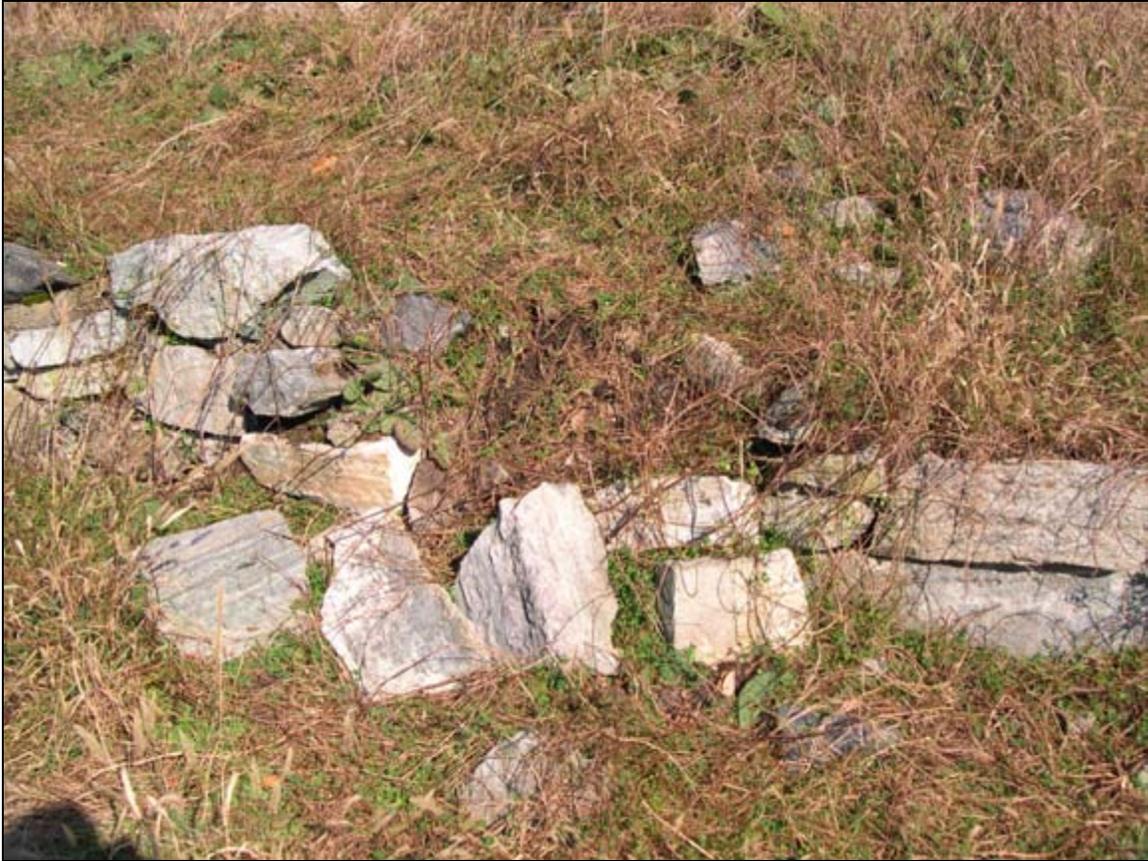
**Photograph 35:** Six Square Foot Collapse, Romans' Battery Parapet (Scarp) Wall, South of Romans' Powder Magazine.  
(D. R. Cubbison, 31 October 2003)

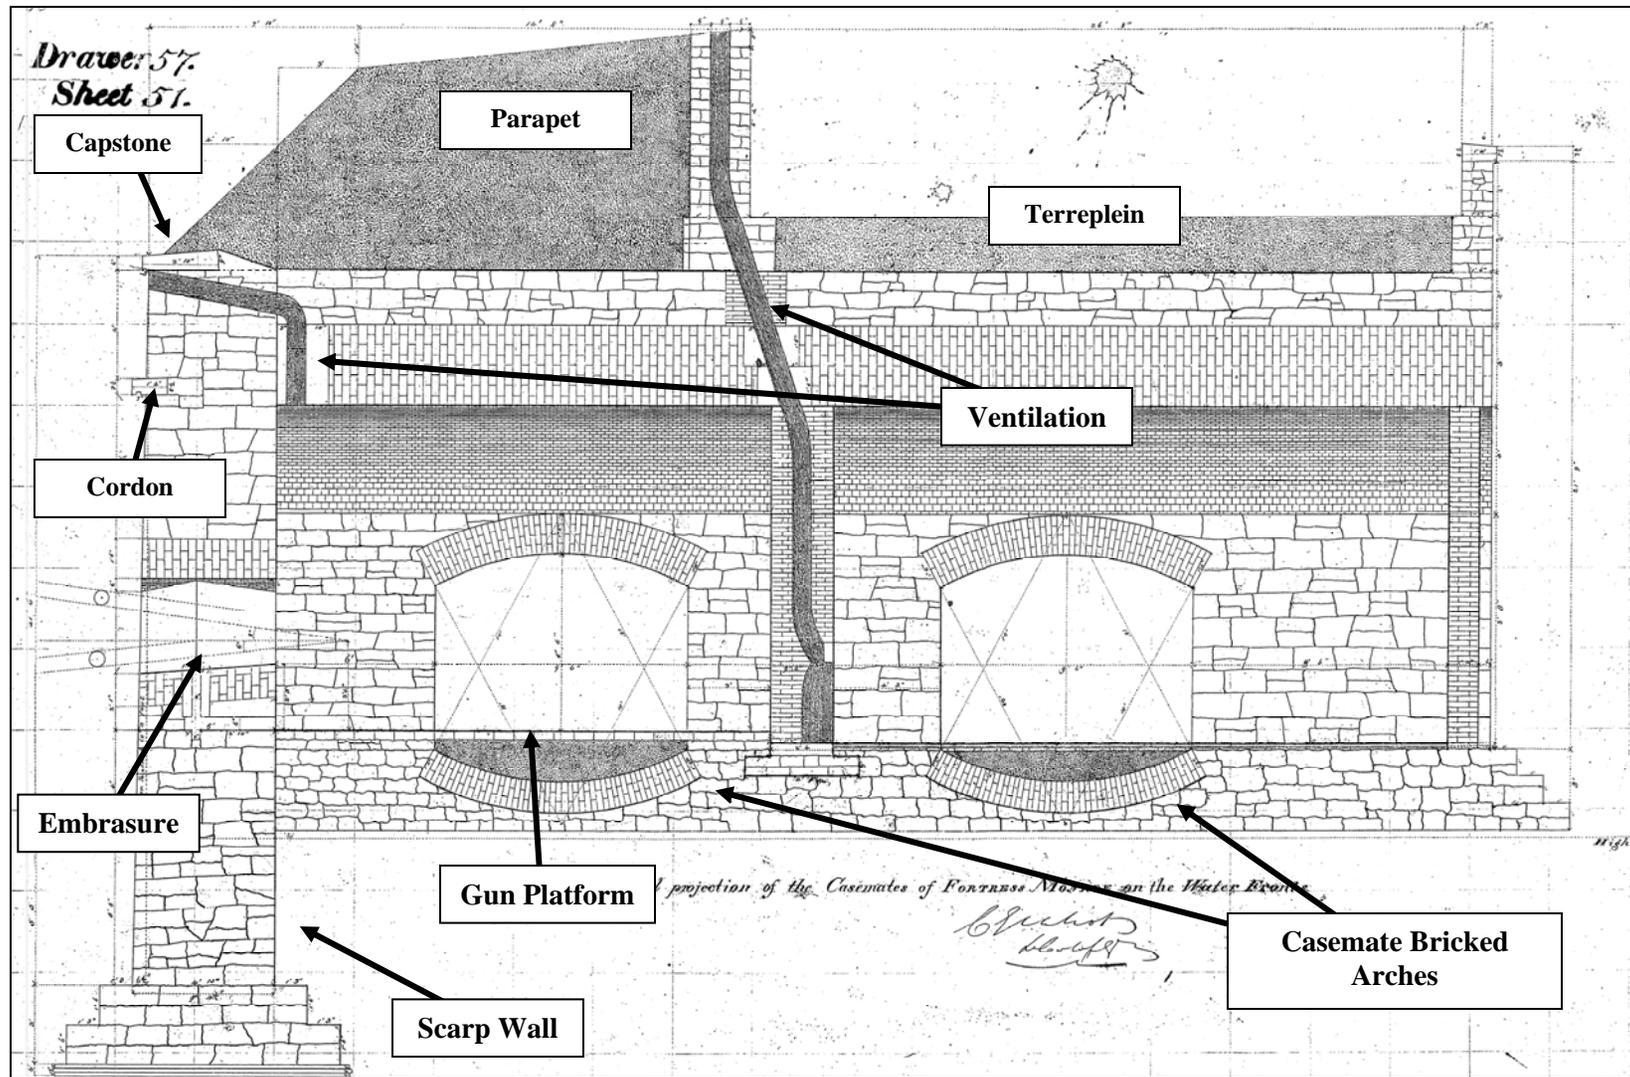
**Figure 4:** Components of a Third Series Coastal Defense Fortification, adapted from “Vertical Projection of the Casemates of Fortress Monroe on the Water Front” (undated) (RG 77, National Archives and Records Administration II).

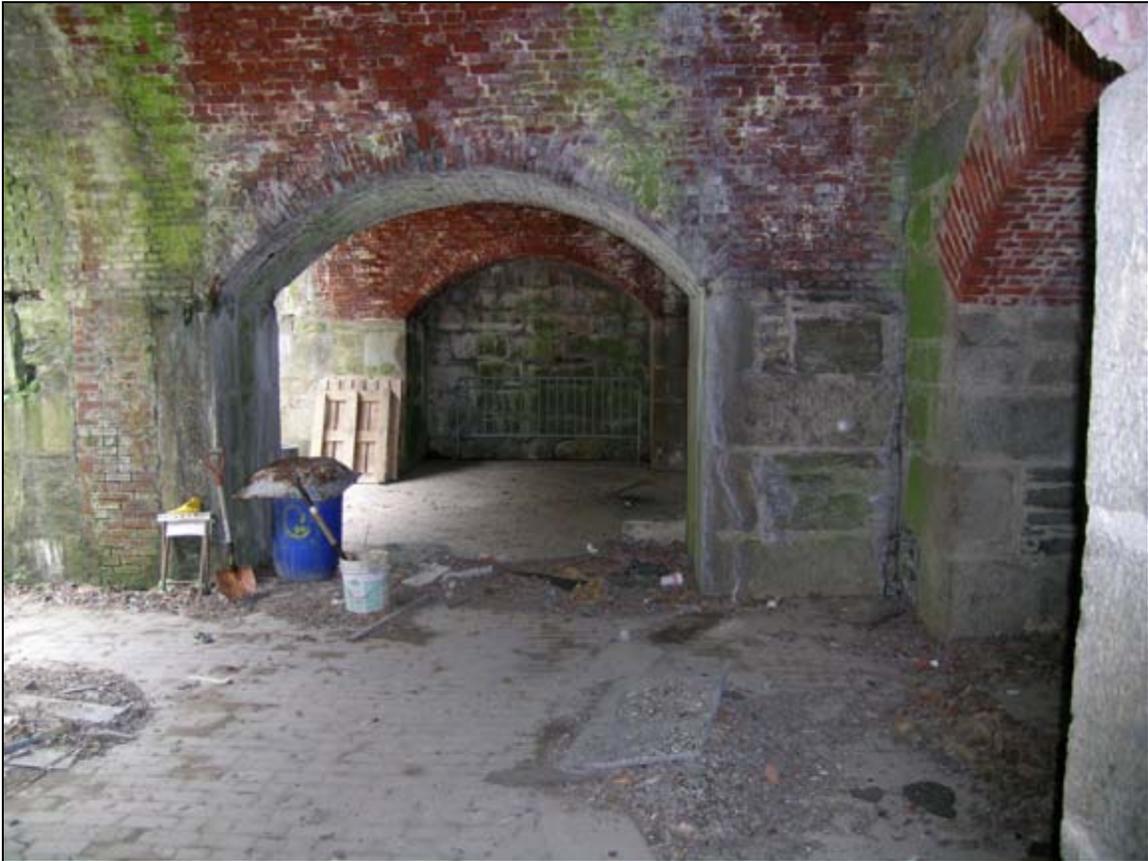
**Photograph 36:** Arch within the casemates at Fort Adams, Rhode Island.  
(Photograph by T. Beckwith, August 2005).

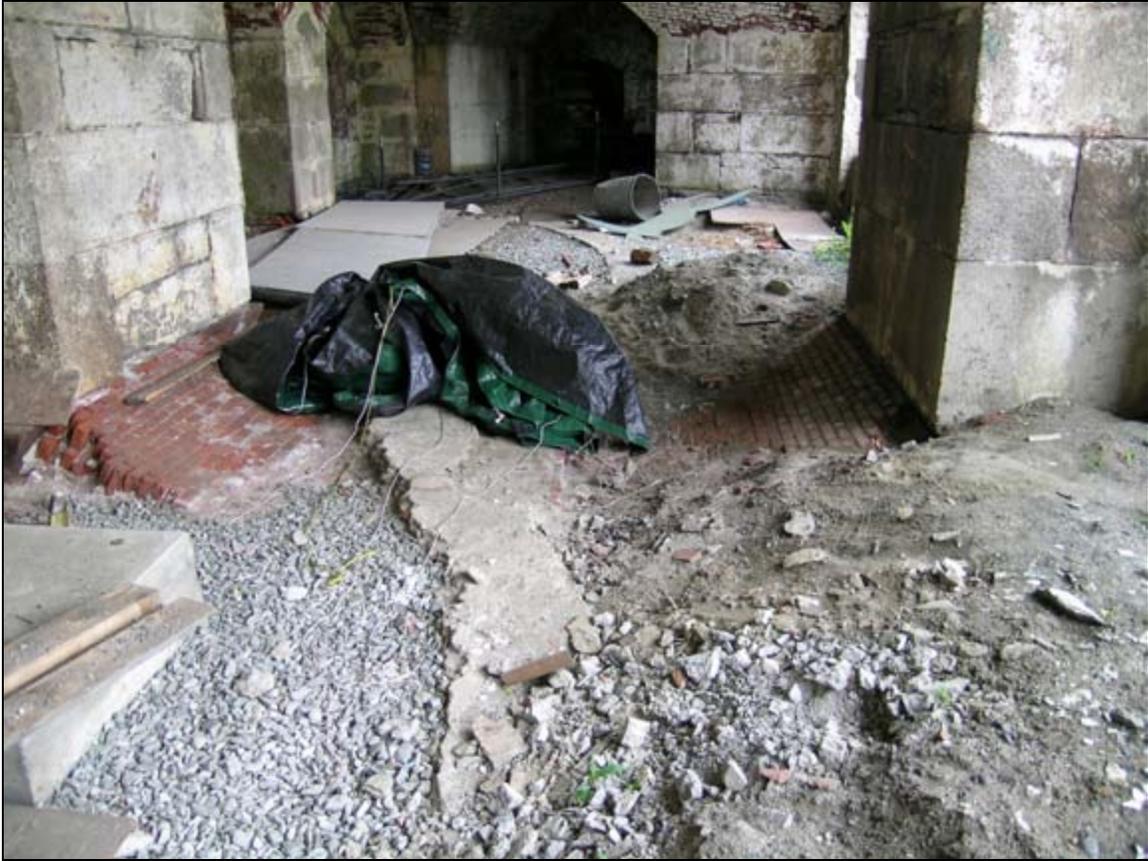
**Photograph 37:** Bottom casemate arch, partially exposed. Fort Adams, Rhode Island.  
(Photograph by T. Beckwith, August 2005).
