# Department of Defense Legacy Resource Management Program

PROJECT 05-239

## **Stabilization and Preservation of DoD-owned Military Fortifications**

Douglas R. Cubbison  
Cultural Resources Manager  
And  
Travis Beckwith  
Architectural Historian  
United States Military Academy  
West Point, New York

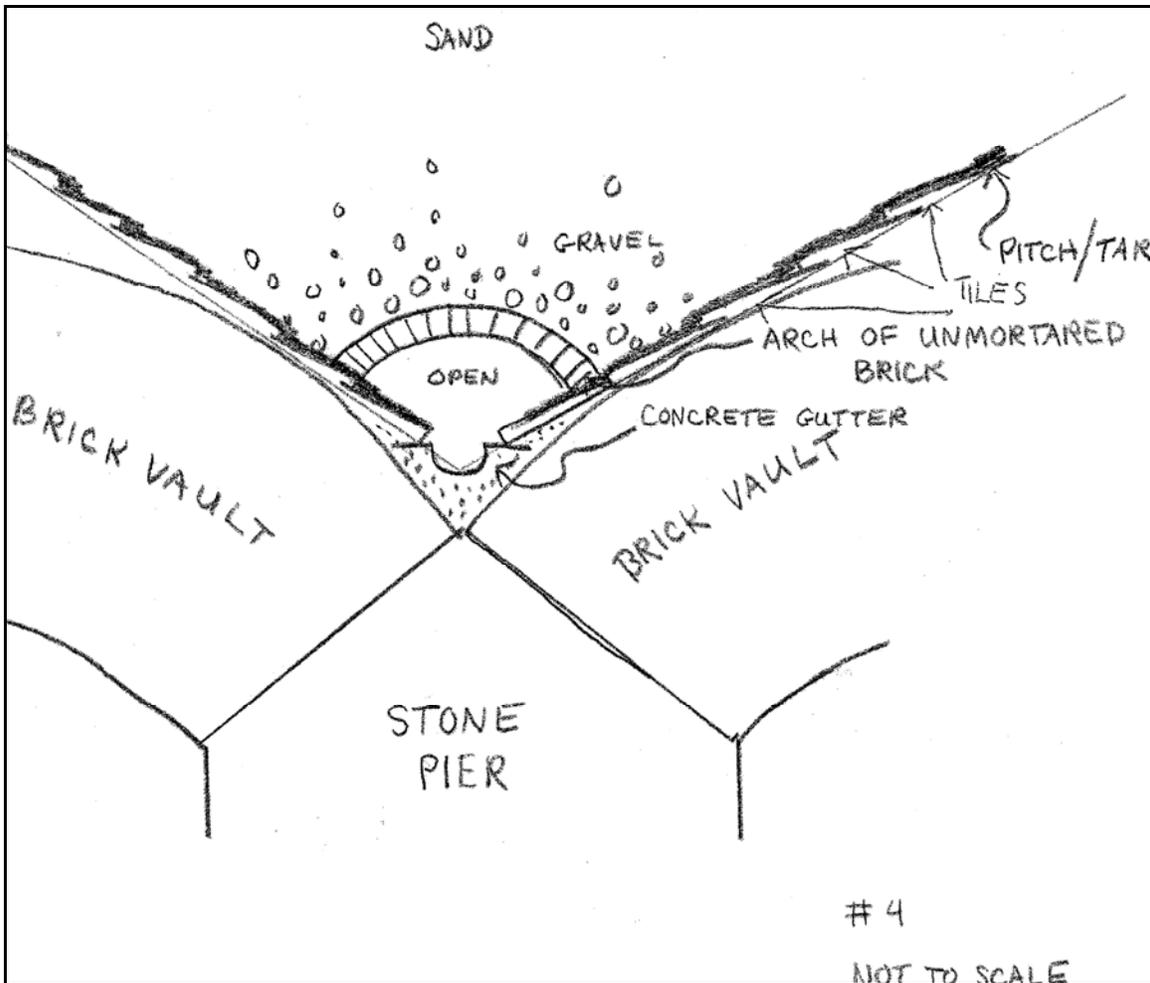
**Figure 8:** Another figure taken from the 1981 investigation into the drainage system of Casemate 22. This illustration details the gutter system that runs parallel to the brick vaults. It is likely that many of the gutters are clogged with debris. Failure of the gutter would prevent the water from draining adequately from the building and create moisture infiltration problems within the masonry walls.  
 (From Phyllis Sprock, "Memorandum for Record, Casemate Drainage System.")

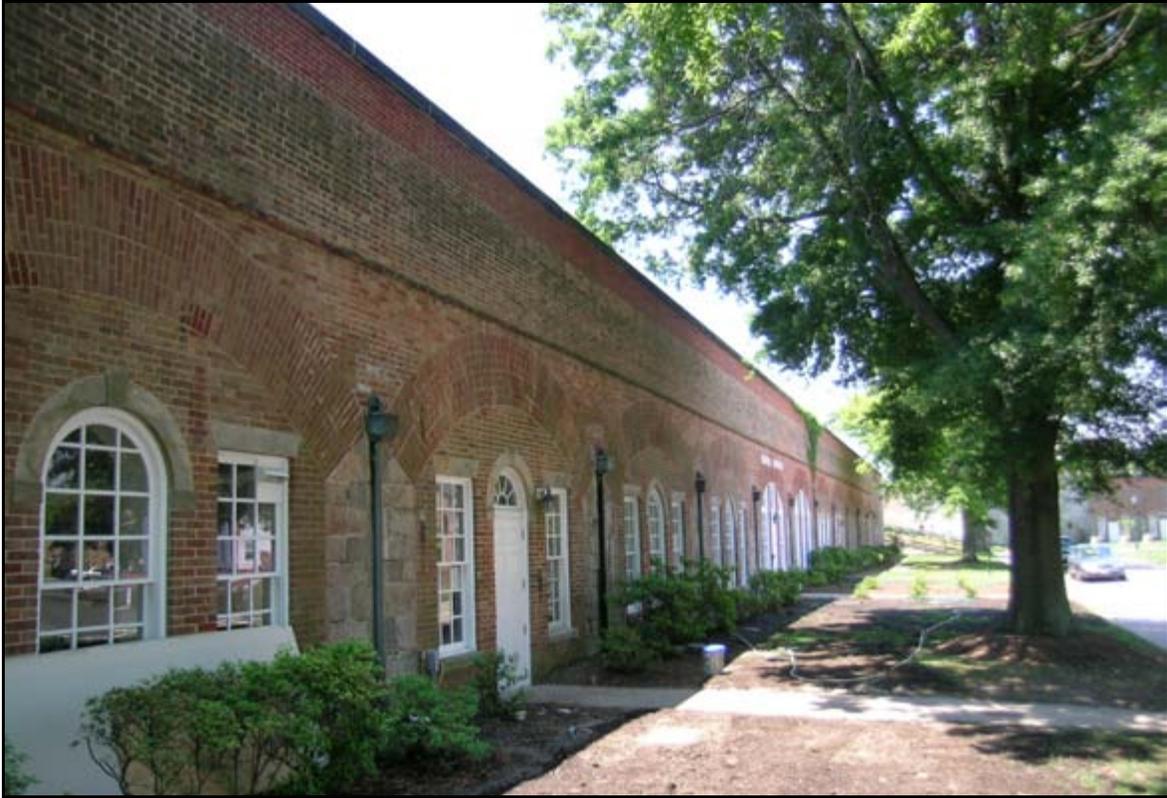
**Photograph 38:** View looking at the exterior of Casemate 21, Fort Monroe, Virginia. These exterior walls exhibit efflorescence around the gutter down spouts. Biological growth can also be discerned along the upper brick courses, another indication of moisture infiltration into the masonry walls.

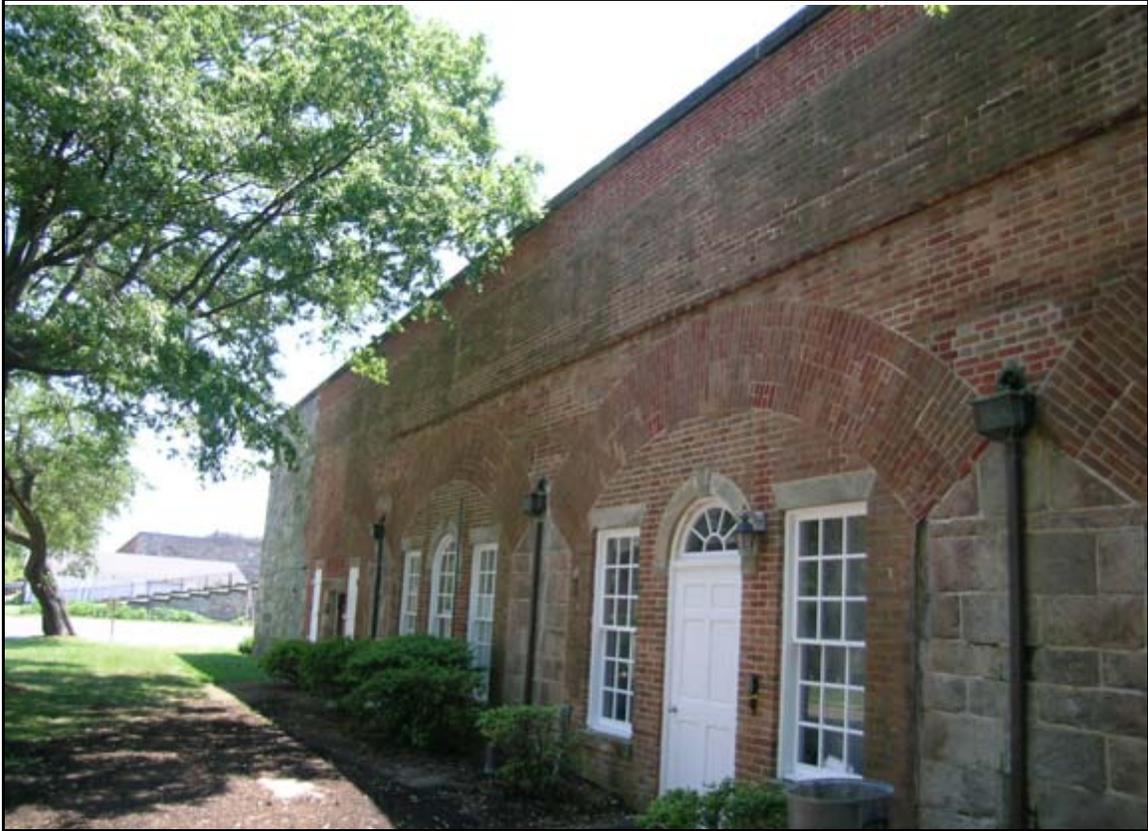
**Photograph 39:** View looking at the exterior of Casemate 21, Fort Monroe. This casemate suffers from extensive moisture infiltration. The failure of the gutter system or the membrane that covers each of the arches allowed moisture to penetrate the structure. Note that portions of this brick wall have been re-pointed. It is unclear if an appropriate mortar mixture was used in this re-pointing of the masonry walls.  
(Photograph by T. Beckwith, June 2005)

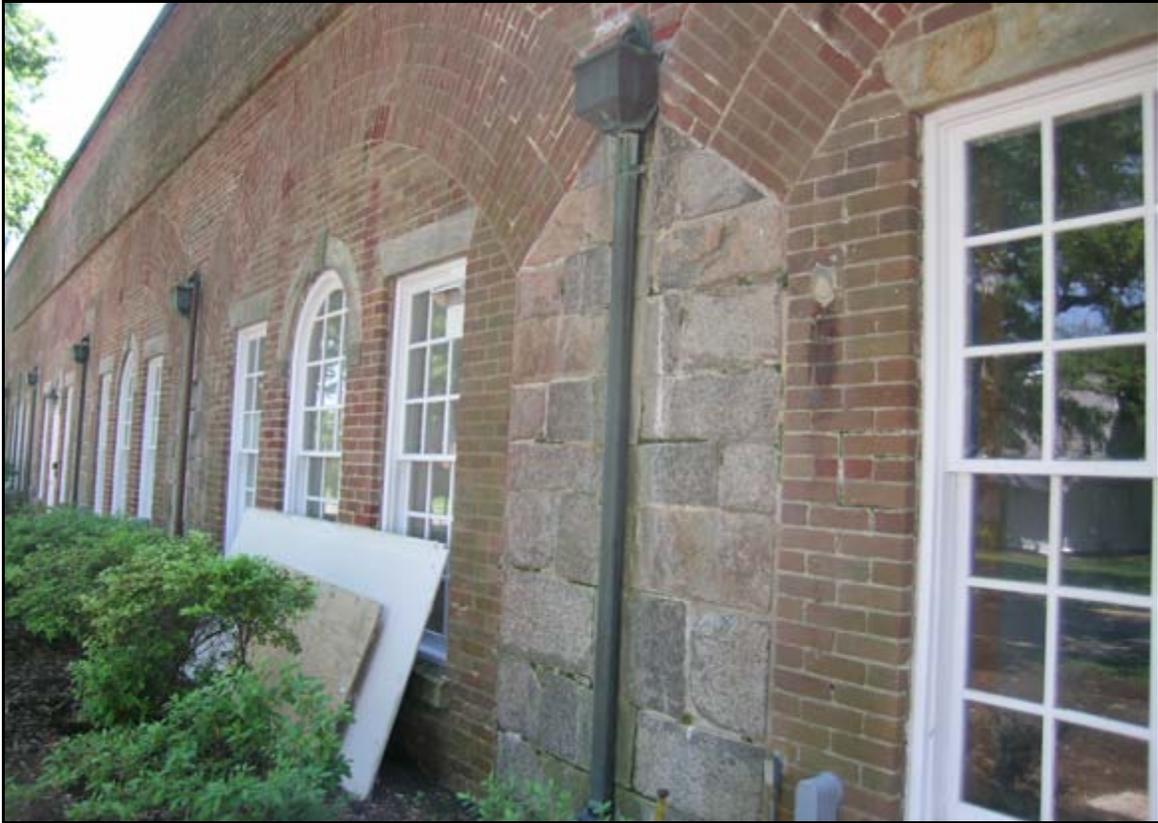
**Photograph 40:** Detailed view of one of the exterior gutters at Casemate 21. These gutters provide an outlet for the moisture that is collected by the gutter system. A cursory inspection of these gutters indicates that at least some water is flowing out of the downspouts. This indicates that a portion of the drainage capability of the gutter system is intact. Note that some of the mortar exhibits signs of biological growth, and that several of the mortar joints have failed.

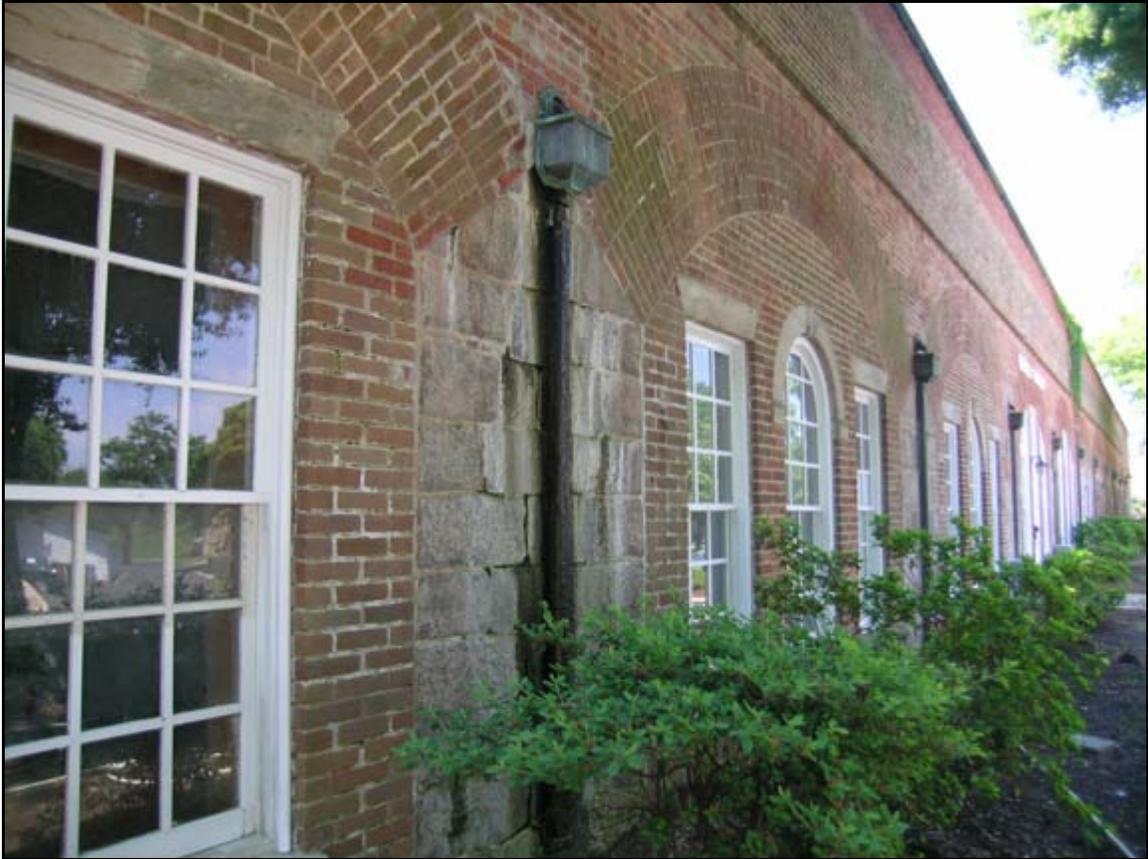
**Photograph 41:** View looking at another gutter on the exterior of Casemate 21. Although this appears to be functioning, the presence of efflorescence around the gutter and on the masonry indicates that moisture is seeping out through the masonry and depositing salts on the brick exterior. This suggests that the interior gutter system has at least partially failed.

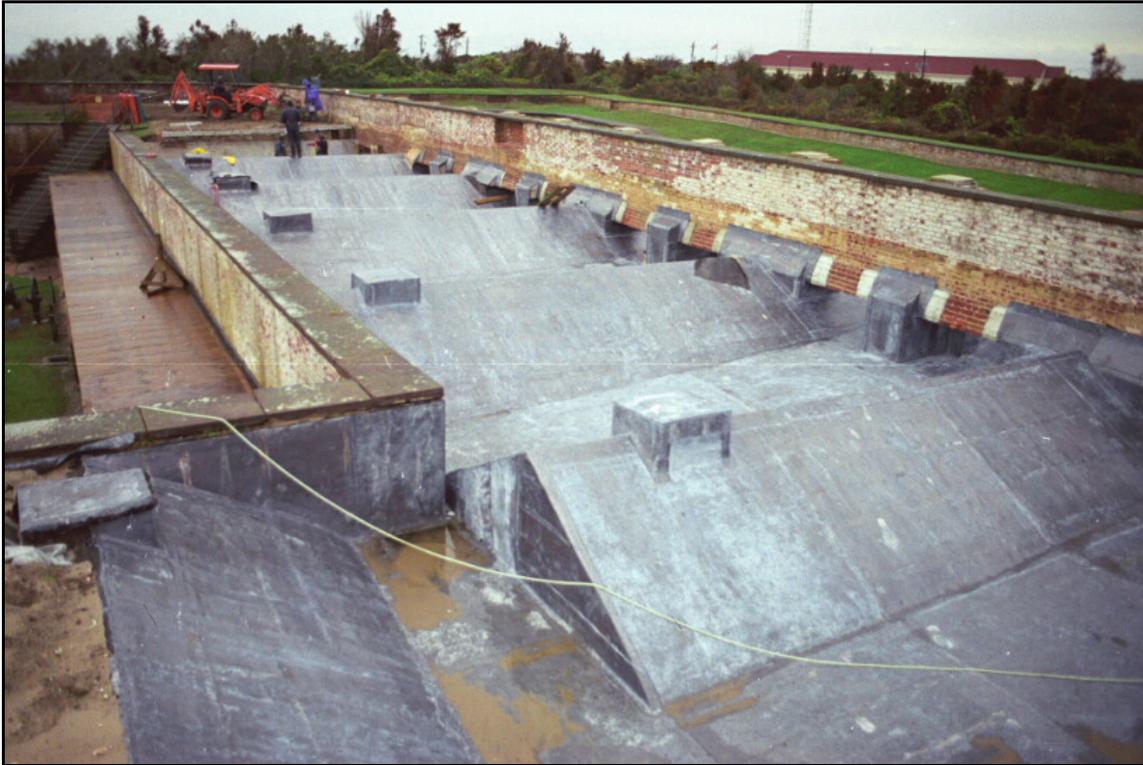
**Photograph 42:** View looking at the excavated casemates at Fort Macon, North Carolina. The design of the gutter system is similar to the system at Fort Monroe, Virginia. The major difference is that the Fort Macon Casemates are constructed of lead coated copper covered with tar while the Fort Monroe Casemates are ceramic tiles coated with tar.

This study was unable to identify any other casemate drainage systems that have been professionally or archaeologically investigated to the extent that Fort Macon and Fort Monroe have been. However, an 1866 design drawing created for West Point for a generic casemate

depicts a similar drainage system, strongly suggesting that this may have been the standard casemate design.<sup>57</sup>

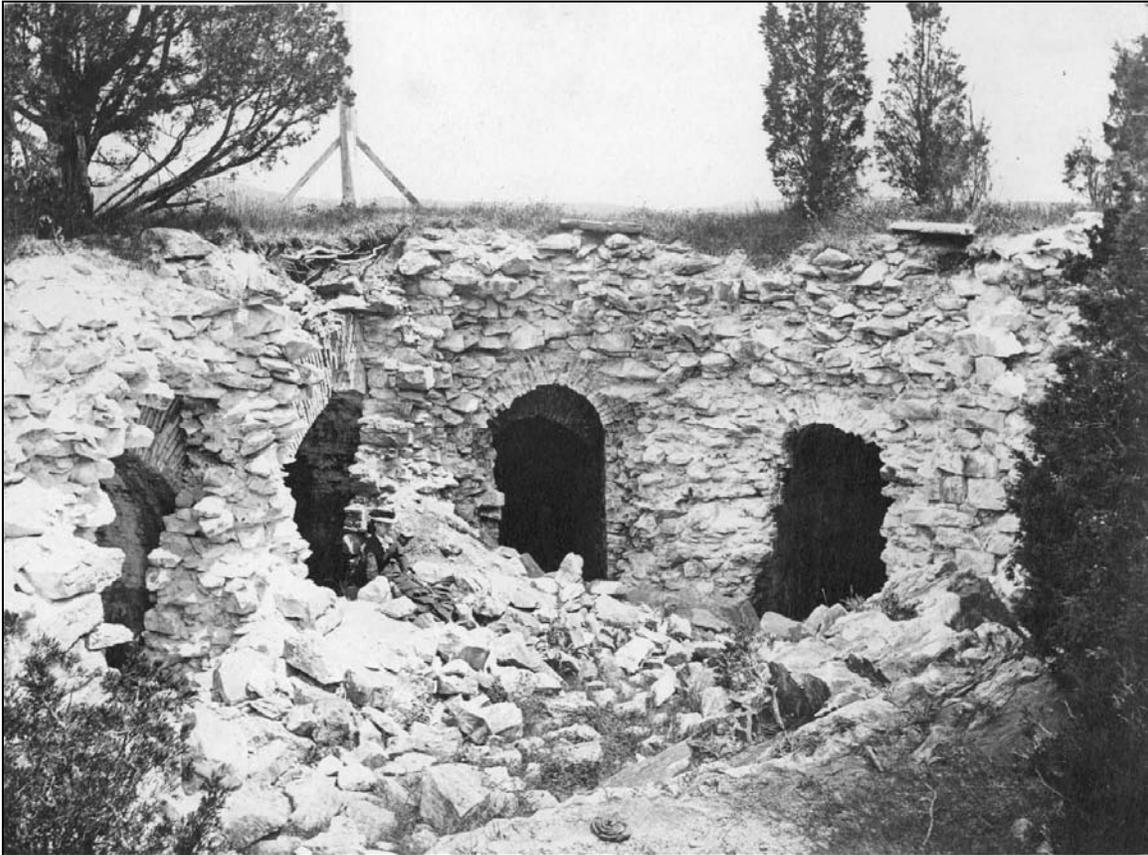
**Figure 9:** Collapsed Brick Casemate, Fort Putnam, West Point, New York, c.1870.  
(Pitman Collection, Special Collections and Archives, U.S. Military Academy Library, West Point, New York).

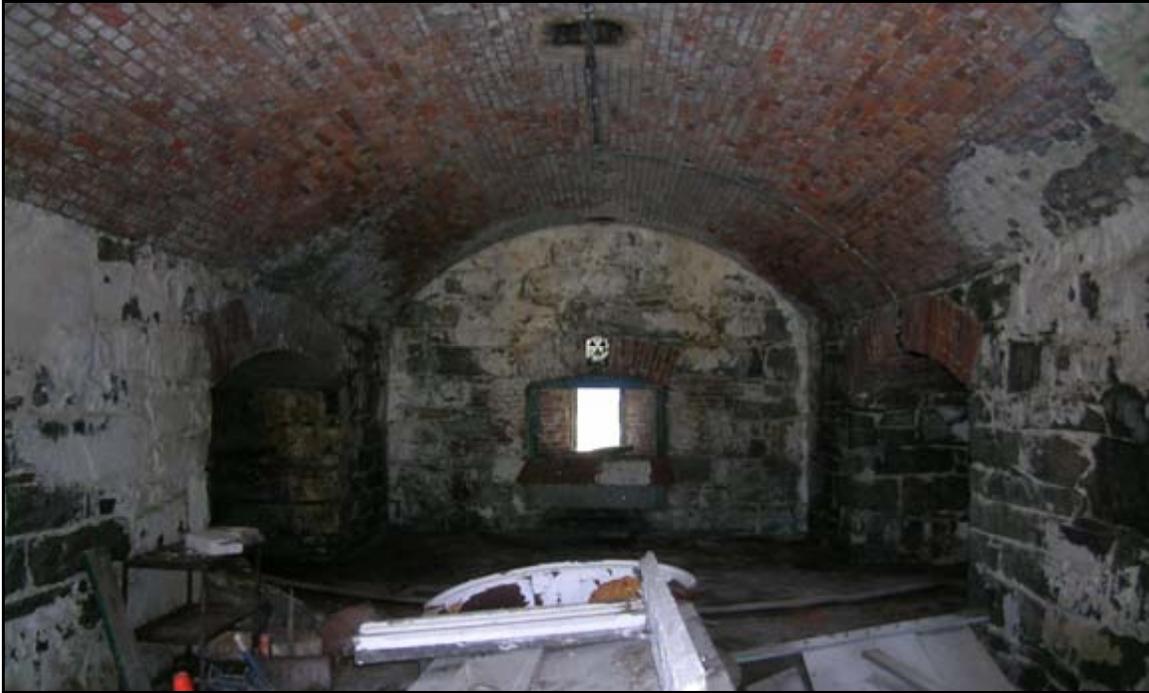
**Photograph 43:** View looking at one of the vaults in Casemate 22, Fort Monroe, Virginia. This arch exhibits signs of significant moisture infiltration; the most obvious is the amount of efflorescence on the surface of the masonry. Over time, the moisture in the walls will cause the mortar joints to fail. Left untreated, this condition will persist and the structural stability of the casemate will be compromised.  
(Photograph by T. Beckwith, June 2005)

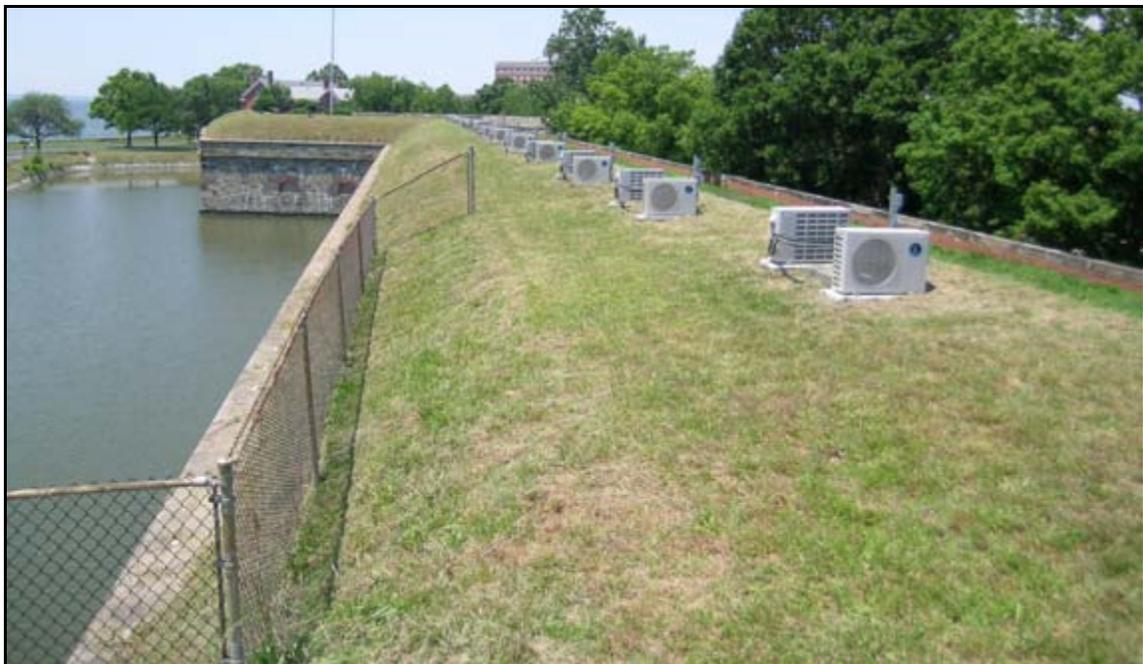
**Photograph 44:** View looking at the top of the Casemate 21, Fort Monroe. The parapet placed on top of the casemates makes it difficult to inspect the condition of the drainage system and to make repairs. The units located along the ridge are air conditioning units, installed within the original smoke vents through the parapet.  
(Photograph by T. Beckwith, June 2005)

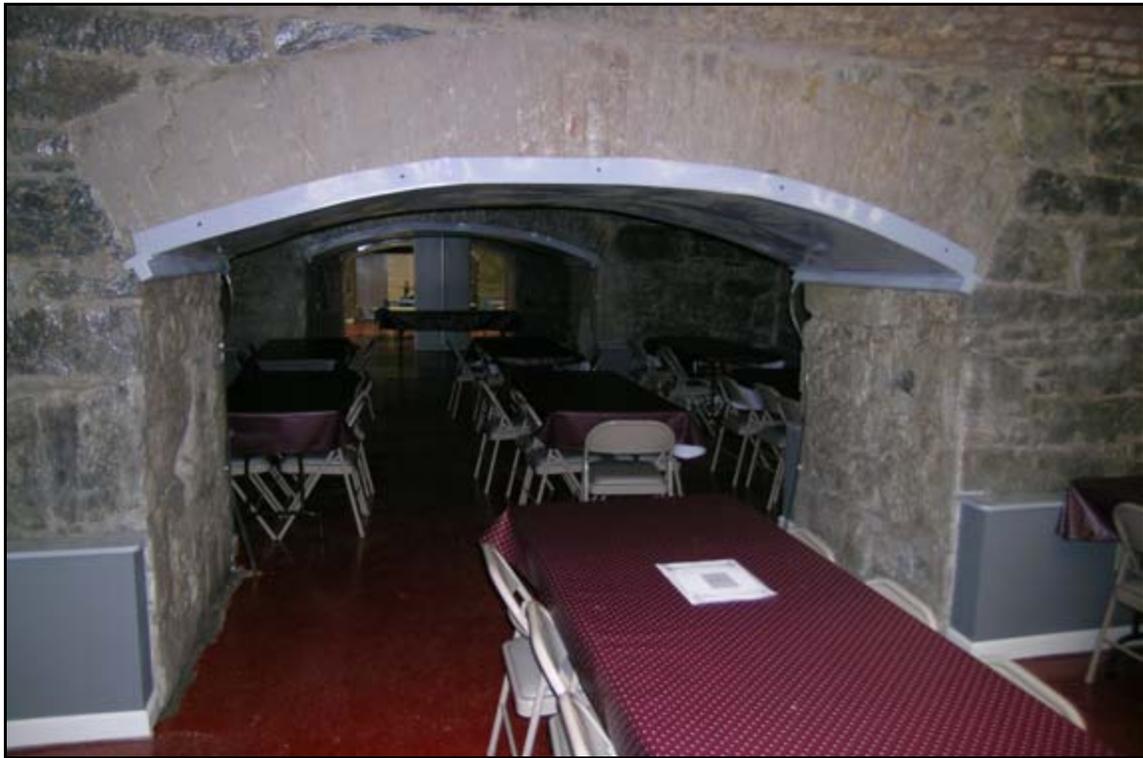
**Photograph 45:** Interior view of Casemate 21 of the arches that provide access between the vaults. Water is seeping through the masonry and collecting on the floor of the vaults, also a recurring problem in Casemates 20 and 22. In the 1990s, engineers installed a water collection system intended to drain the water. While this has been marginally effective at preventing water from pooling, it does not solve the cause of the problem, which is the failure of the gutter system.

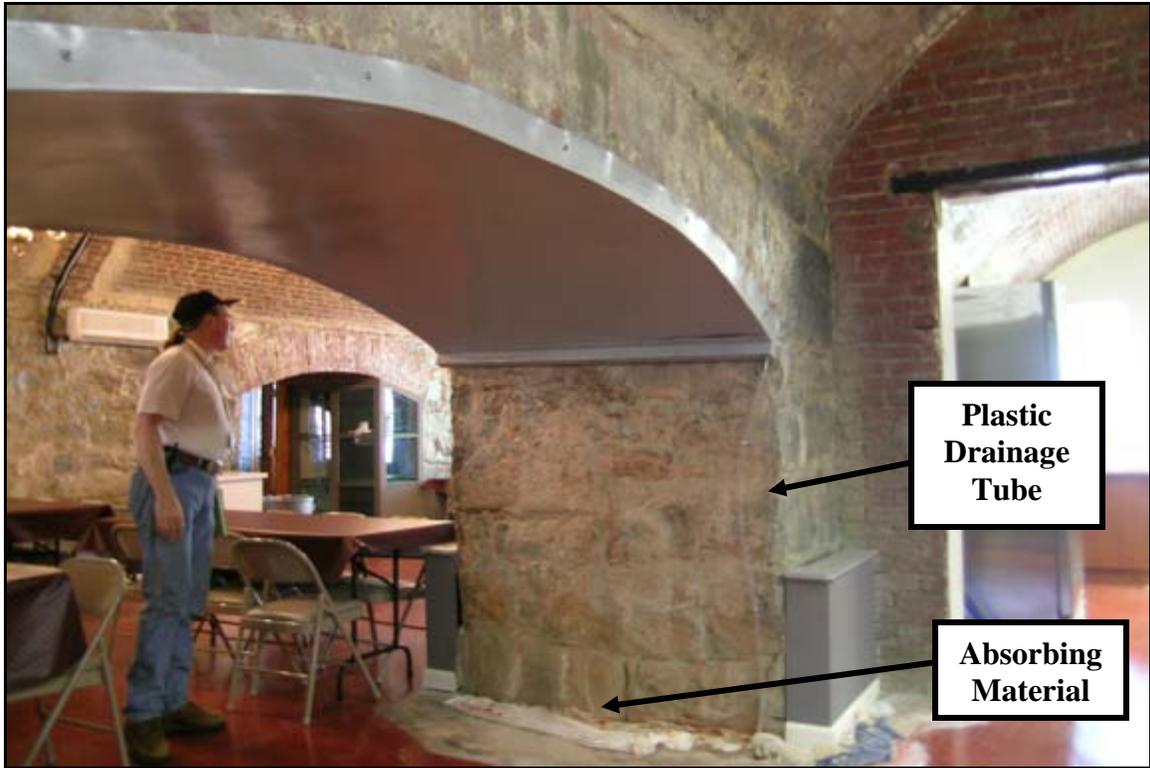
**Photograph 46:** Another view of the water collection system that engineers installed in Casemate 21. This system consists of an impermeable barrier attached to the underside of the archways. The clear tube in the center of the photograph allows water to drain from the system. The deterioration of the bricks and the mortar will continue despite the installation of this system. Note the absorbing material placed on the floor to collect water that has spilled from the system, which is not functioning as intended. It is likely that the continued presence of this system will accelerate the deterioration of the bricks and mortar.

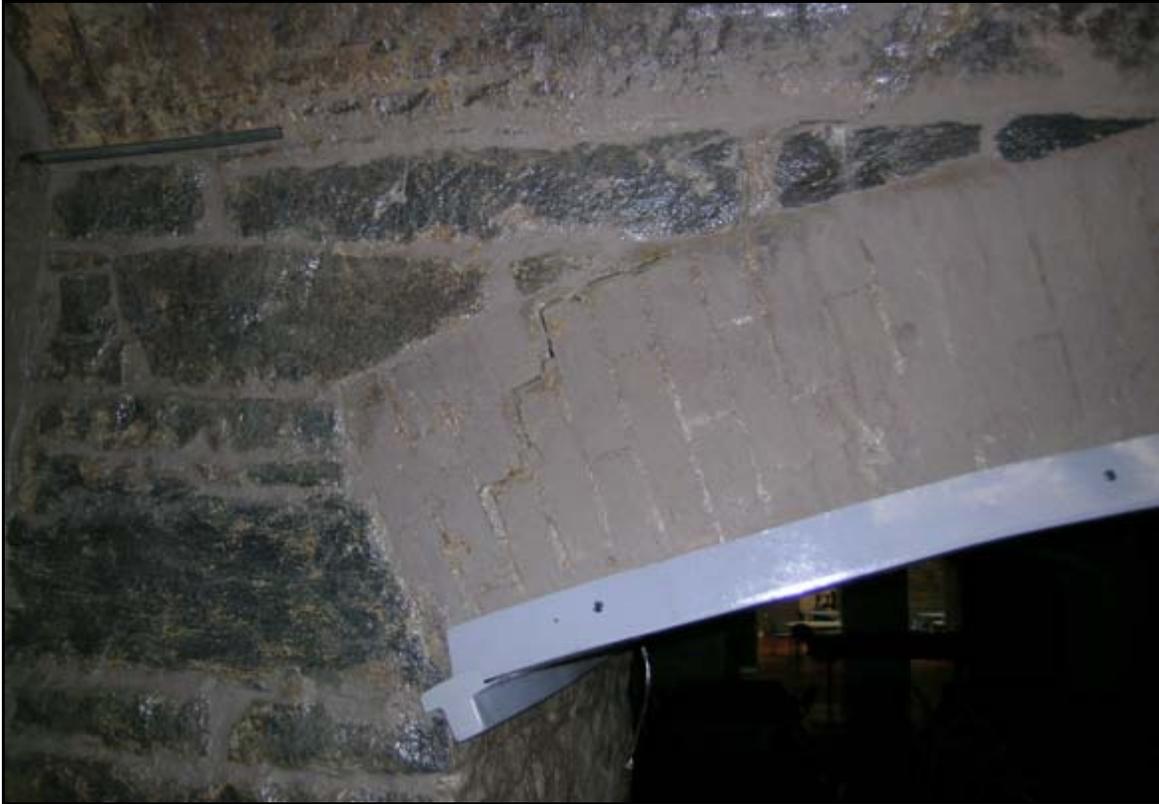
**Photograph 47:** Detailed view of one of the arches in Casemate 21. The mortar in this arch failed and a crack has developed in the arch, which has likely compromised its structural integrity. Note the glossy surface of the stone. At some point, a coating was applied to the masonry to control dust. This coating may be contributing to the deterioration of the mortar as it serves to trap moisture in the walls.

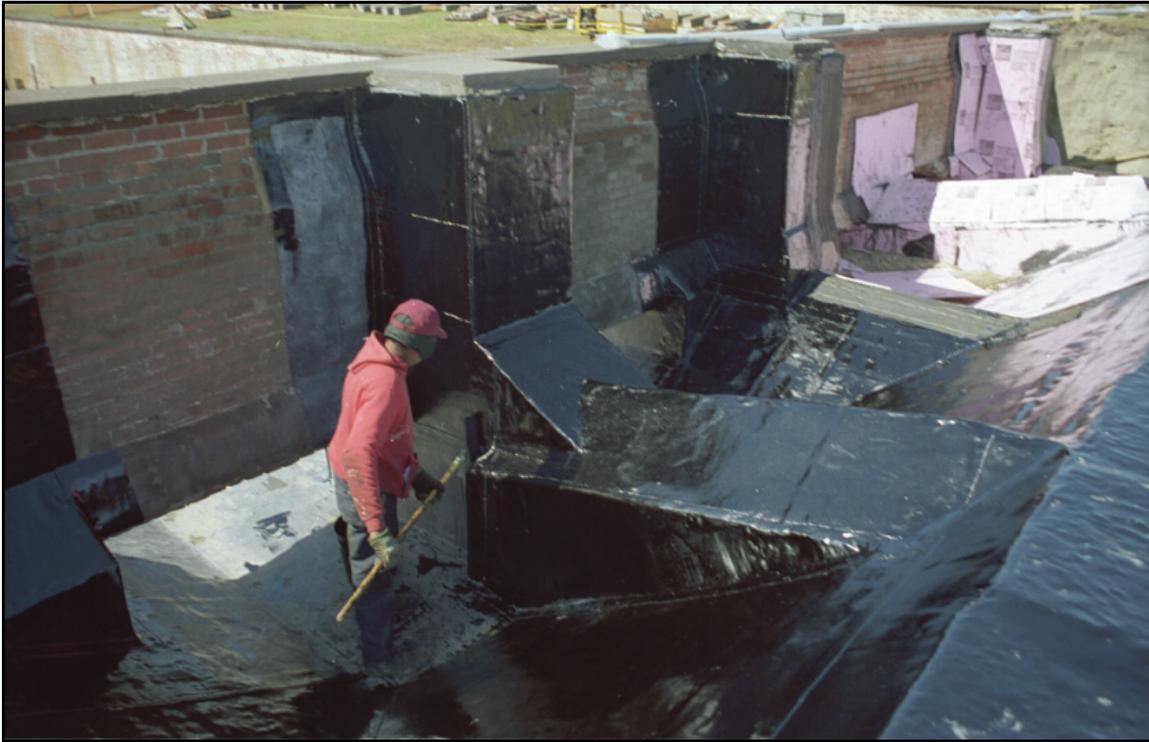
**Photograph 48:** View looking at the waterproofing of the casemates in Fort Macon, North Carolina. Engineers placed new lead sheeting over the old lead sheeting, and then sealed it with five coats of tar and tarpaper. A PVC drainage system was then added above the tar.  
(Photograph courtesy of Fort Macon State Park, Division of North Carolina Parks and Recreation.)

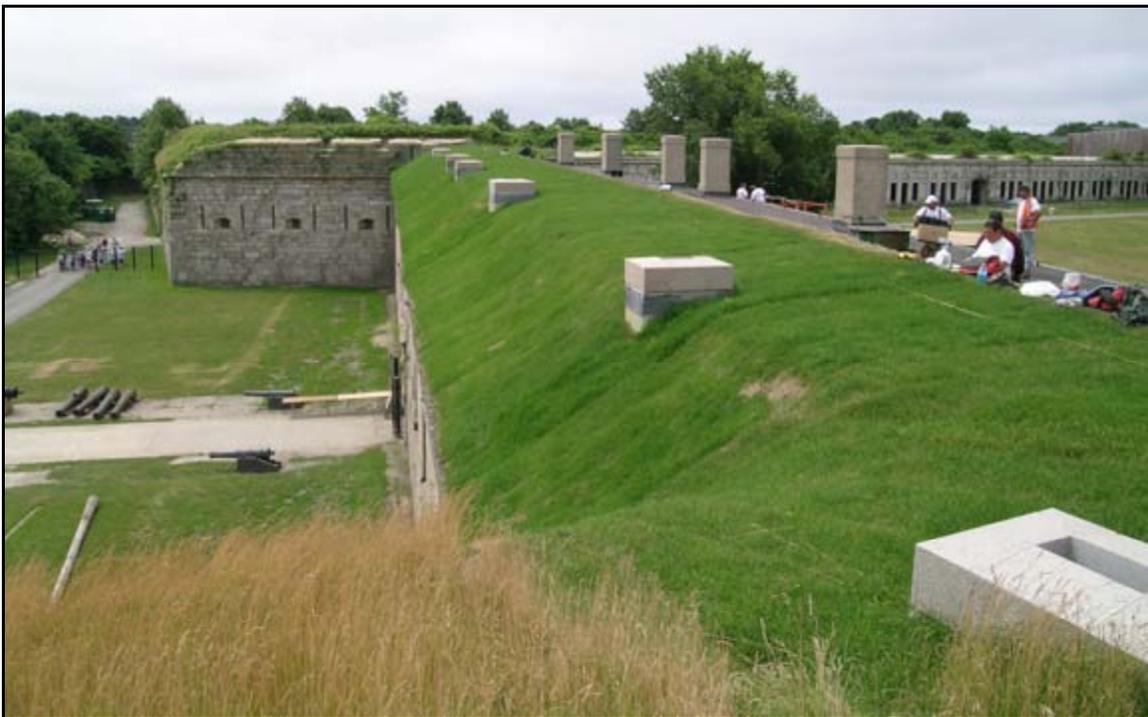
**Photograph 49:** View looking at earthen ramparts at Fort Adams, Newport, Rhode Island. The waterproof membrane is located underneath the earth. Workers are installing a conventional tarred roof system at the terreplein. Note the historic masonry smoke vents in the foreground.

protected by soil, with a top of sea grass that will provide both hot weather and cold weather protection. This system is a patented system developed by the Sarnafil Corporation.<sup>63</sup> Approximately two feet of soil had to be removed from the top of the rampart to implement this approach. The terreplein portion of the casemates was protected using a more traditional approach of tar paper and gravel, designed to drain into an existing gutter system. Lead flashing was incorporated at several different locations of this project to provide comprehensive waterproofing; and all exposed masonry to include the scarp walls and other walls was re-pointed at the same time. The system, installed within the past year, has worked very well [Photographs 49 through 52; and Figures 11 through 14]. Only a small amount of water infiltration has been noted, and is believed to be occurring from the horizontal faces of the Cordon Stones. Because the water infiltration problems in Fort Adams have been effectively solved by this preservation approach, museum exhibits are now installed within some of the casemates, and other casemates are available for public and private rentals, generating necessary revenue for the Fort Adams Trust and continued preservation efforts at Fort Adams. A major advantage of this system is that limited earth removal is necessary, thus reducing budget and schedule impacts. Essentially, this system installs a new roof directly at the top of the casemates.

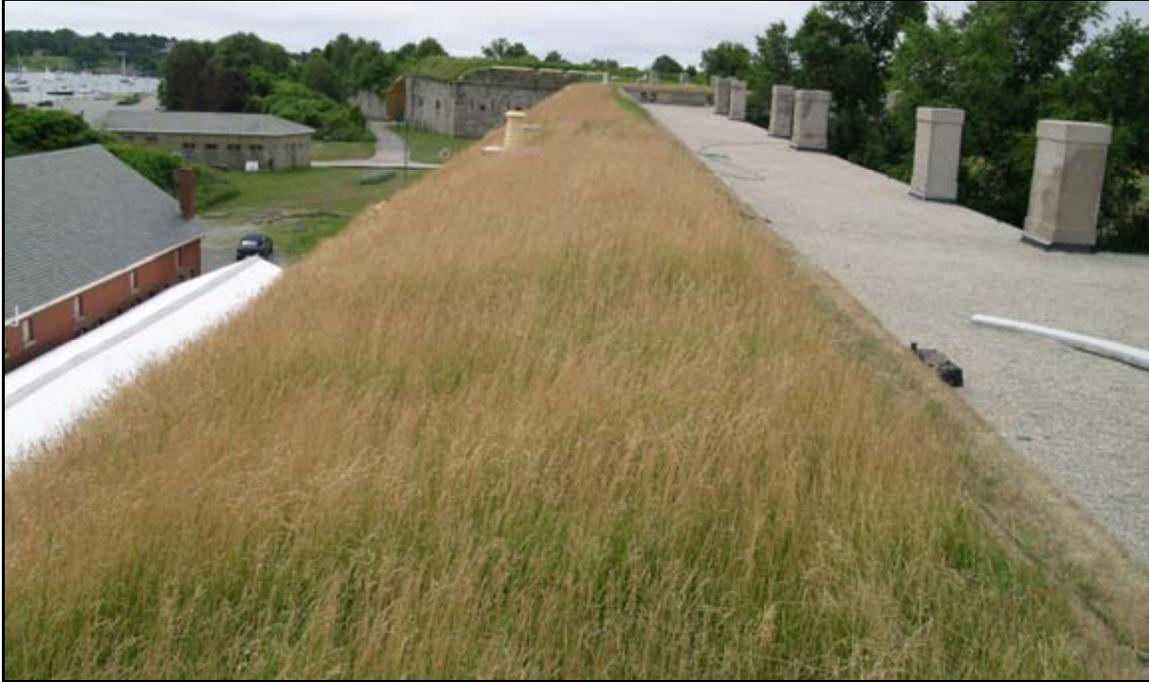
**Photograph 50:** View looking at earthen rampart at Fort Adams, Newport, Rhode Island. The sea grass planted on the rampart is left uncut to provide greater erosion protection to the soil underneath. The sea grass was specifically chosen for the coastal conditions of Rhode Island.  
(Photograph by T. Beckwith, July 2005).

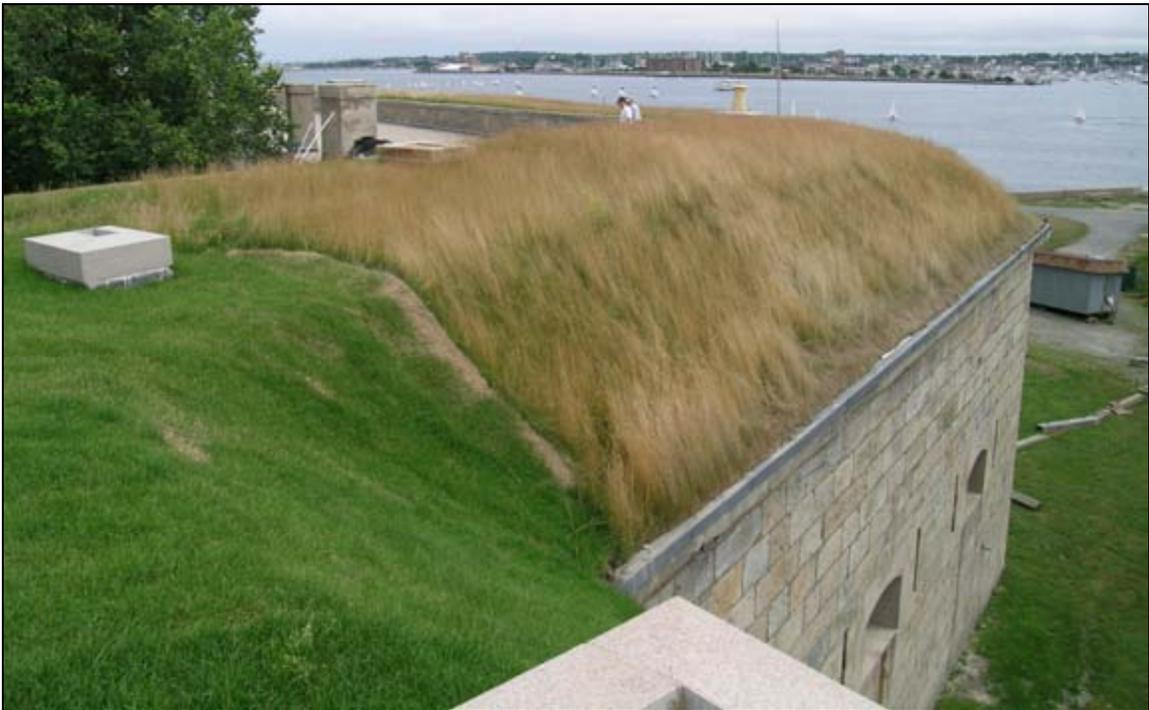
**Photograph 51:** Another view looking at the earthen rampart at Fort Adams, Rhode Island. Note the flashing located between the earth and the cordon stone.  
(Photograph by T. Beckwith, July 2005).

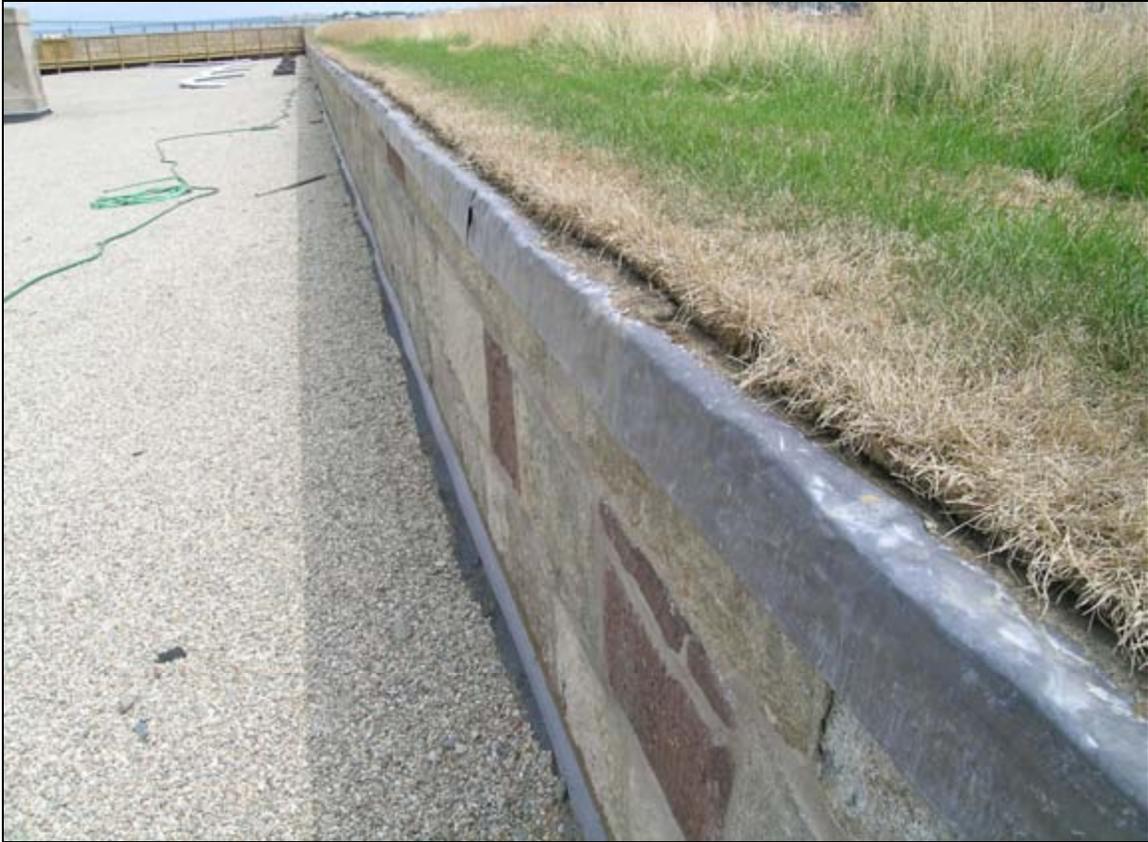
**Photograph 52:** View looking at the stone wall that separates the earthen rampart from the terreplein. Note the lead flashing along the rampart wall. This keeps moisture from infiltrating and degrading the rampart wall. Additionally, note that the rear parapet wall has also been re-pointed.  
(Photograph by T. Beckwith, July 2005).

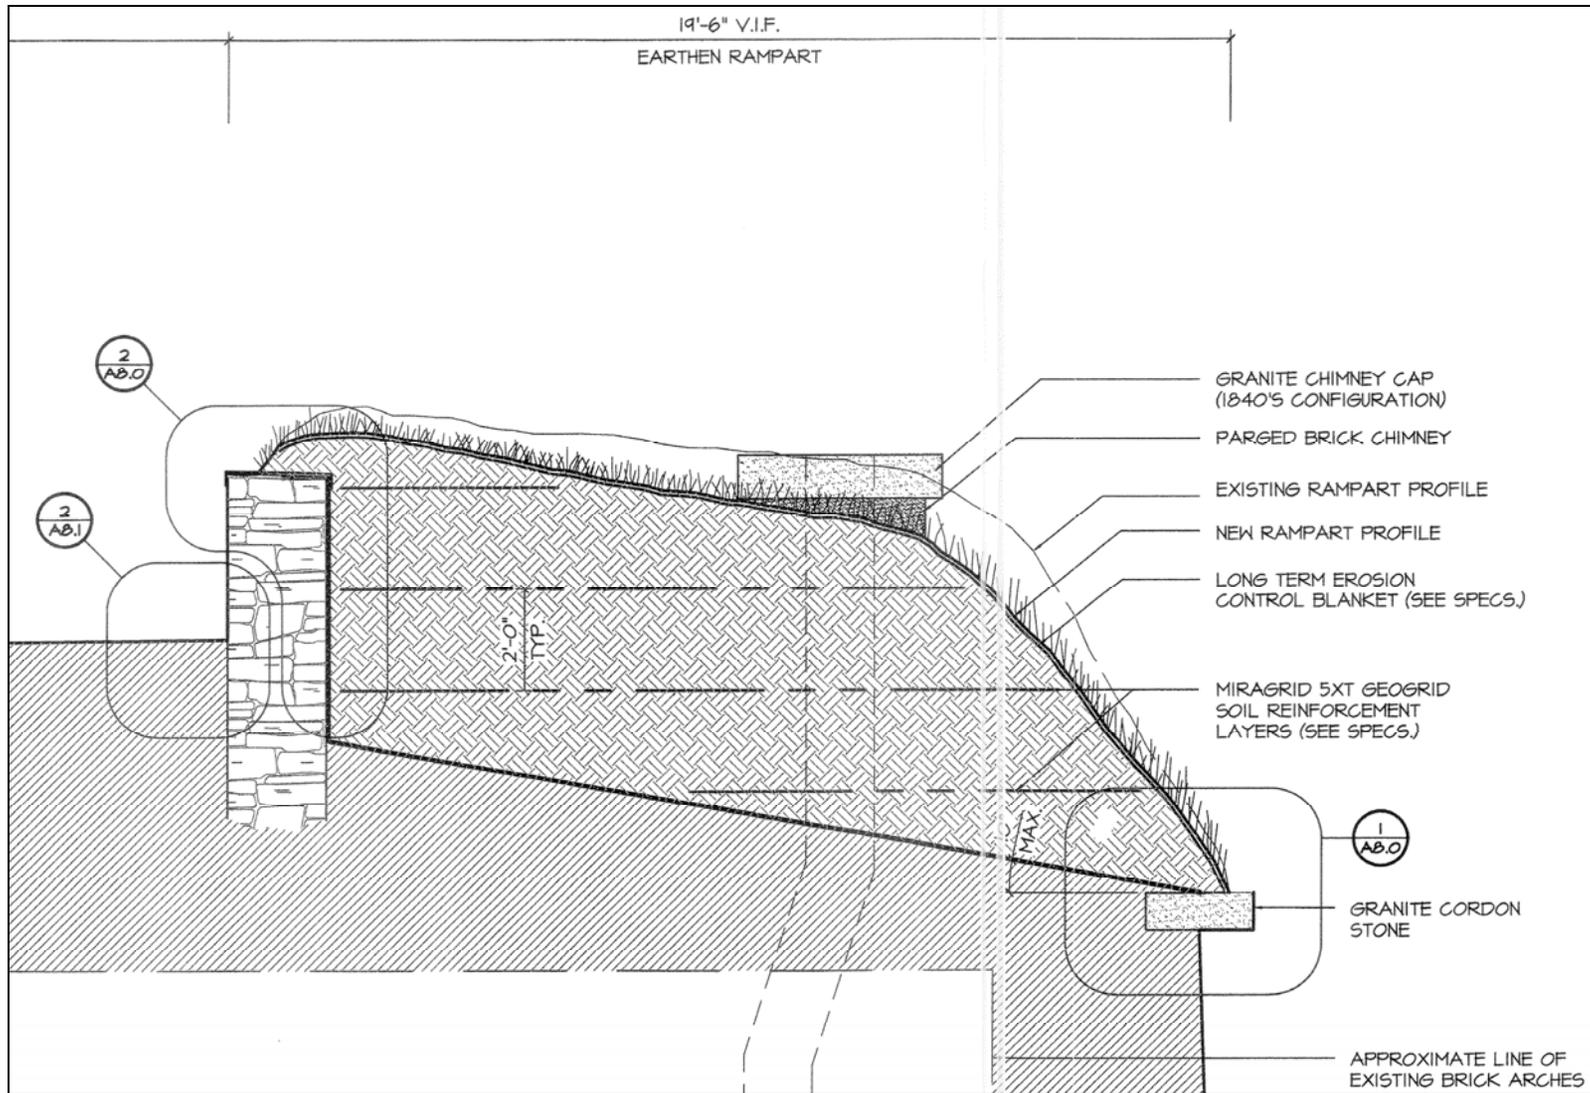
**Figure 11:** Detailed view looking at the profile of the earthen rampart at Fort Adams, Rhode Island.

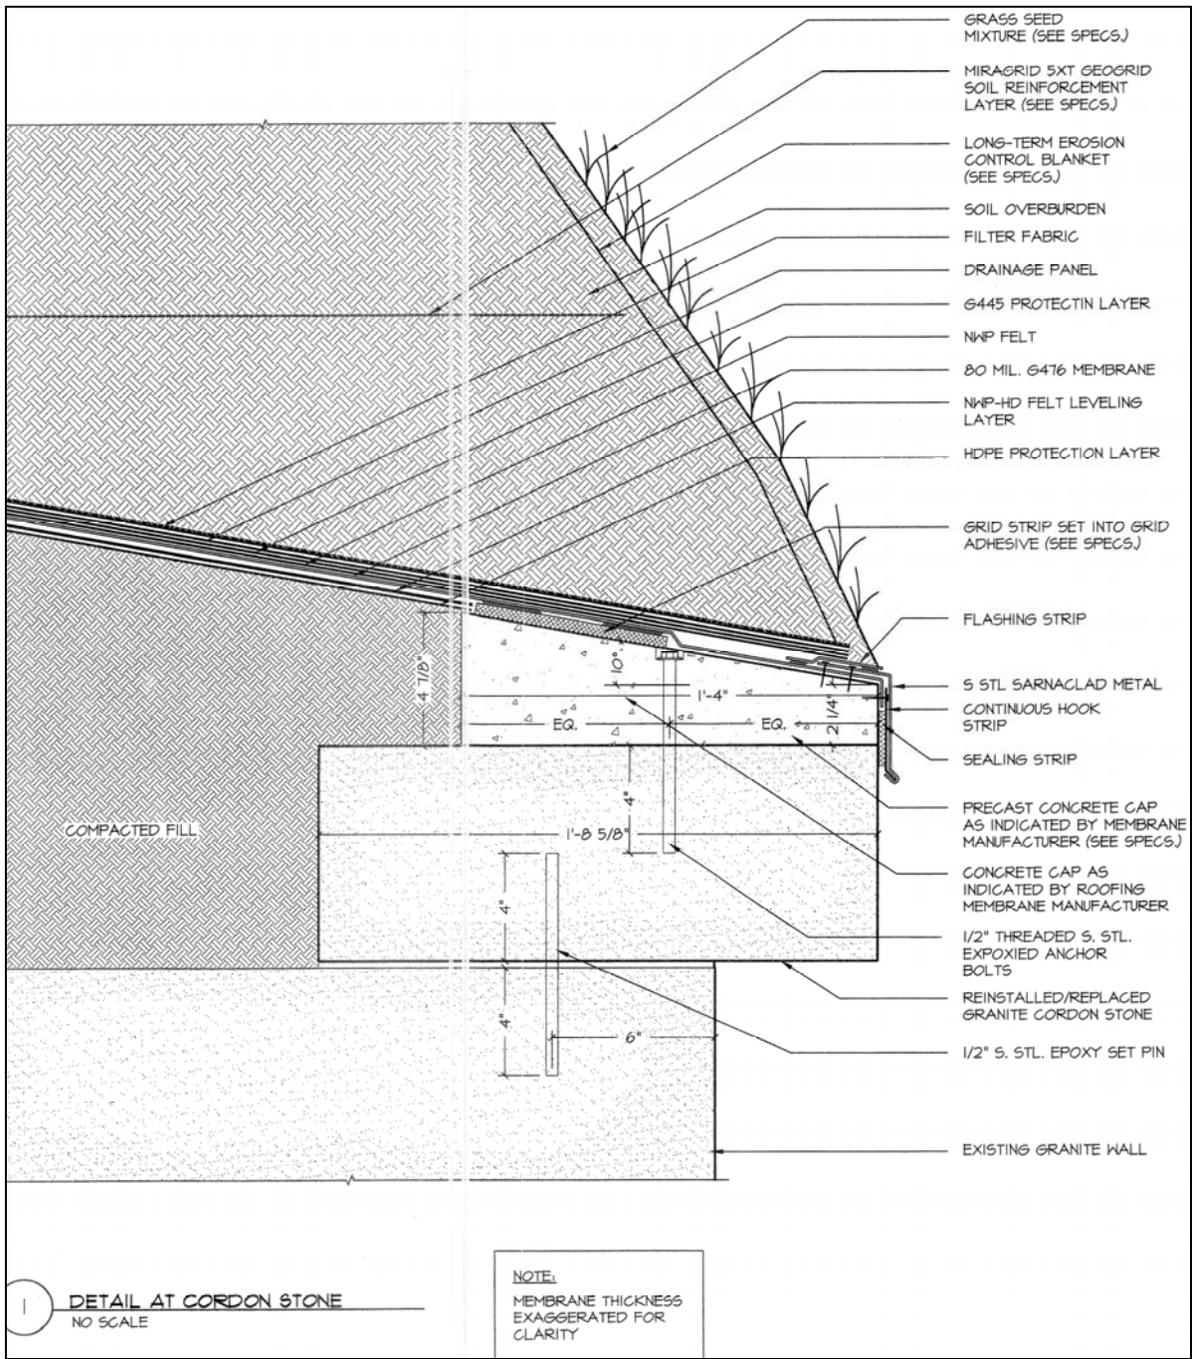
**Figure 12:** Detail illustrating the capstone of the earthen rampart at Fort Adams, Rhode Island.  
 (Detail from *Terreplein and Rampart Repairs at Fort Adams State Park Newport, Rhode Island*, Newport Collaborative Architects, Inc. Newport, Rhode Island, 15 July 2004, sheet 9 of 17)

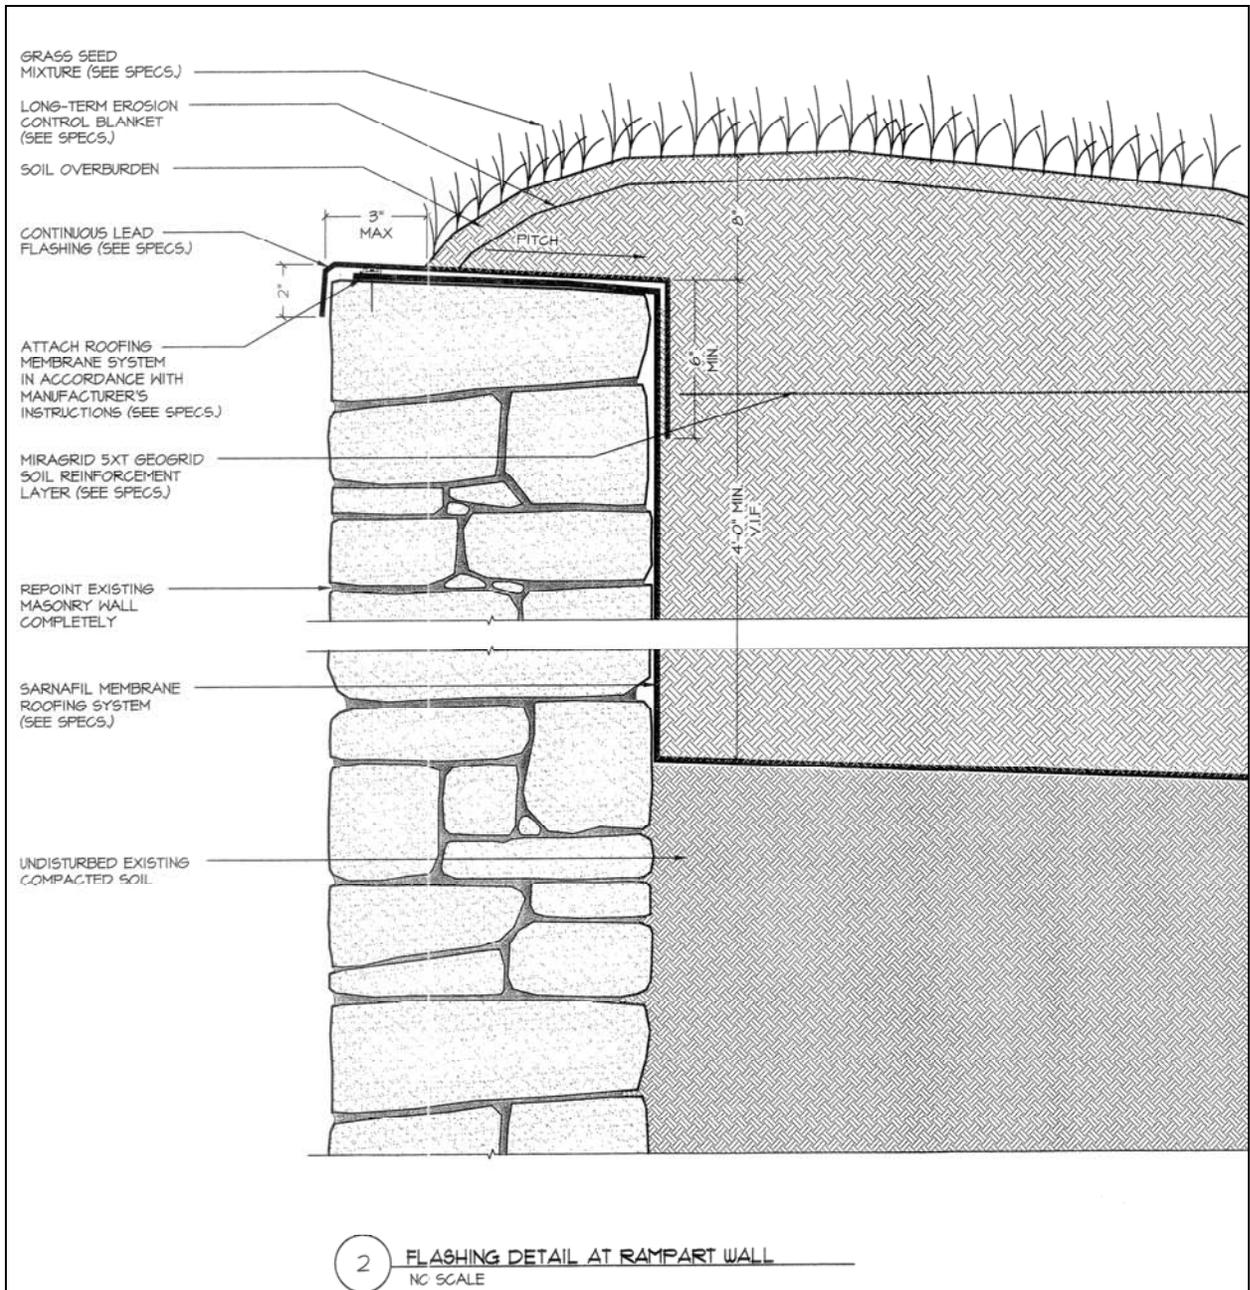
**Figure 13:** Detail of the flashing at the rampart wall. The lead flashing keeps moisture from infiltrating the rampart wall.
