# Department of Defense Legacy Resource Management Program

PROJECT 05-239

## **Stabilization and Preservation of DoD-owned Military Fortifications**

Douglas R. Cubbison  
Cultural Resources Manager  
And  
Travis Beckwith  
Architectural Historian  
United States Military Academy  
West Point, New York

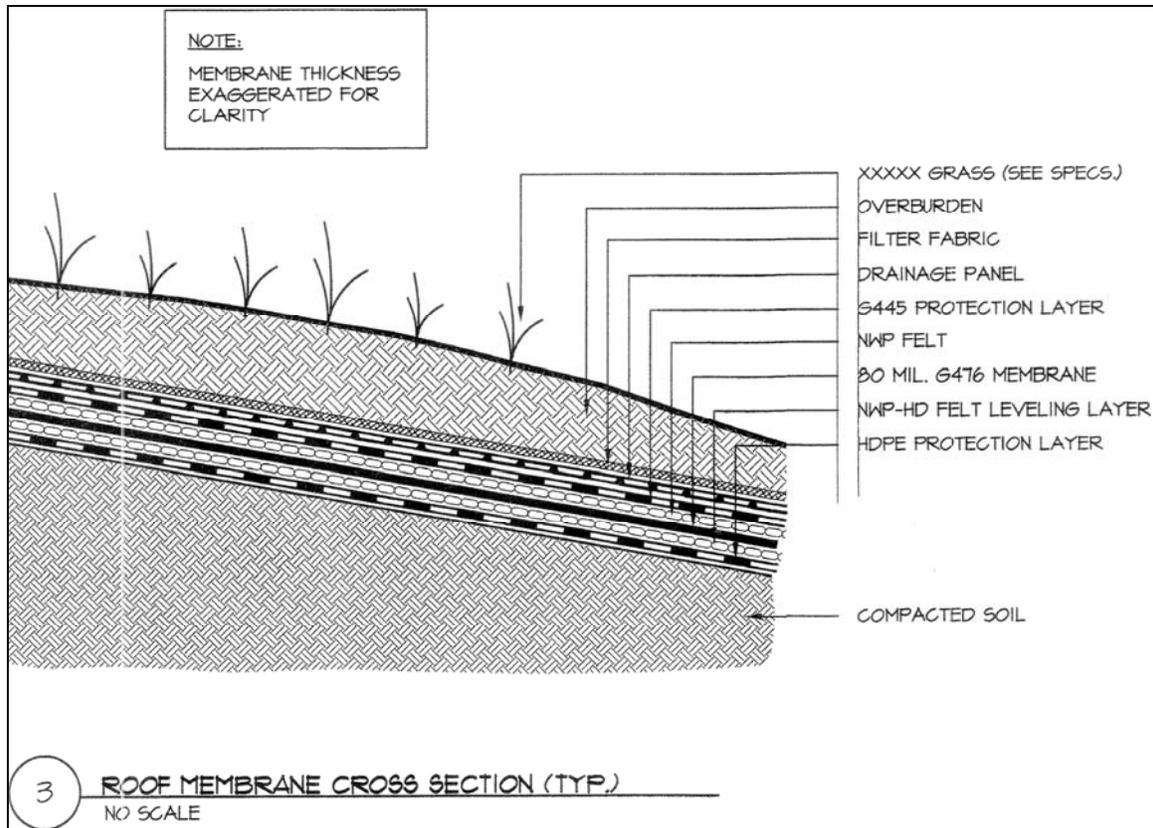
**Figure 14:** Detailed cross section of the roof membrane.

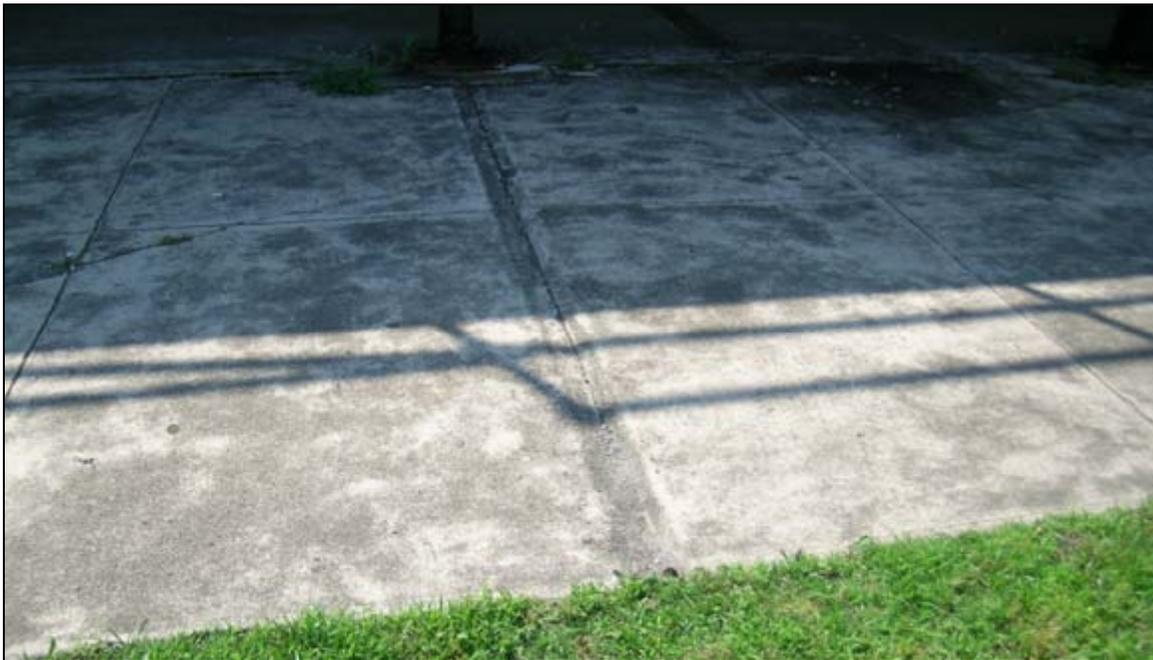
**Photograph 53:** View looking at the groove that leads water away from the base of the foundation at Battery DeRussy, Fort Monroe, Virginia. The slope of the earth at the junction of the concrete foundation has been raised, and water can no longer drain away from the fortification. These slopes should be re-graded to ensure that moisture flows away from the battery.

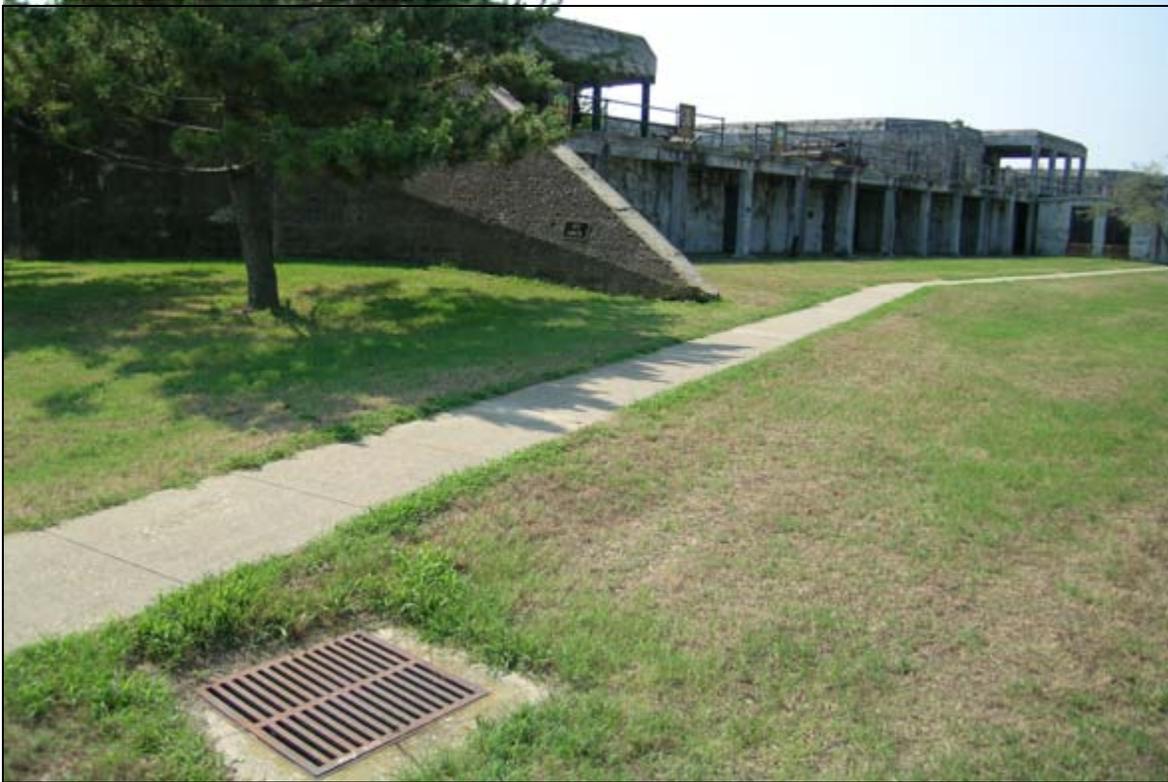
**Photograph 54:** Installation of a new sidewalk in the rear of Battery DeRussy at Fort Monroe altered drainage patterns, and separated the battery from the storm water drain in the foreground. The result is water pooling and failing to drain from this Endicott Series Battery.

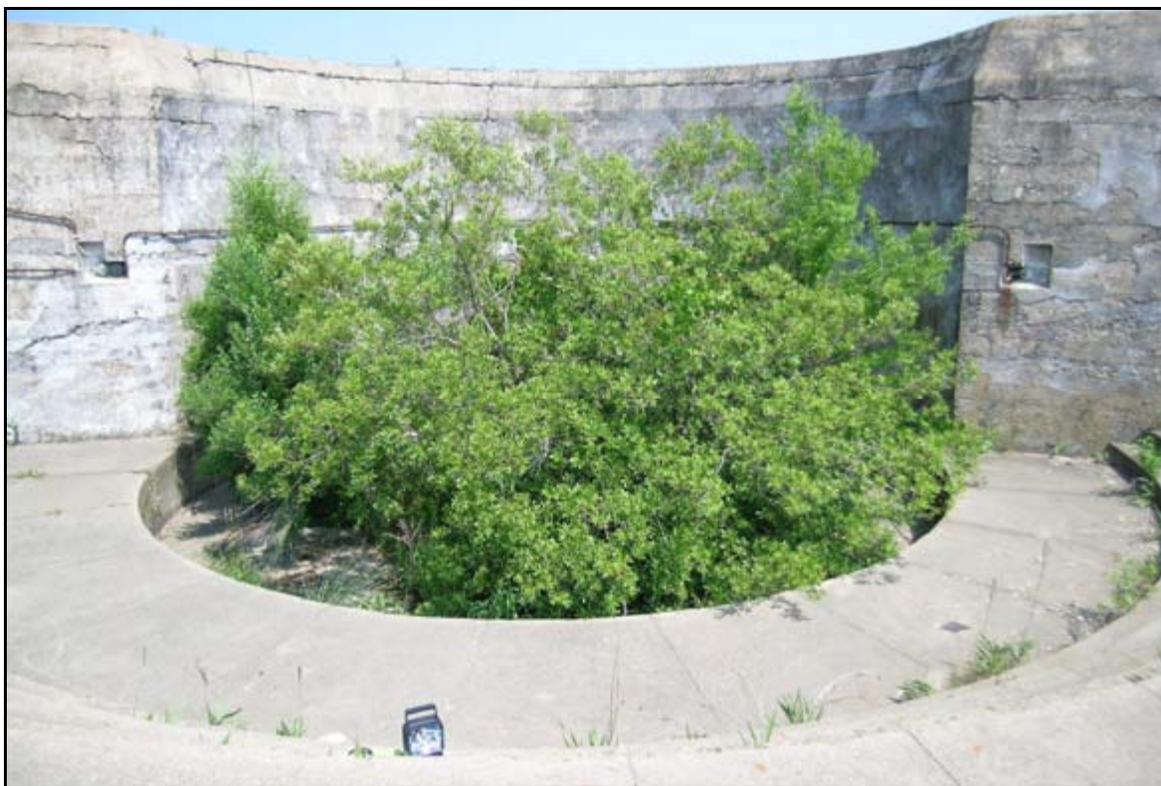
**Photograph 55:** View looking at one of the gun pits at Battery DeRussy, Fort Monroe, Virginia. This gun pit is entirely filled in with soil, which allowed a considerable amount of vegetation to grow. The presence of vegetation is a clear indication that there is a significant moisture infiltration issue. Vegetation and soil needs to be removed from all of the gun pits. Once this task is complete, the drain in the center of the pit should be cleared of debris and inspected to ensure that the drain lining is intact.

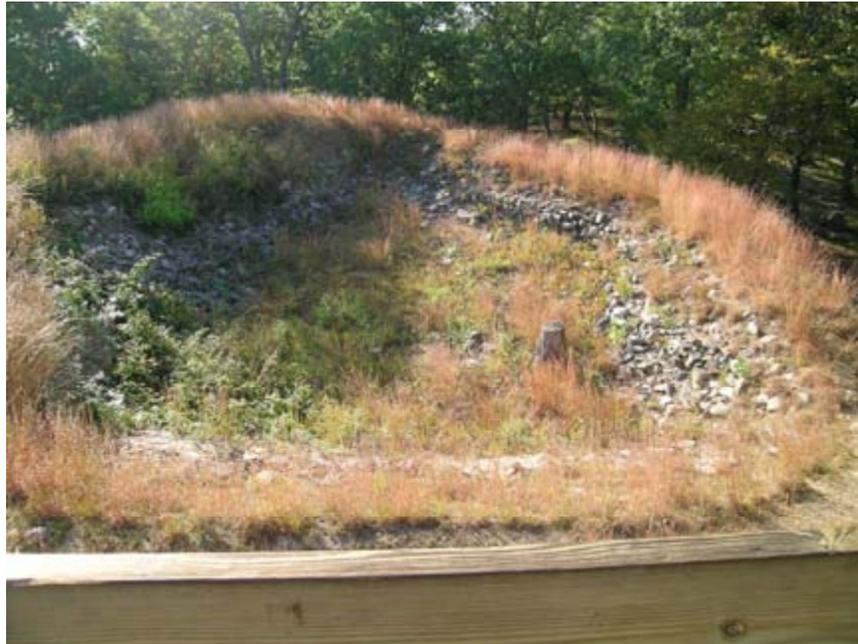
Interior of Redoubt No. 2 previous to demonstration project.  
Note total collapses of stone ramparts and numerous areas of active erosion.  
[D. Cubbison, September 2005]

In the spring of 2006 the Redoubt No. 2 demonstration project was performed at West Point. Removal of the sand bags from the interior proved to be more challenging than originally anticipated as the sand bags had totally disintegrated. It was determined that attempting to remove the large quantity of sand from the interior of the redoubt would result in an unacceptable level of traffic across the rampart of the redoubt, exacerbating already serious erosion conditions. Accordingly, the decision was made to remove the sand from the historic interior wall, and to spread it across the floor of the redoubt. During the evaluation of the redoubt, the southeastern corner of the battery was determined to be too badly eroded to be restored. This corner appeared from a careful examination of the battery to be a natural water drainage route, and this water drainage had removed all vestiges of the original battery walls. The initial approach had been to construct a French drain in this location to facilitate water drainage, and to reconstruct the walls as indicated in the previous documentation of the redoubt. However, because all vestiges of the walls had vanished by the time that this demonstration project was started, the decision was made to permit natural water drainage, and to not perform any restoration of the walls. Additionally, during stabilization of the redoubt walls, small stones that had collapsed from the walls outside of the redoubt were used to fill in the area behind the walls, thus creating a French drain to facilitate collection of natural drainage from the redoubt walls, and permitting it to naturally percolate through the dry-stacked stone walls. This will also serve to relieve pressure from the earth rampart upon the dry-laid stone interior wall. The mason and West Point Cultural Resources Manager believed that this approach will facilitate water drainage within the redoubt. Additionally, although measures will be taken to restrict pedestrian traffic to the interior of the redoubt, it was recognized during site visits that some level of pedestrian traffic to the interior of the redoubt would continue to occur. Accordingly, a simple set of stone stairs was integrated into the east interior wall when it was restored, so that pedestrians would not climb over the dry-laid stone walls and accelerate their disintegration. At the time of the preparation of the final report, the final re-seeding of the redoubt had not occurred due to winter conditions in the Hudson Highlands. The demonstration project was a success, and validated the approach for preservation and stabilization of integrated dry-laid stone and earth as presented in this report.

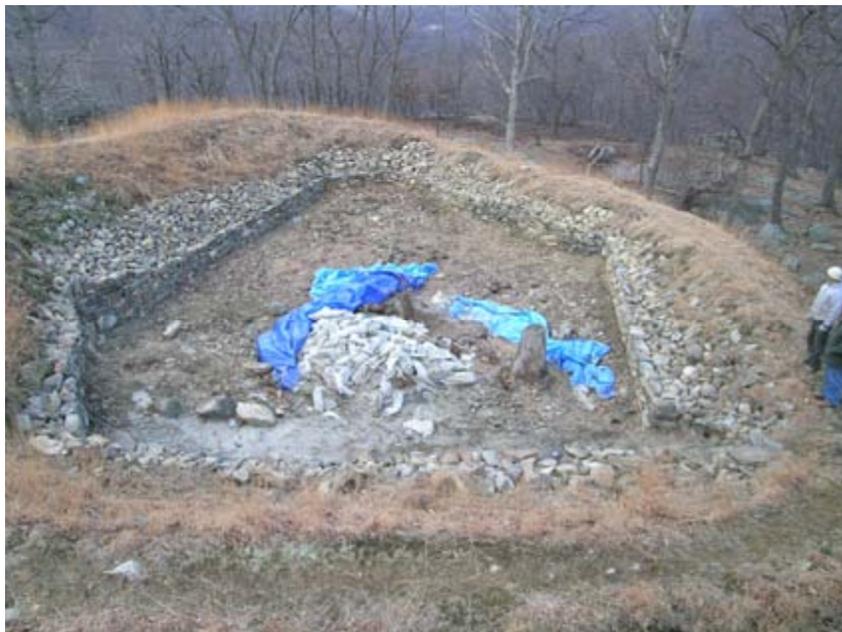
Interior of Redoubt No. 2 following demonstration project.  
Note stone used as "French Drains" around dry-laid stone wall.  
[D. Cubbison, February 2006]

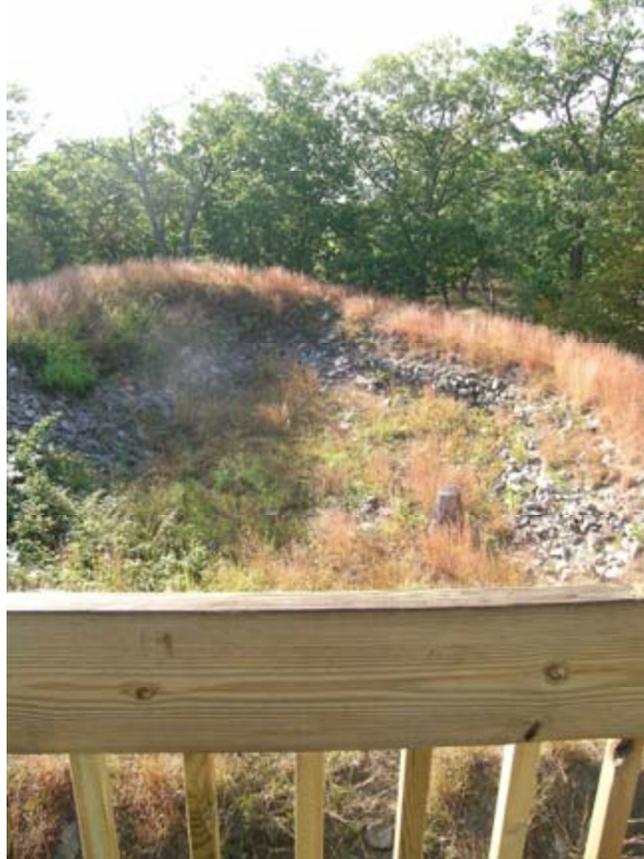
Detail, Interior of Redoubt No. 2, previous to demonstration project.  
[D. Cubbison, September 2005]

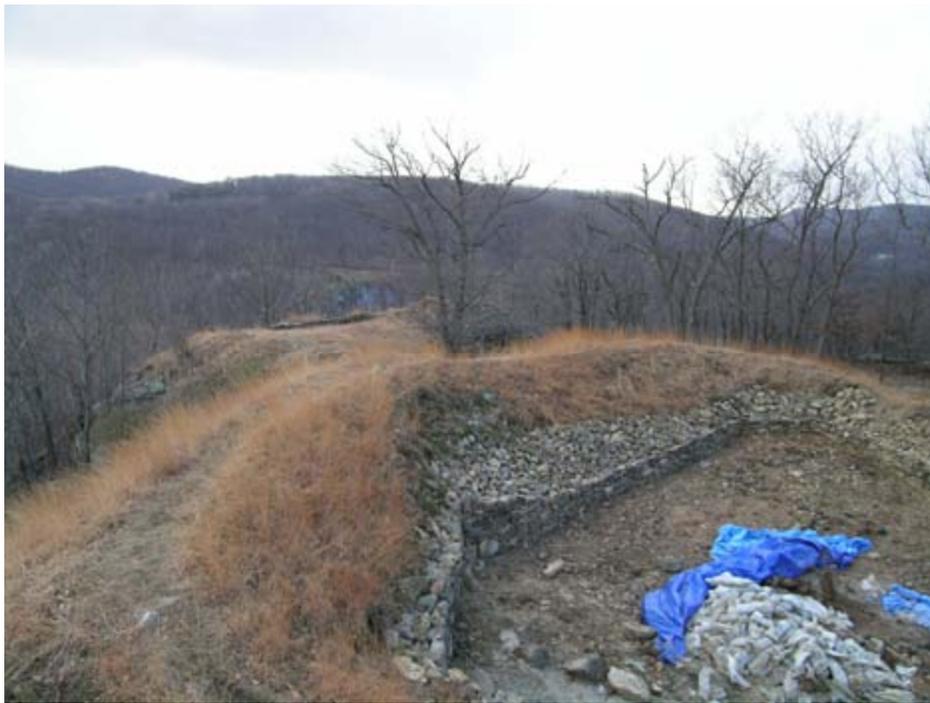
Detail, Interior of Redoubt No. 2, following demonstration project.  
[D. Cubbison, January 2006]

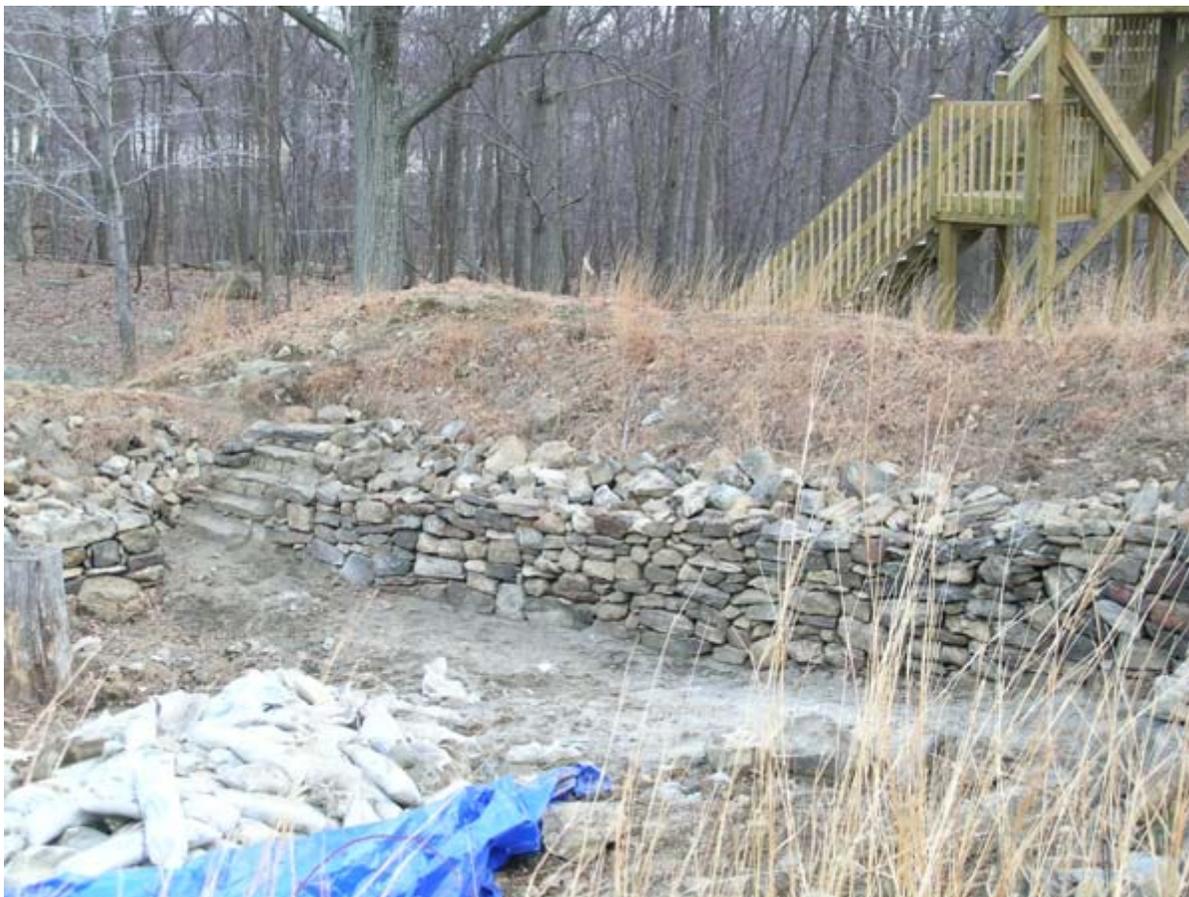
Stairs added to Interior of Redoubt No. 2, demonstration project.  
[D. Cubbison, January 2006]

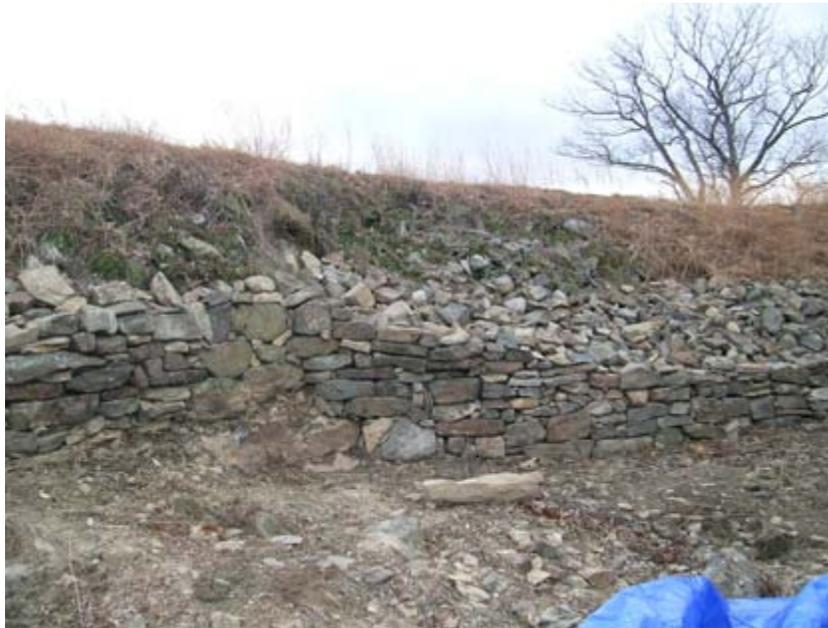
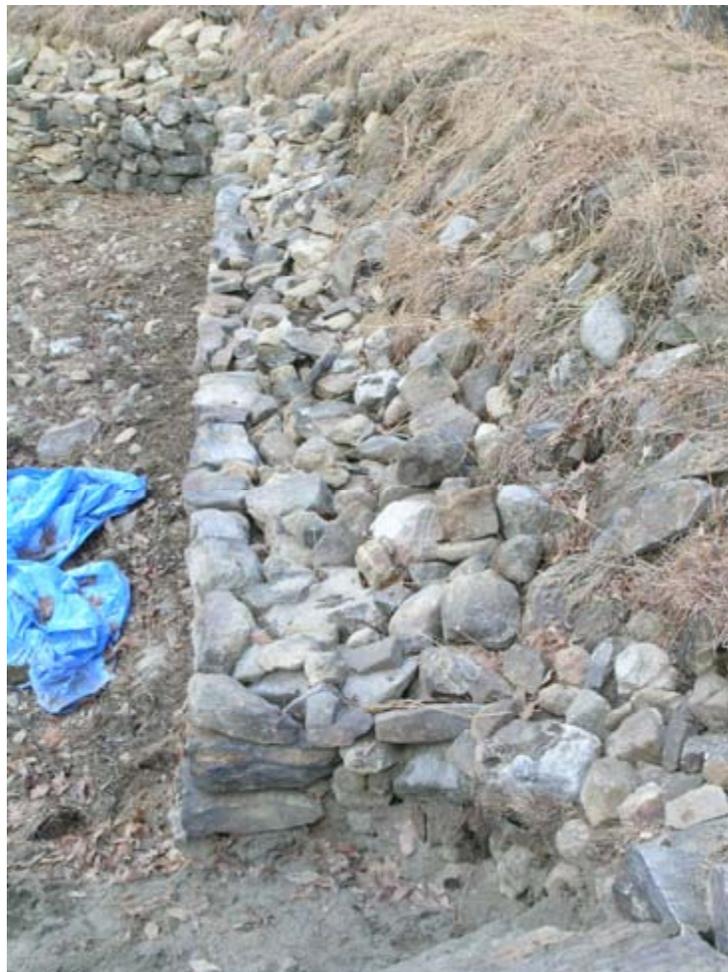
Use of Previously Lost Stone as “French Drain” in Redoubt No. 2 Demonstration Project  
[D. Cubbison, January 2006]

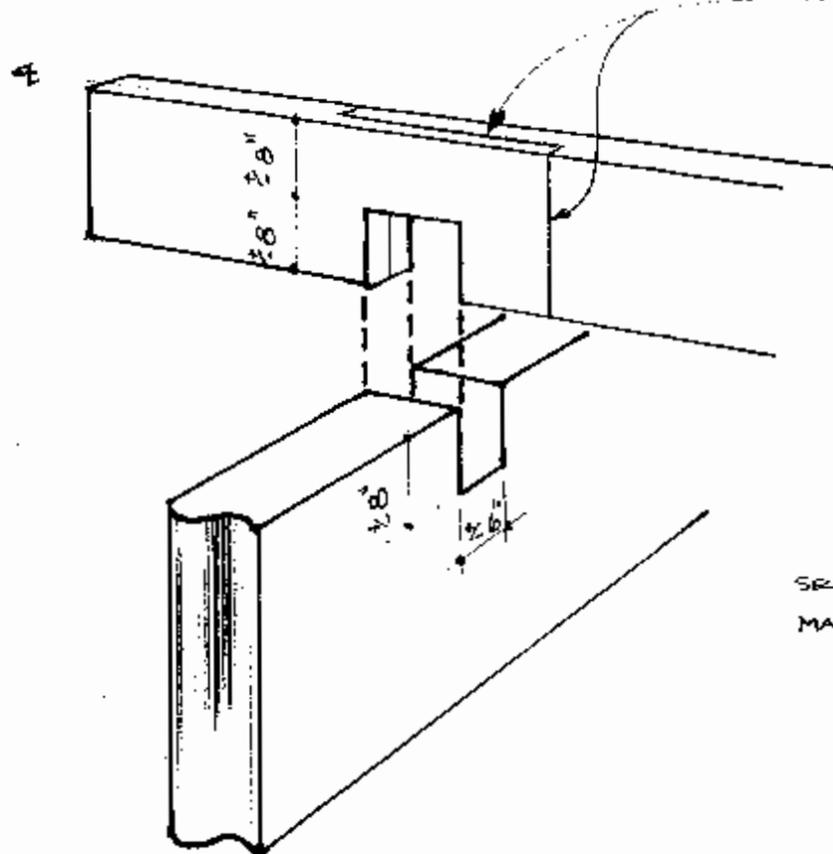
- AT MIDDLE MAIN BEAM - SECONDARY BEAMS TO BE SPLICED (POSSIBLY OVERLAPPED) AS PER GLU-LAM MANUF. (NOTE: THIS CONDITION EXISTS ONLY AT CENTER MAIN BEAM W/ SECONDARY BEAM CONNECTION)

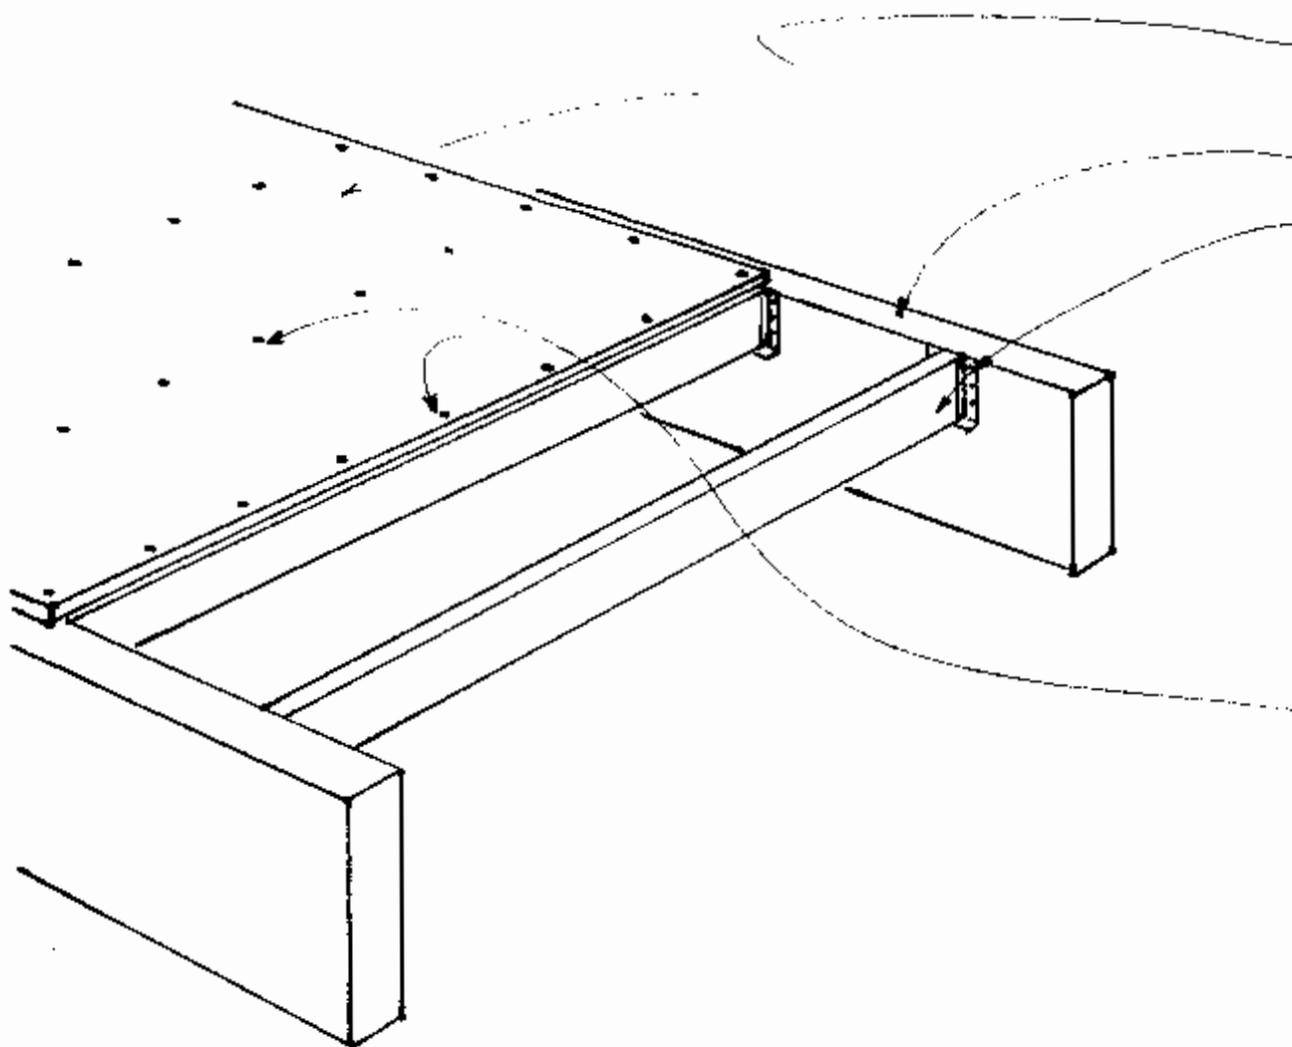
- 4x8 x 3/4 T&G PLYWD. FASTENED TO JOISTS/ BEAMS W/ 2 1/2" x 1/4" S.S. SCREWS MAX 8" APART
- SECONDARY BEAM (6" x 16' GLU-LAM)
- 2x6 x 8 PT FRAMING CUT TO FIT W/ STD. GALV. 2x6 JOIST HANGERS, USING 12 D x 3" GALV. NAILS - TOE IN AT HANGERS

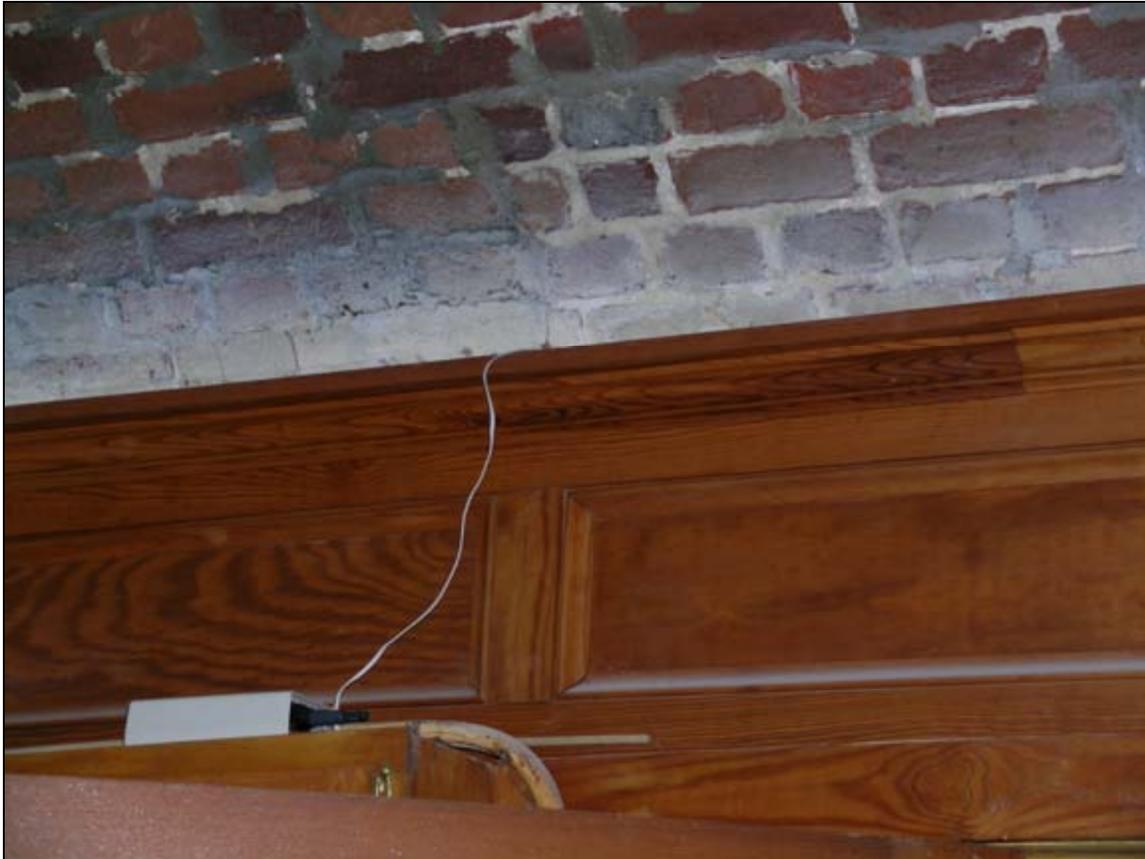
**Photograph 1:** Photograph of the placement of the GE Humilog System data recorder. This recorder measured data on the terreplein side of the casemate. The electrodes used to measure the WME are not visible in this photograph but they were placed in the mortar joints in the brick vault portion of the casemate.

underneath the earthen rampart and the terreplein. Small holes were drilled into the mortar joints at both locations. Metal electrodes were placed into these holes, which were used to measure WME levels within the walls. The mortar joints were chosen rather than the masonry units themselves to prevent unnecessary damage to the interior walls.

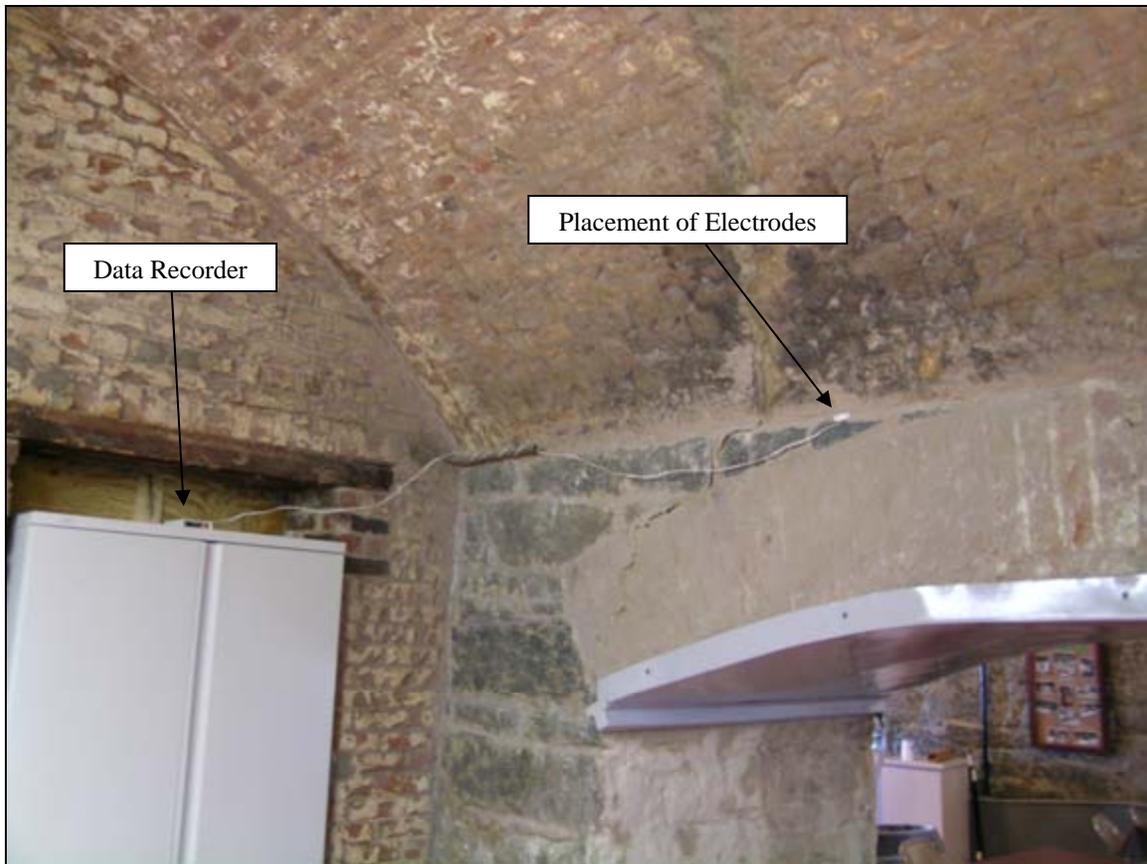
**Photograph 2:** View of the data recorder placed on the earthen rampart side of the terreplein. The arrow indicates the location of the electrodes. These electrodes placed within the wall and measure WME levels within the masonry. In this location, the electrodes were placed within the mortar joint and not the masonry unit. This was done to prevent any unnecessary damage to the wall.
