Performance Testing of Historically Appropriate Blast-Resistant Windows Volume 2 – Test Data

ERDC/CERL TR-07-39

Shock Tube Testing for Historic Windows

ABSC Shock Tube Test Range
San Antonio, Texas
August 28-29, 2007

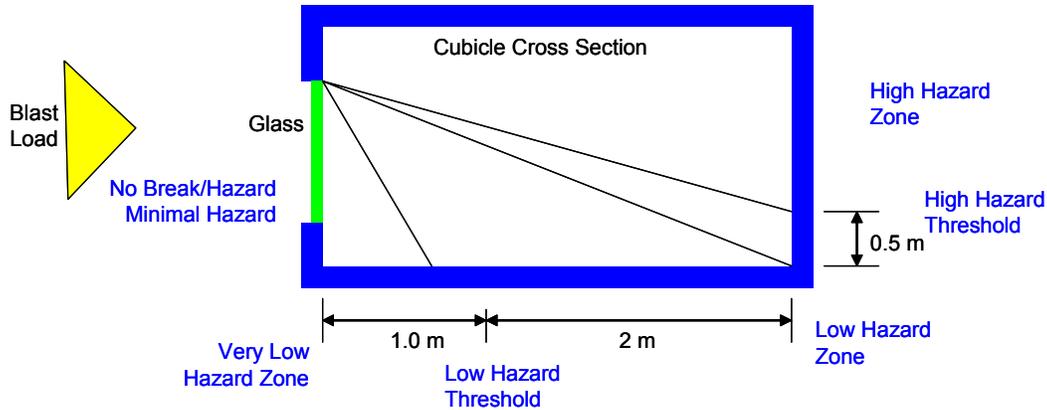
Figure 1 Hazard Level Diagram per ASTM F-1642

A Yokogawa data acquisition system, sampling at 1 MHz, was used to record pressure-time histories for the installed gauges. Following application of the blast load, the floor of the test cubicle was inspected for glass fragments. The witness panel was also inspected for fragment impact. Frame and glass panel deflections were recorded. For this testing, no fragments or penetrations were observed in the witness panel. Only glass dusting was observed on the interior of the cubicle. A hazard level was assigned to each test specimen based on the observed fragmentation using the rating system prescribed in the ASTM protocol as shown in Figure 1.

Both glazing systems performed well in the tests. All samples resulted in a Minimal Hazard level rating which means there was only glass dusting inside the test cubicle. This dusting was insufficient to weigh and created by flexure of the laminated inside lite. Three samples of each type were tested which is sufficient to obtain a rating in accordance with ASTM F-1642.

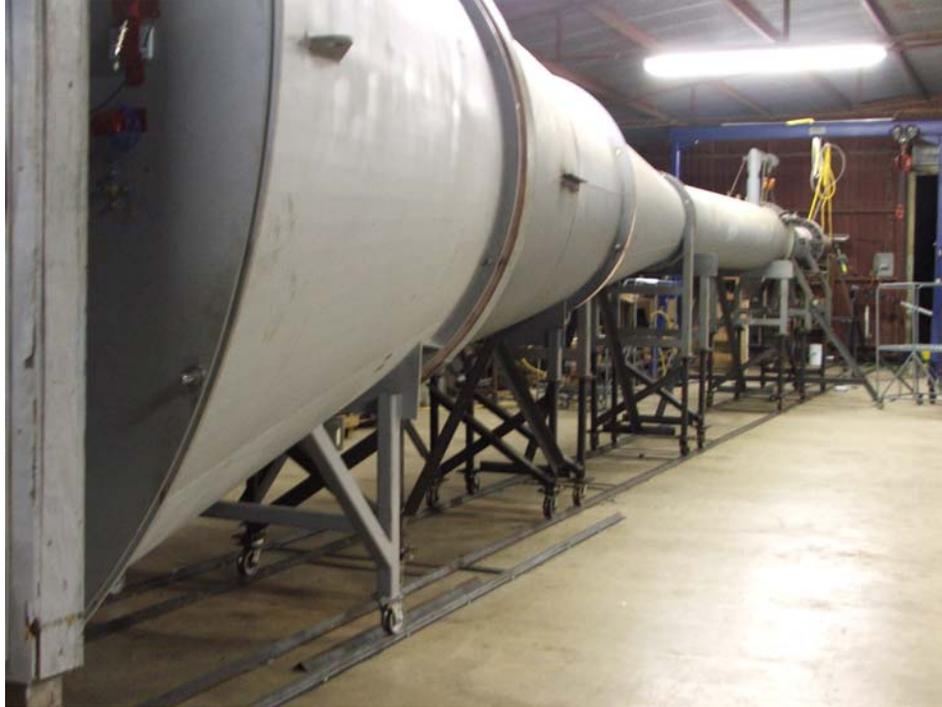
Figure 2. ABS Consulting Shock Tube Apparatus

Blast loads were applied using a “shock tube” as shown in Figure 2. This device uses a sudden burst of compressed air to create a blast pulse, which travels down the tube and is applied to the test specimen mounted in an enclosure (test cubicle) attached to the end. The blast load creates a specified positive blast pressure and impulse on the test specimens. Negative phase blast loads are developed but are typically less than the negative pulse typical of a high explosive load.

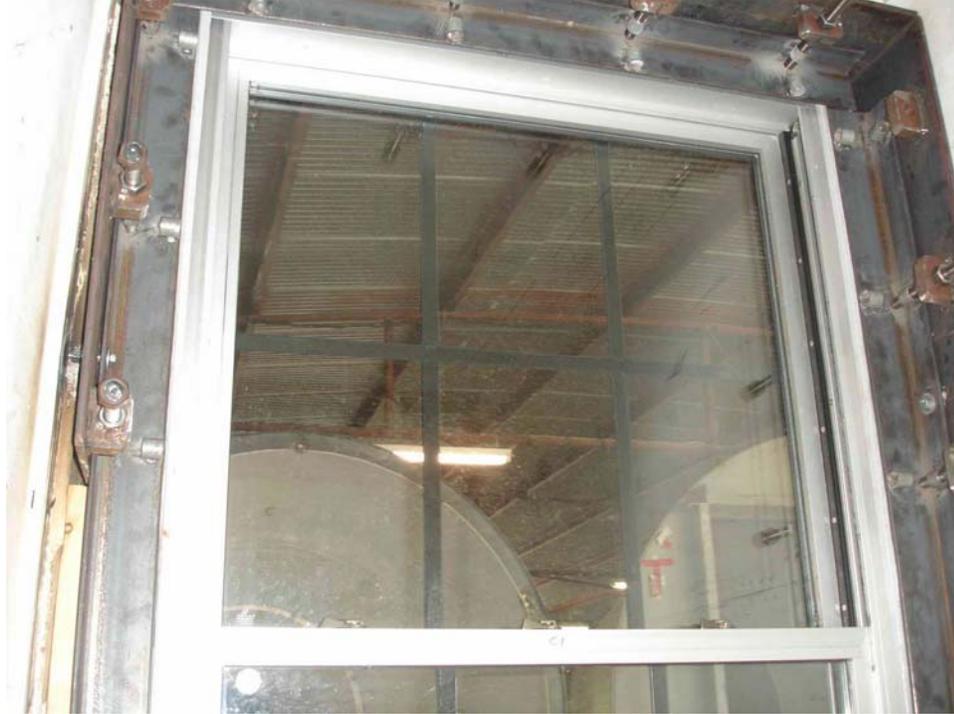
Figure 3. Steel Sub-frame with Window Mounted in Test Cubicle

Test windows were mounted in sub-frames by the manufacturers. These sub-frames were mounted in the test cubicle fully supported by a steel angle on all sides from the rear (non-loaded) face and by a flat “capture” plate on the front (loaded) face to restrain the window during rebound. A general elevation and section of this arrangement is shown in the fixture drawings in Appendix C.

Custom Windows were double hung units. Kawneer windows were fixed lite on top and bottom with an operable project-out vent in the center section. Non-structural sealant was applied to the junction of the frame and the steel channel sub-frame for both window systems. Window frame assemblies were rigidly supported on all four sides. Window anchorage and attachment to the wall substructure was not evaluated in the testing. Figure 3 shows a typical window mounted in the test sub-frame affixed to the test fixture.

The test cubicle, nominally 10 feet deep, 51 inches wide, and 96 inches high, was enclosed to prevent blast pressures from wrapping around the structure and reaching the back side of the window. This represents a typical window installation on an exterior wall. A witness panel was provided on the back wall to detect the impact of glass shards. The witness panel is nominally 10 ft. from the test window. Actual distance varies with window configuration. For the double

hung windows, the glazing components are at different locations along the axis of the cubicle. The minimum distance from glazing to the witness panel is approximately 110 in. This produces a somewhat conservative rating of hazard level with respect to fragments on the witness panel since fragments travel less than 120 in.

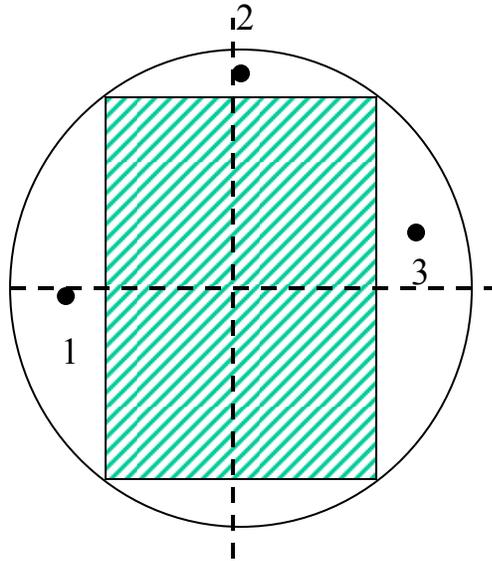
Figure 4 Pressure Gauge Locations

Blast pressure gauges measuring reflected pressure were mounted on the front of the test cubicle facing the oncoming blast wave, immediately adjacent to the test specimen (see Figure 4). Data are recorded on a digital oscilloscope and waveforms are converted to pressure-time histories in DPlot format for each gauge.

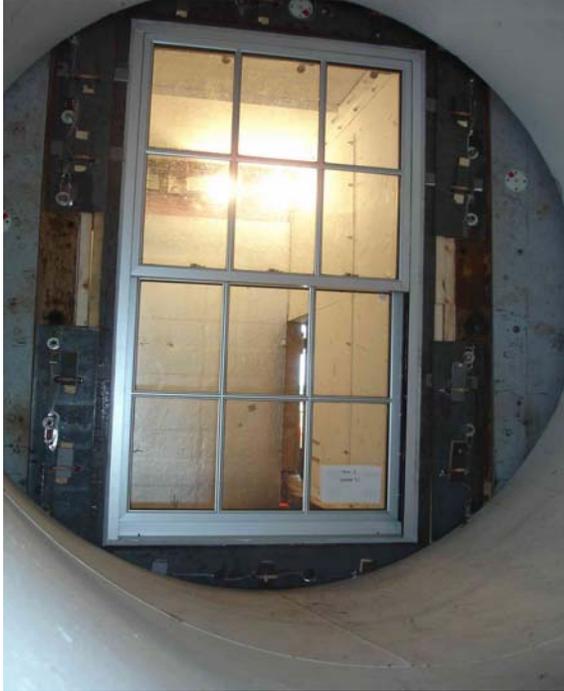
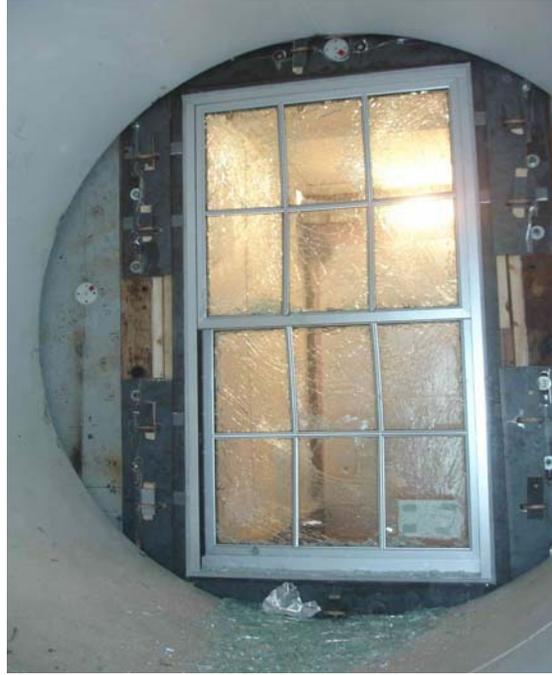
Notes: Inside and outside lites fractured, no fragments in cube, operable following test

ASTM F-1642 Hazard Level:	Minimal Hazard	Certified for Test Pressure per ASTM F1642:	Yes
		Certified Performance Level:	Minimal Hazard
		Specimen Number:	C1
		Other Specimens:	C2, C3

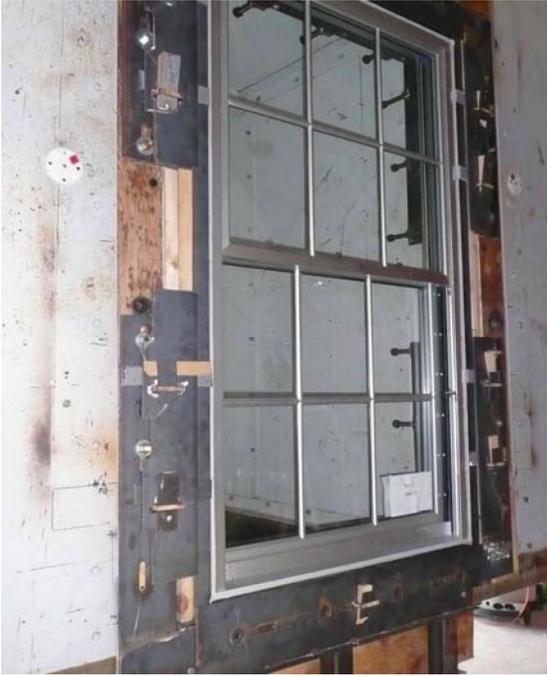
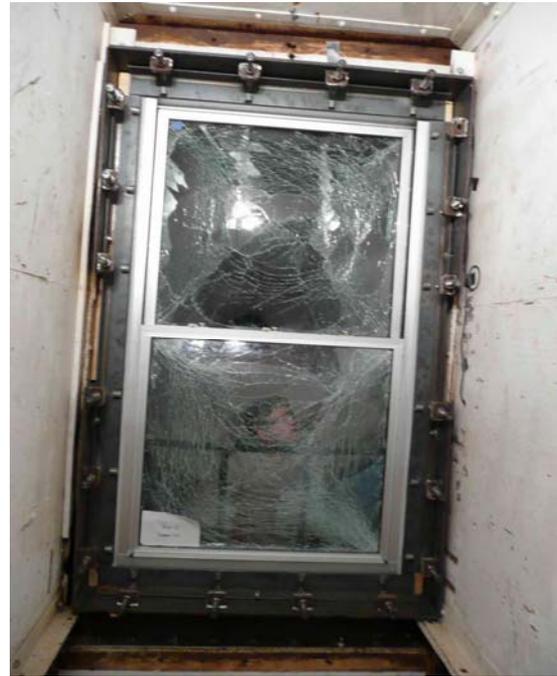
Notes: Inside and outside lites fractured, no fragments in cube, operable following test

ASTM F-1642 Hazard Level:	Minimal Hazard	Certified for Test Pressure per ASTM F1642:	Yes
		Certified Performance Level:	Minimal Hazard
		Specimen Number:	C2
		Other Specimens:	C1, C3

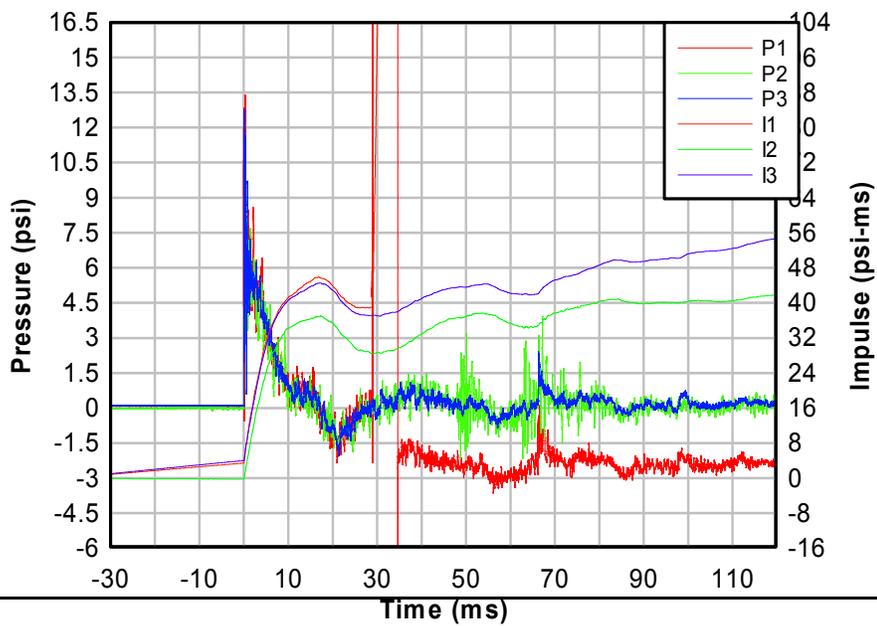
**ERDC Historic Windows
Test 2**

Gauge Number				Average
	1	2	3		
Peak Reflected Pressure (psi)	11.2	10.6	11.3		11.0
Positive Phase Duration (ms)	16.4	16.8	17.3		16.8
Positive Phase Impulse (psi-ms)	45.7	36.8	44.4		42.3

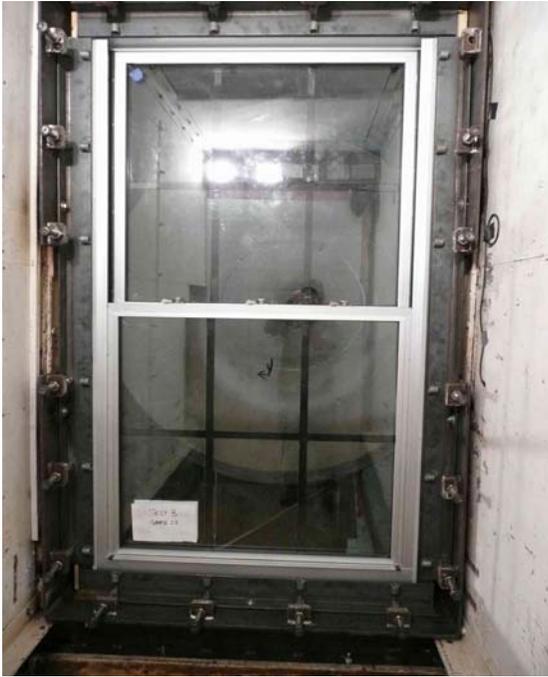
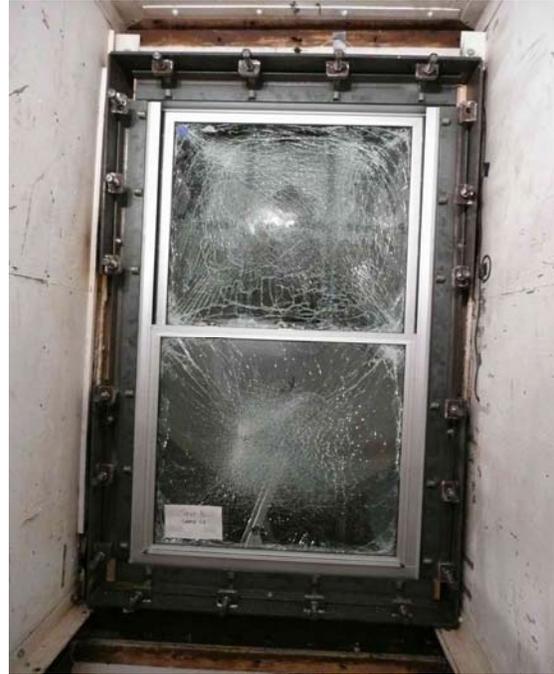
0-1m	1m-3m
Mass of Glass (g)	Dust	N/A
United Dimension (in):	~0	~0
	Interior	Perimeter
Length of Tears and Pullout (in):	1-1/4"	0

Notes: Inside and outside lites fractured, no fragments in cube, operable following test

ASTM F-1642 Hazard Level:	Minimal Hazard	Certified for Test Pressure per ASTM F1642:	Yes
		Certified Performance Level:	Minimal Hazard
		Specimen Number:	C3
		Other Specimens:	C2, C3

Only one instance of pvb interlayer tearing was noted (Test 3). This may have been caused by impact from the non-structural muntin. No frame or fastener failure was noted during the tests. In all cases, windows remained operable although significant force was typically required due to interference from deformed laminated glass lites.

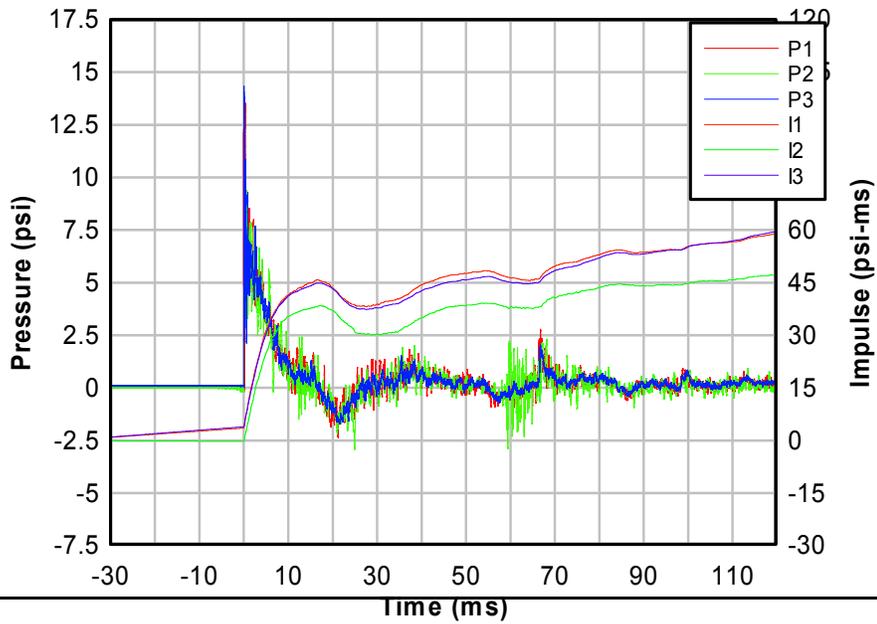
**ERDC Historic Windows
Test 3**

Gauge Number				Average
	1	2	3		
Peak Reflected Pressure (psi)	12.4	10.5	10.2		11.0
Positive Phase Duration (ms)	16.7	17.0	17.3		17.0
Positive Phase Impulse (psi-ms)	45.7	38.7	45.1		43.2

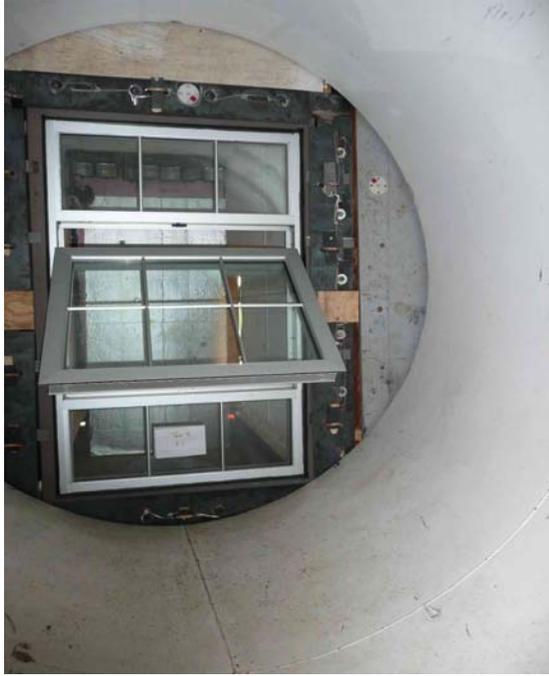
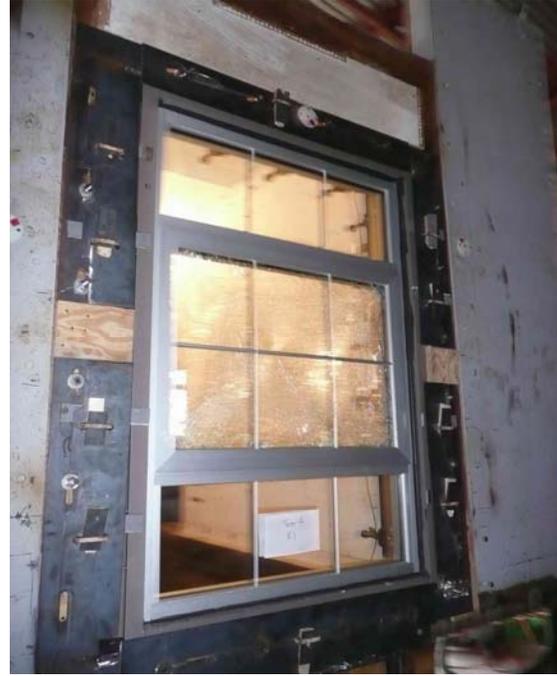
Notes: Inside and outside lites fractured on project out, no break of fixed, no fragments in cube, operable following test

ASTM F-1642 Hazard Level:	Minimal Hazard	Certified for Test Pressure per ASTM F1642:	Yes
		Certified Performance Level:	Minimal Hazard
		Specimen Number:	K1
		Other Specimens:	K2, K3

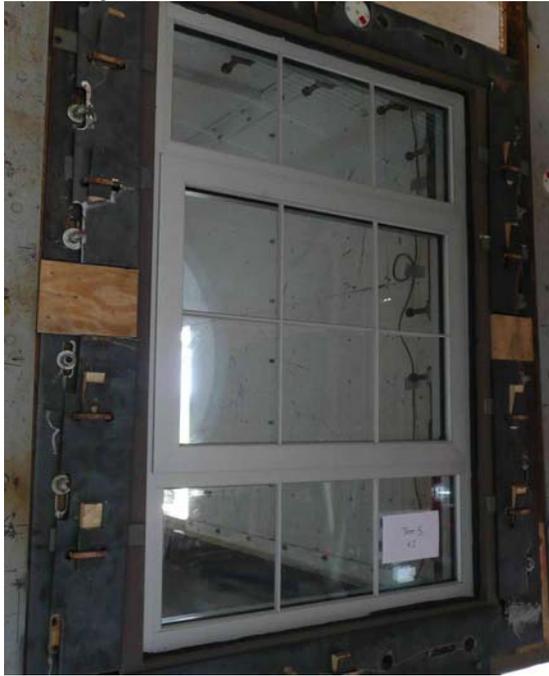
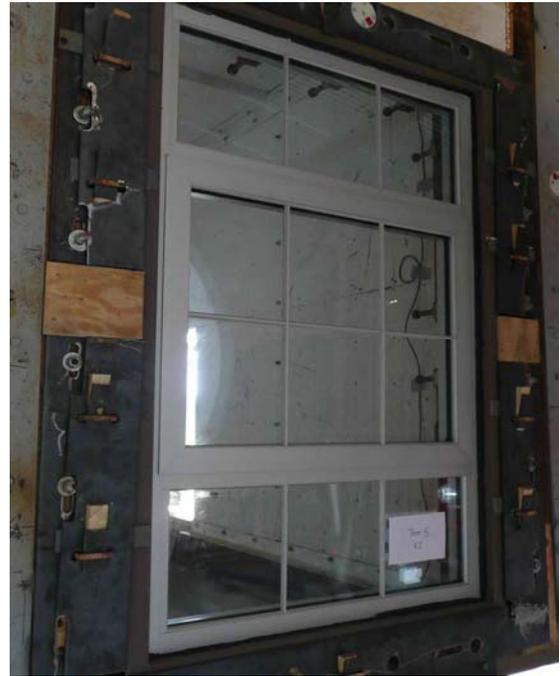
ASTM F-1642 Hazard Level:	No Break	Certified for Test Pressure per ASTM F1642:	No
		Certified Performance Level:	
		Specimen Number:	
		Other Specimens:

New diaphragm material was used beginning with test 5 due to the presence of scratches in the diaphragms made from the original material. This material exhibited a significantly lower burst pressure than that used for tests 1-4. Consequently, the blast loads for test 5 were much lower, and in fact, did not produce glass breakage in sample K-2. New diaphragms were installed and

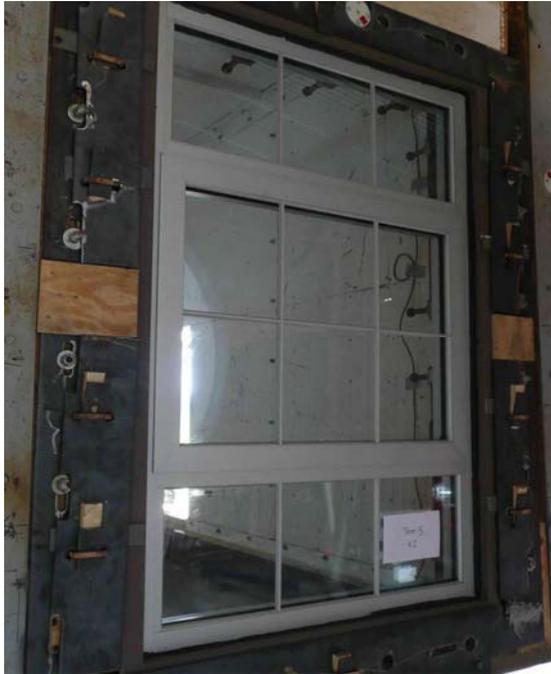
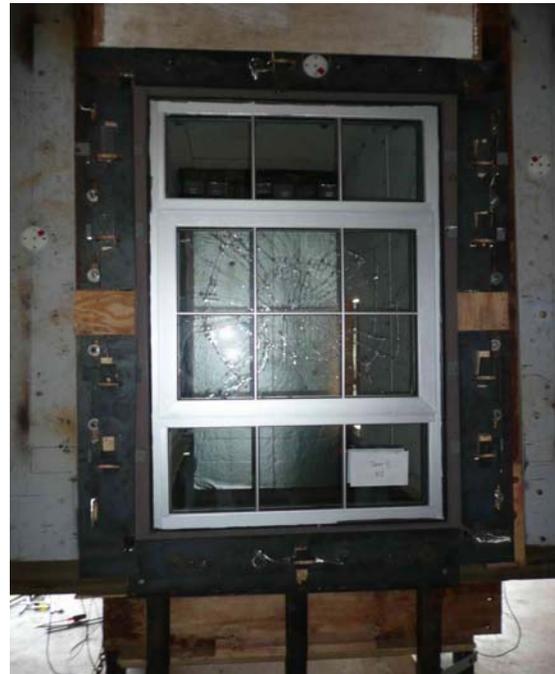
Notes: Inside and outside lite fractured on project out, no other breaks

ASTM F-1642 Hazard Level:	No Hazard	Certified for Test Pressure per ASTM F1642:	No
		Certified Performance Level:	
		Specimen Number:	
		Other Specimens:

K-2 was retested (recorded as test 5A). The new diaphragm material again burst at a lower driver pressure although somewhat higher than test 5. The original diaphragm material was located and installed for another retest of K-2. This retest was recorded as test 5B. Blast loads for this test were consistent with tests 1-4 and met the target loads. Original diaphragm material was used for the final test 6.

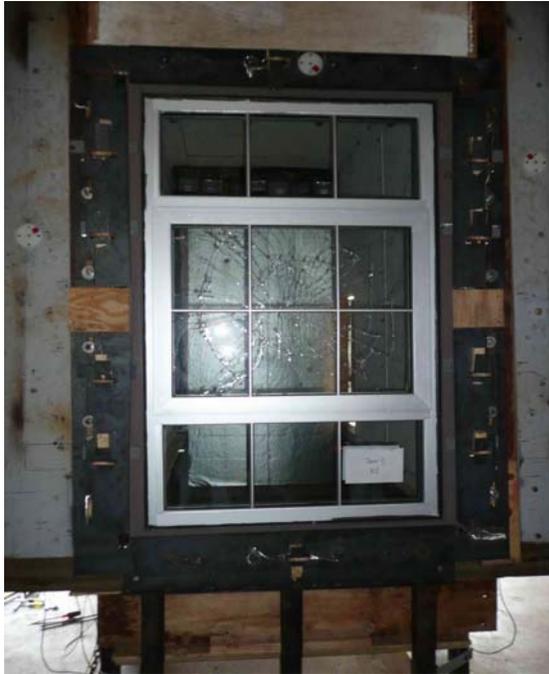
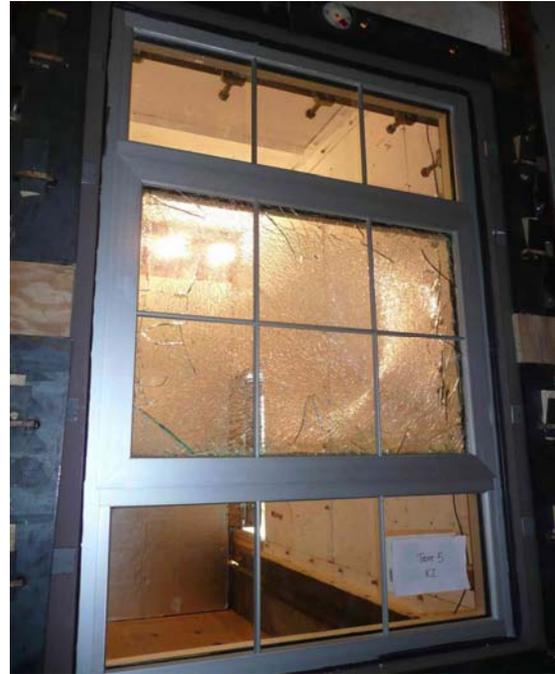
Notes: Inside and outside lite fractured on project out, no other breaks

ASTM F-1642 Hazard Level:	Minimal Hazard	Certified for Test Pressure per ASTM F1642:	No
		Certified Performance Level:	Minimal Hazard
		Specimen Number:	K2
		Other Specimens:	K1, K3

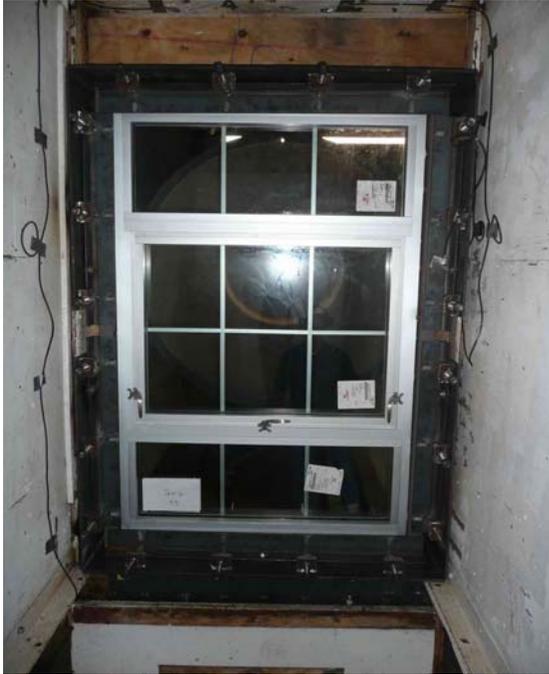
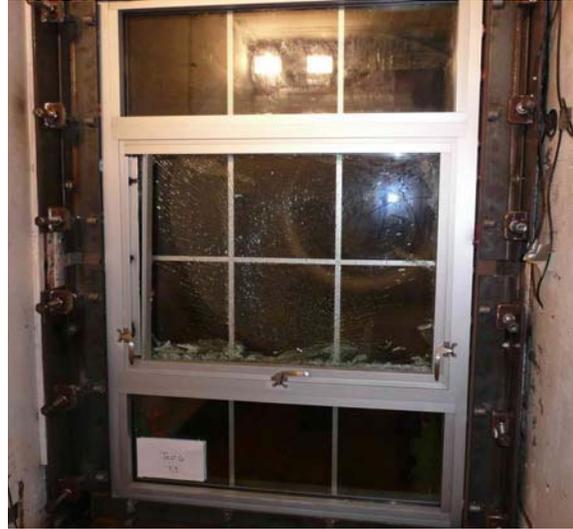
Notes: Inside and outside lites fractured on project out, no break of fixed, no fragments in cube, operable following test

ASTM F-1642 Hazard Level:	Minimal Hazard	Certified for Test Pressure per ASTM F1642:	No
		Certified Performance Level:	Minimal Hazard
		Specimen Number:	K2
		Other Specimens:	K1, K3

During test 6, gauge 3 did not record data. This was attributed to a gauge connection failure. The remaining two gauges recorded data consistent with previous tests.

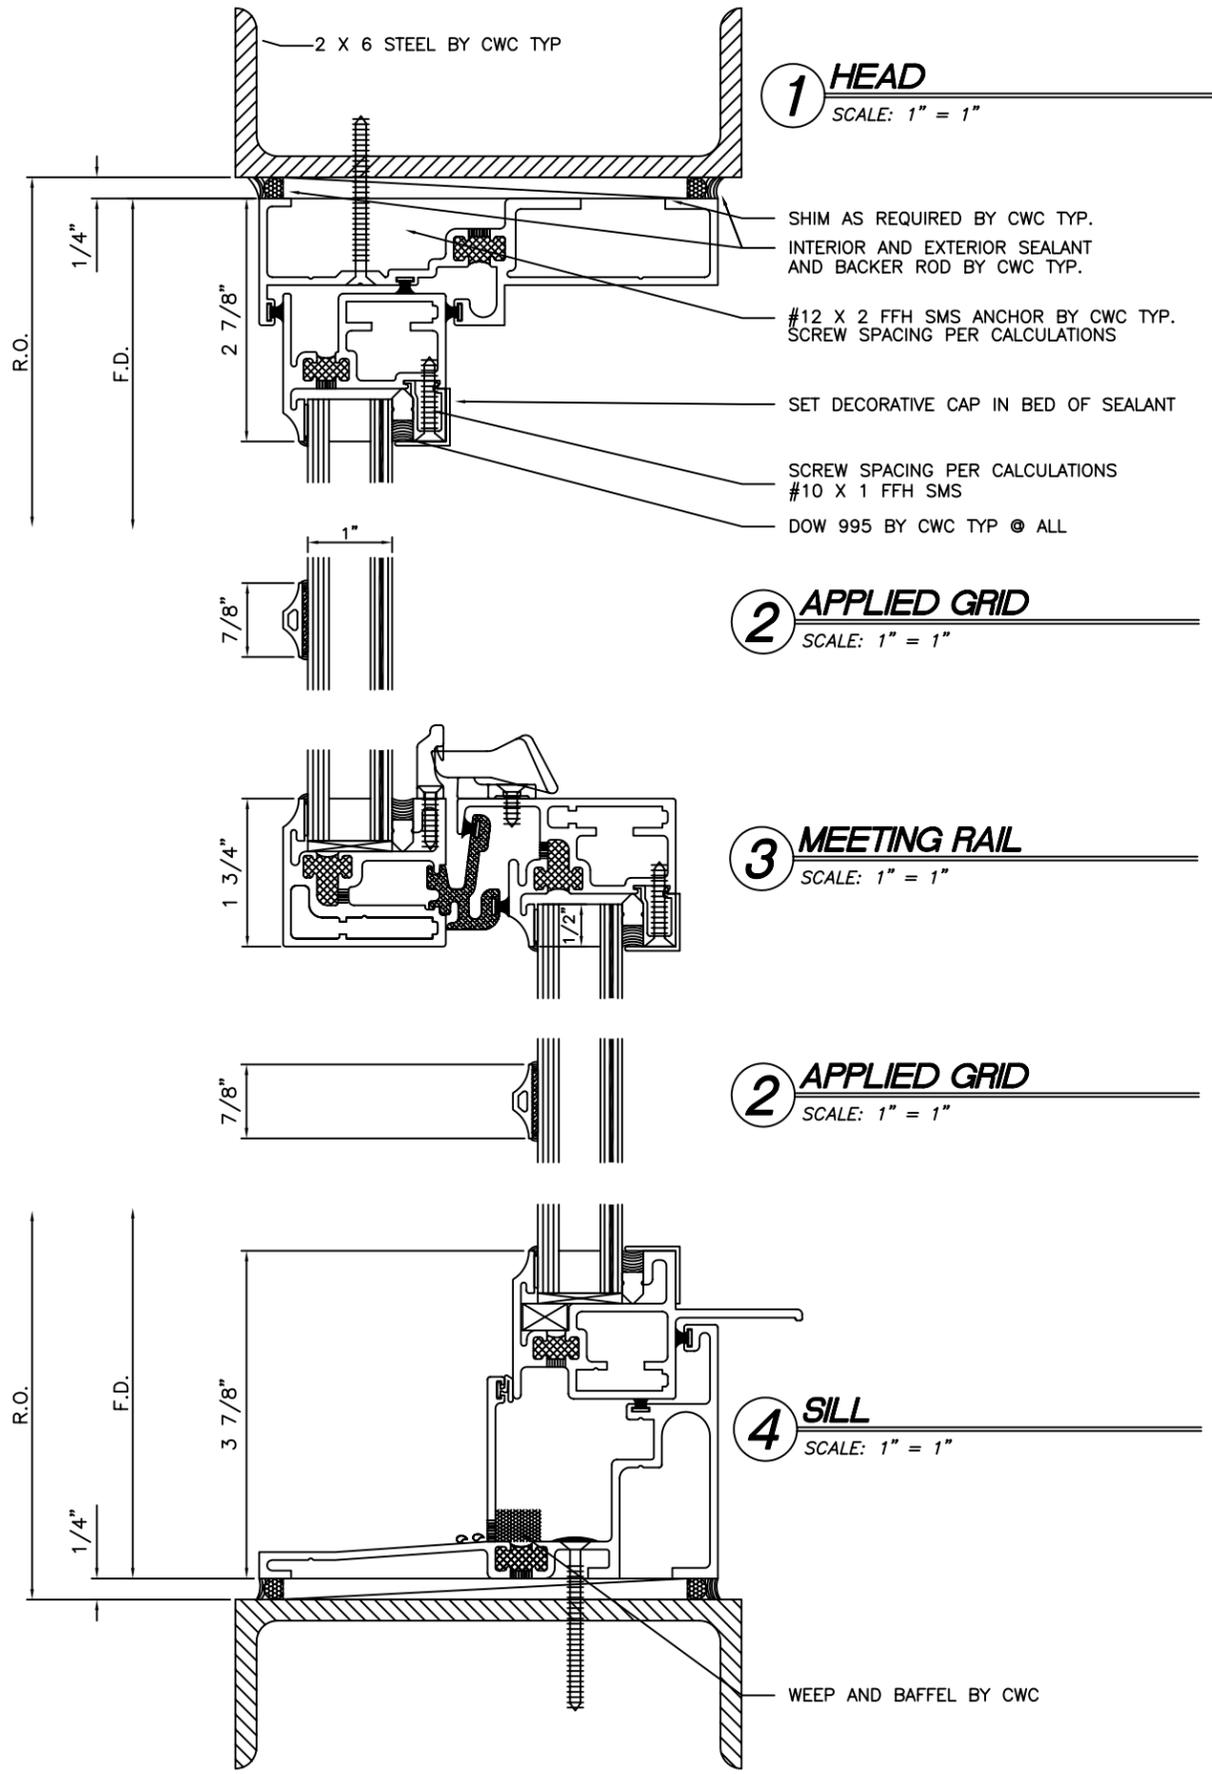
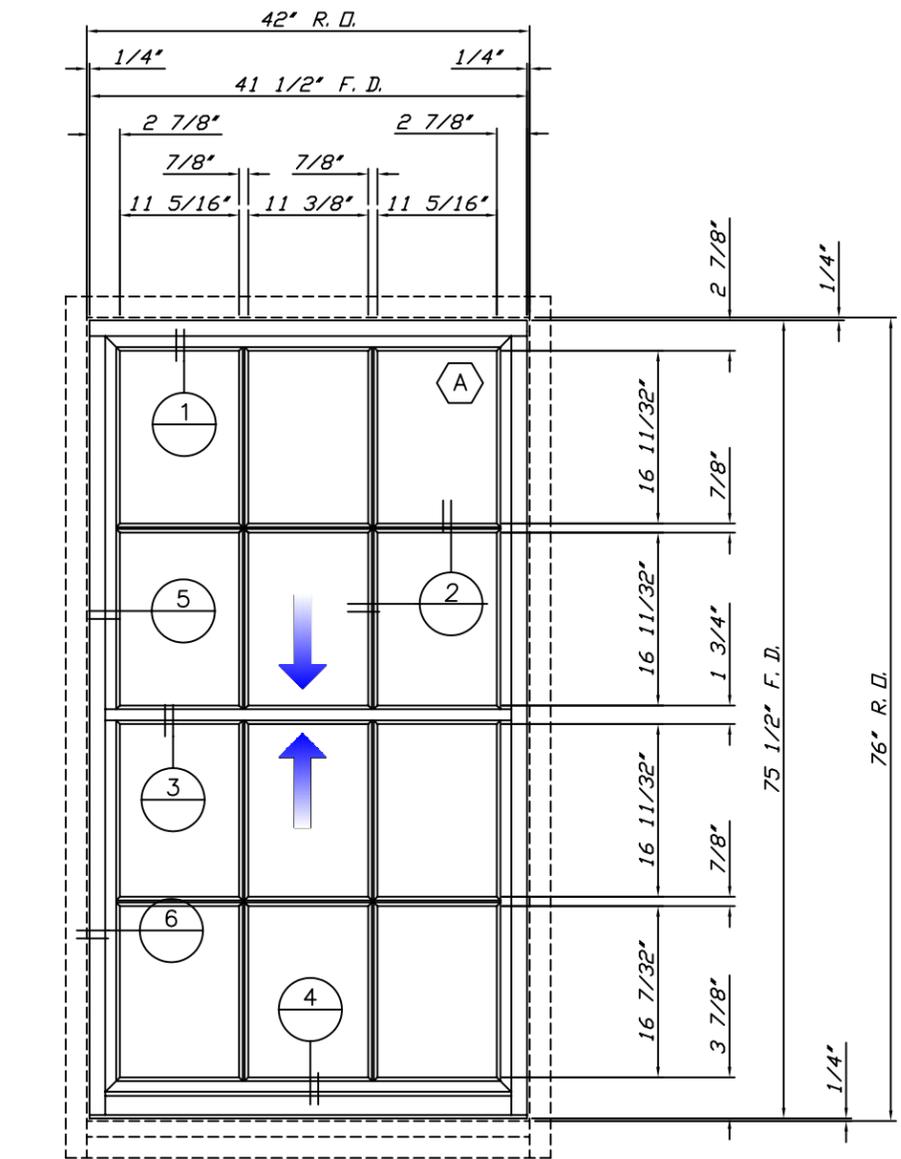
PRICE: **D1**

NOTE: CONDITIONS SURROUNDING WINDOW PERIMETER ARE DRAWN FOR REFERENCE ONLY, AND NOT THE RESPONSIBILITY OF CUSTOM WINDOW.

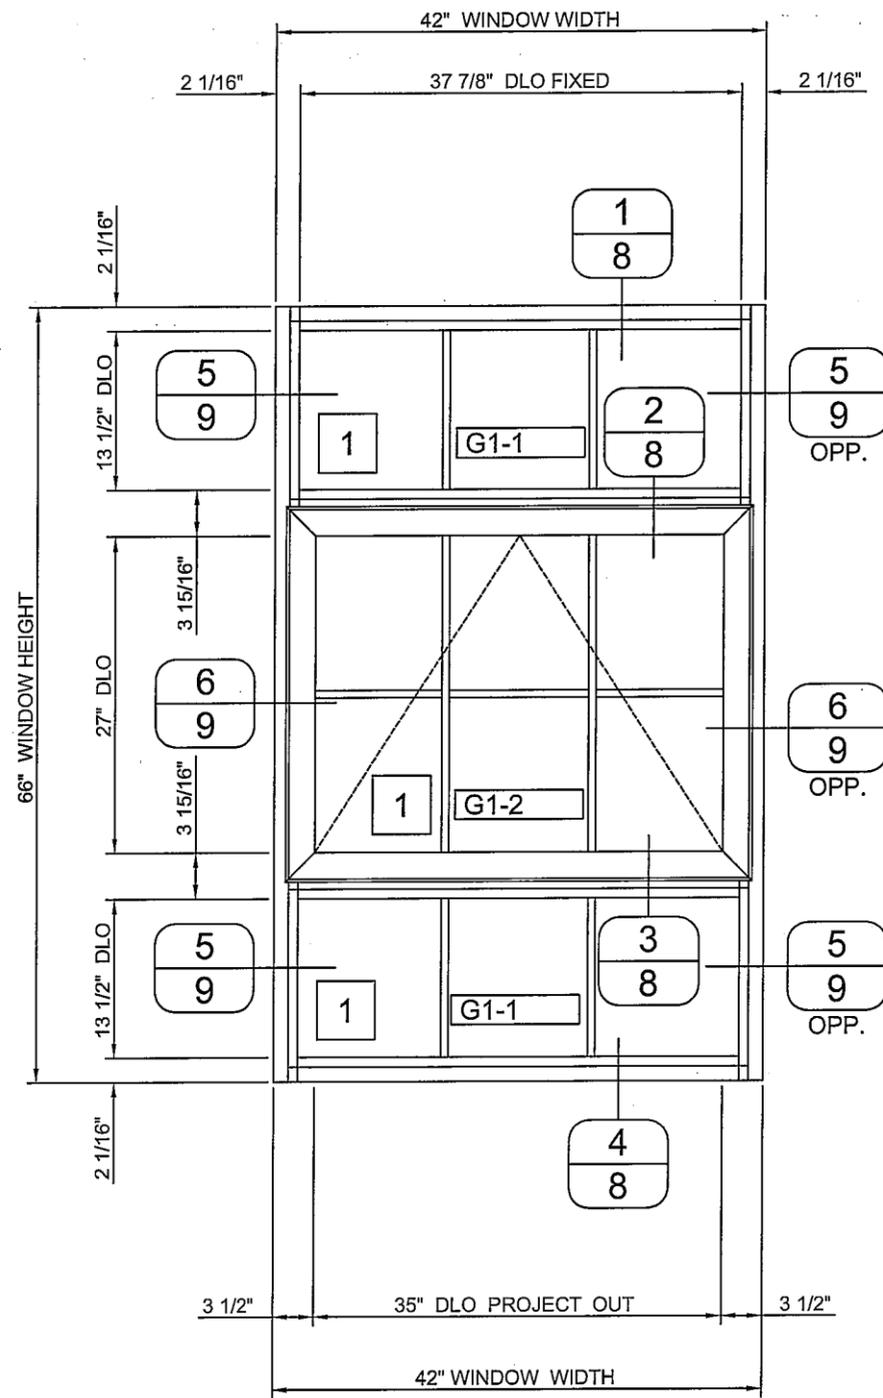
**8325TL WINDOW - FIXED/PROJECT-OUT/FIXED
(3) THUS REQUIRED**

TESTING CRITERIA:
 PEAK APPLIED PRESSURE: 9.6 PSI
 POSITIVE PHASE IMPULSE: 42 PSI-MSEC
