**Comparison of Vapor Intrusion  
Investigations: Case Studies with a Range  
of Findings and Response**

**Derral Van Winkle  
NAVFAC Southwest  
09 May 2019**

# Case Study 1: NAS North Island, OU20

# Case Study 2: Naval Base San Diego, Installation Restoration Site 22

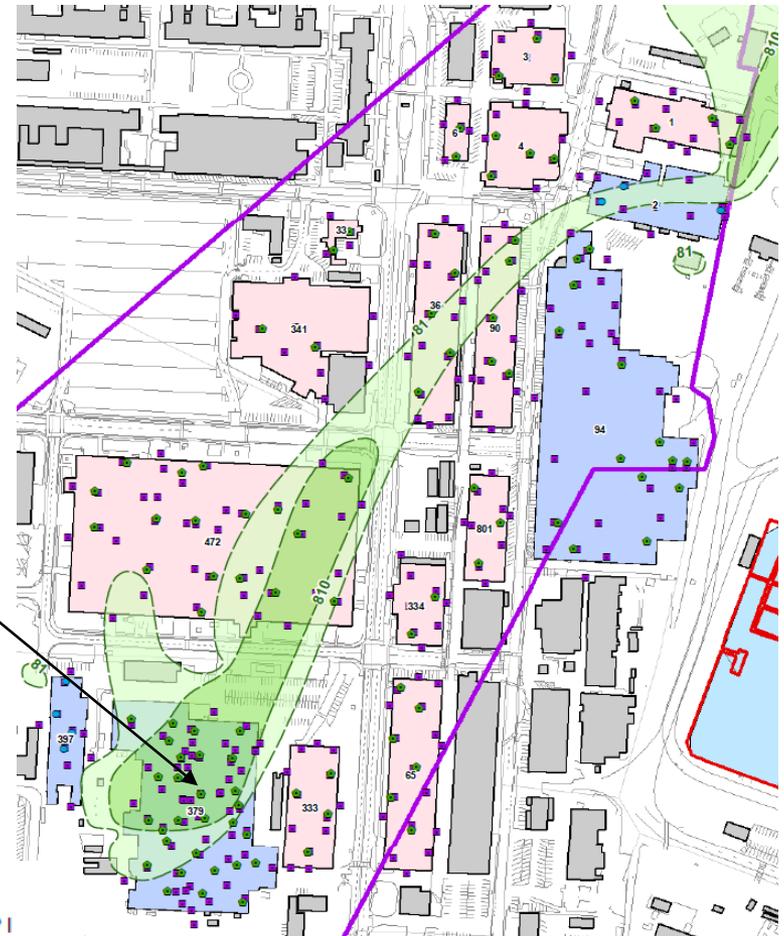
- Building 379 – 172,000 square foot footprint
- Overlies LNAPL 25 feet deep, which includes cVOCs and heated to 130 °F from base steam line
- cVOCs in soil gas/sub-slab in places  $>10M$  ug/m<sup>3</sup>
- Initial indoor air concentrations exceed the USEPA Region 9 ARAL

- VAPOR PIN - GROUP II
- SUB-SLAB PROBE - GROUP I
- SUMMA CANISTER SAMPLING LOCATION

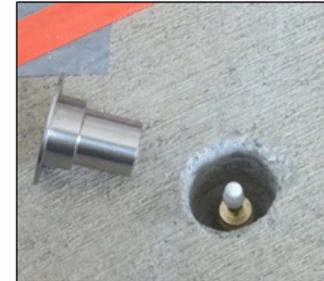
- Sub-slab/vapor pin installation
- Initial Indoor air screening
  - HAPSITE/Electron capture detection
- Contemporaneous indoor/outdoor and sub-slab sampling
- Regular ongoing monitoring of indoor air (49 events since 2016)
  - SUMMA canisters - before and after mitigation efforts

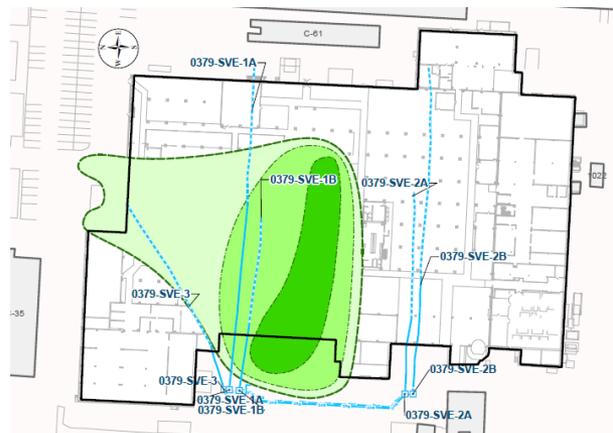
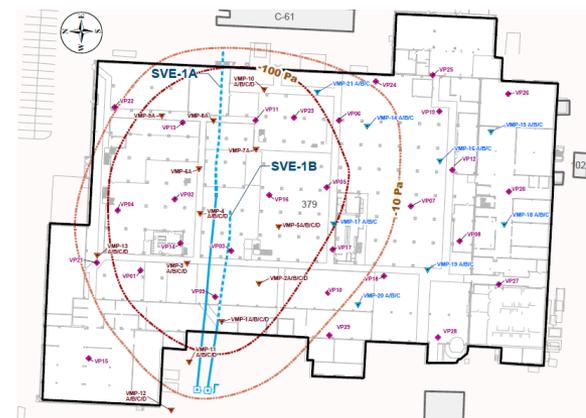
- Sealed 15,000 linear feet of cracks and joints
- Sealed pathways identified in restroom, floor of lunch room
- Deployed air purification units in selected rooms
- Two horizontal soil vapor extraction (SVE) wells installed below Building 379 slab

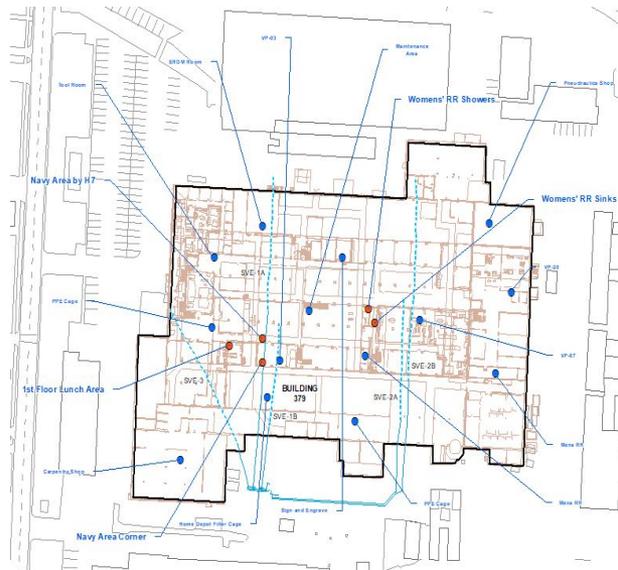
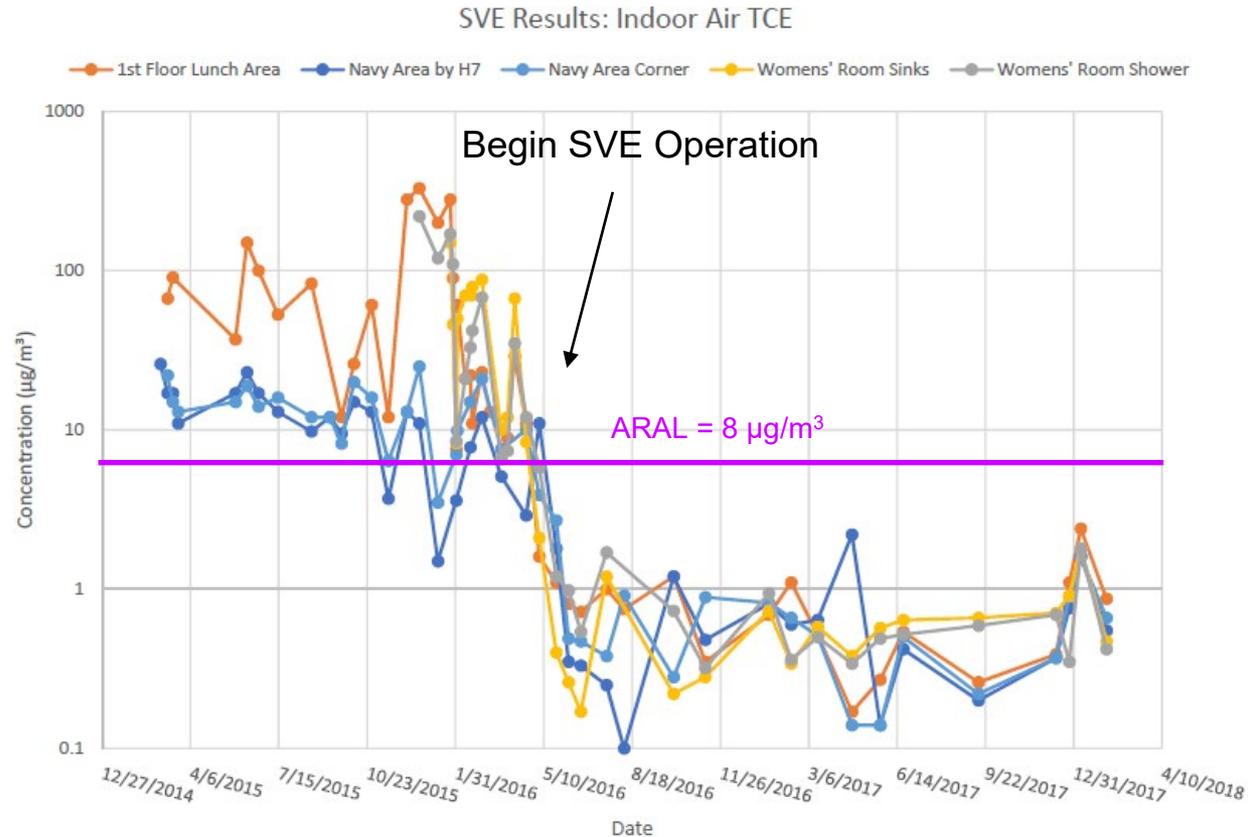
- Measurements/Results – Indoor Air Concentrations

- Initial screening
  - Indoor Air Concentrations > USEPA Region 9 ALARs
- Contemporaneous measurements
  - Indoor air TCE concentrations reduced after initial mitigation
  - Result in building-specific attenuation factor (**0.000001**)
- Ongoing monitoring of indoor air
  - Verifies that concentrations after mitigation remain below USEPA Region 9 ARALs

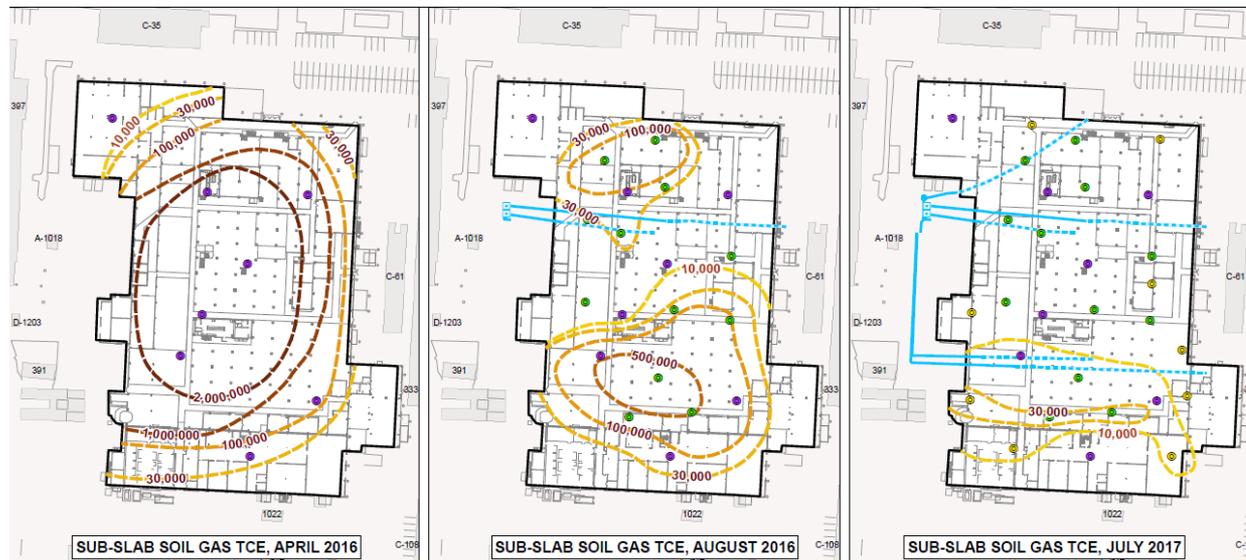
- Enhancements – take advantage of installation steam piping
- Three additional SVE wells, enhanced removal of NAPL with steam injection
- TCE footprint decreased after 15 months of initial operation
- Significant TPH/cVOC recovery (>6,300 gallons recovered)

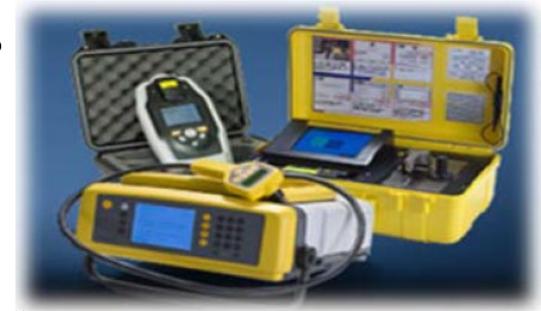
- **Planning & Investigative Approach Taken**
  - Initial Planning
    - Communications Plan
      - Initial stakeholder meeting; Fact Sheets pre and post phases; Open house meetings; Rapid Response Plan
    - Building Prioritization
      - Existing data and Johnson and Ettinger Modeling; Quantitative Decision Framework; 100-foot boundary
  - Measurements - Phased Building Surveys
    - Phase 1 (99 buildings) – Gather existing data, evaluate building systems, walk through
    - Phase 2 – (44 buildings) Initial indoor air screening – HAPSITE; fixed SUMMA canister samples; pressure cycle sampling
    - Phase 3 - Concurrent indoor, outdoor air, sub-slab soil vapor, 8 to 24-hour SUMMA canister sampling – confirmation and data gap evaluation

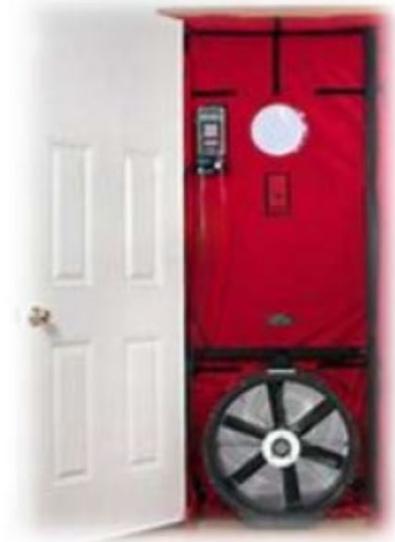
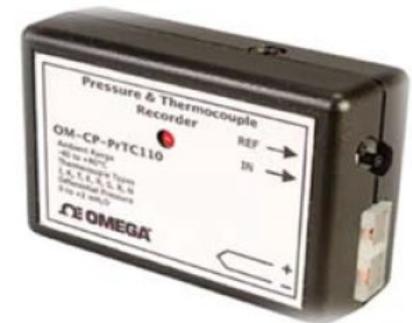
- In many buildings intermittent low concentrations of 1,2-DCA, chloroform steady during pressure cycling; suggests small inside sources
- TCE concentrations below USEPA Region 9 accelerated response action level and DTSC response level
- PCE concentrations slightly above screening thresholds in initial HAPSITE testing at two resident halls
  - Pressure cycling confirms vapor intrusion
  - Entry points: sewer cleanouts and ventilation hatches – washers/dryers
  - Phase 3: 8/24-hour SUMMA sampling and pressure monitoring implemented

- Negative pressure observed with normal operating HVAC; adjustments made to positive pressure
- Evaluation of sampling results after adjustments ongoing
