Appendix G

Storm Water Hcekkk/gu'/'Eqpxg{cpeg'Tguvqtcvkqp'Rncp

## INTRODUCTION

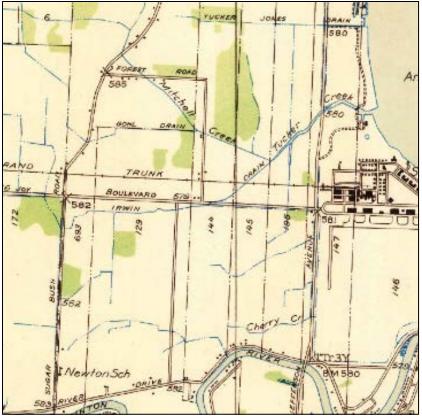
Figure 1: Selfridge Airfield 1936

There are two county drains in the vicinity: the Tucker Jones, which is located off-site to the north and the Irwin Drain, which is located off-site to the west. Although historic aerial photograph review indicates that these ditches were constructed prior to 1973, none of the ditches on SANGB currently represent county drains or even portions thereof. The reason none of the SANGB drains are part of the county drain system is because maintenance of drains for the installation is outside the jurisdiction and management of the Macomb County Office of Public Works (county drain commissioner) and must be handled by SANGB. As such, none of the ditches at SANGB *currently* meets the definition of a county drain. However, based on review of historic USGS topographic maps, it appears that many of the drains in question were at least in part, constructed as county drains. These drainage assets were likely established county drains circa 1900, and were later transferred to SANGB sometime between 1940 and 1960. Excerpts from the 1936, 1952, and 1984 USGS topographic maps for SANGB are included as Figures 1 through 3.

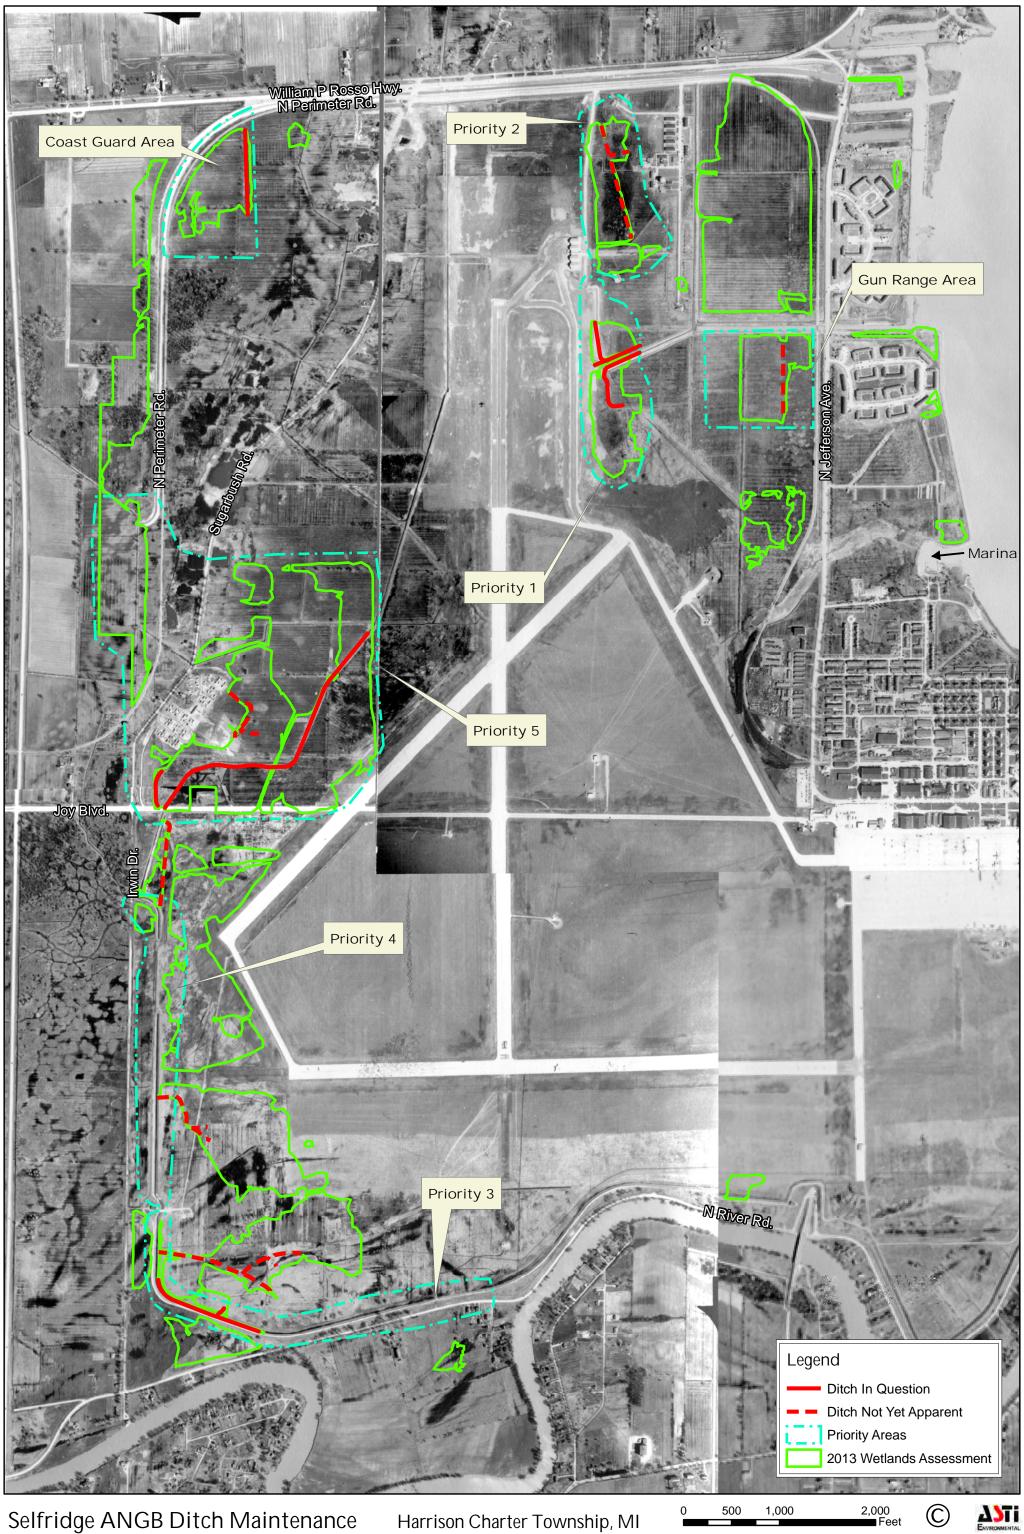
Historic Aerials - 1952

1952	Runways/taxiways extended to the north; housing apparent on the east side of N. Jefferson Ave.; more storm water drainage construction/relocation evident on the west side of airfield due to the northern expansion; structures evident along Sugarbush Road.	Conditions unchanged from 1940.	Conditions unchanged from 1940.	The northern extension of the airfield under construction; single ditch in Priority 1 is seperataed from the remainder of the system in Priority 5; instead, new ditch segment created to flow north to Perimeter Road and on the west side of the north airfield extension. Land surrounding the ditch appears to be in agricultural use.	Area is no longer entirely in agricultural use due to the airbase expansion. Existing ditches are not evident.	Conditions unchanged from 1949.	Conditions unchanged from 1949; surrounding land disturbed likely from construction and development.	Development along Sugarbush Rd. evident; land surrounding drains in question remain in agricultural use.

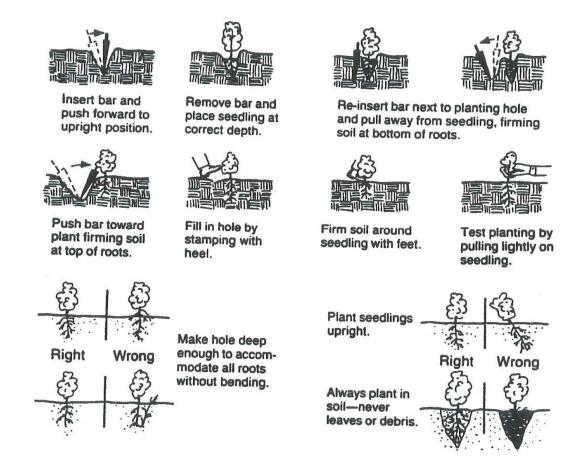
#### A Method for Planting Bare-Root Seedlings and Sprigs of Grasses

A method of hand planting bare-root seedlings and sprigged grasses is shown below. With a planting bar/iron or shovel/spade, make a notch in the soil no less than 8 inches deep. Place the roots in the notch to the same depth as the plant was in its original growing container. Firm soil around the roots by pressing the notch closed. Water immediately, and mulch, where necessary, within 2 feet of the plant. Since fertilizers tend to dry out young seedlings, do not fertilize bare-root seedlings until the end of the first year.
