Integrated Natural Resources Management Plan for the Camp Santiago Joint Training Center Puerto Rico Army National Guard

May 2022

**INTEGRATED NATURAL RESOURCES
MANAGEMENT PLAN (2021-2025)**

**Camp Santiago Joint Training Center
Puerto Rico Army National Guard**

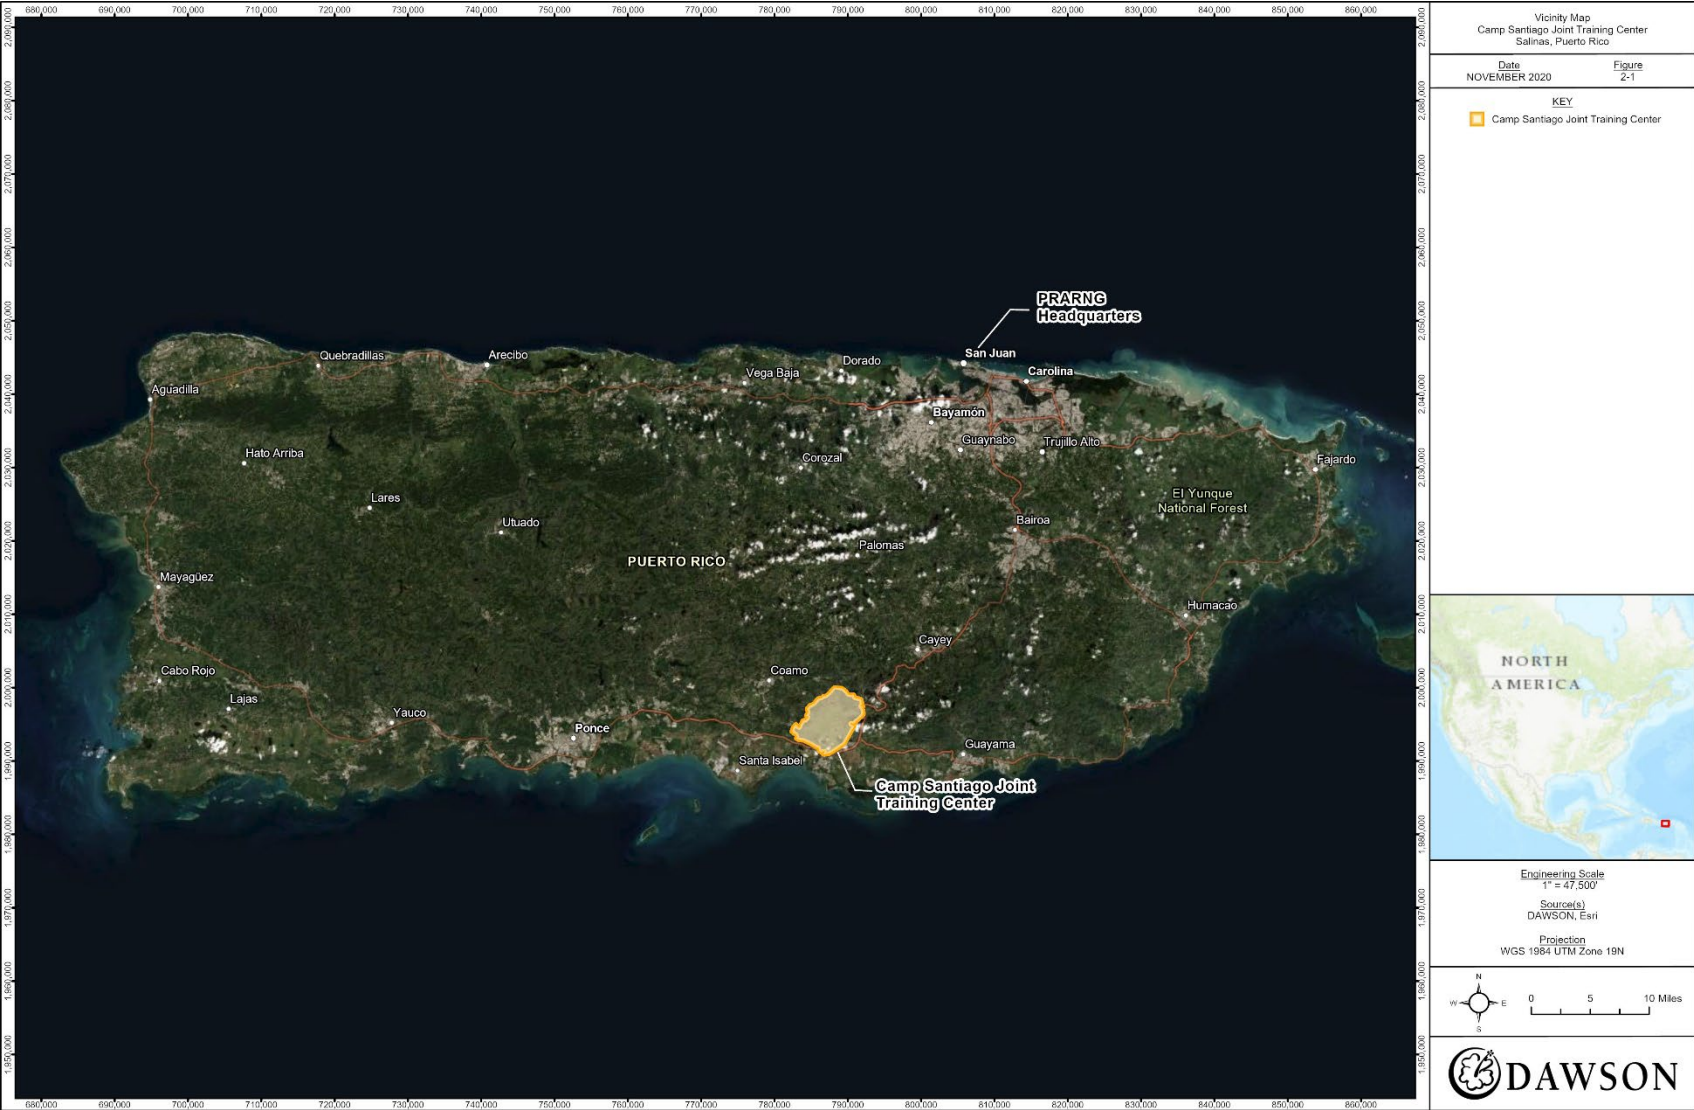
Figure 2-1. Vicinity Map

The Puerto Rico Army National Guard (PRARNG) Camp Santiago Joint Training Center (CSJTC), hereafter referred to as “Camp Santiago,” is the only Army training installation in the Caribbean Operating Area. The 12,649-acre facility is located in the south-central coast of Puerto Rico near the town of Salinas (see **Figure 2-1**).

Figure 2-1 shows the general location of Camp Santiago in southern Puerto Rico, while **Figure 2-2** illustrates Camp Santiago in more detail. **Table 2-1** provides a summary of the designated training areas shown on the Camp Santiago Map

Camp Santiago is located within the municipality of Salinas and bordered by two other municipalities, Santa Isabel on the southwest and Coamo on the west (see **Figure 2-1**).

Camp Santiago is located on the south-central coast of Puerto Rico, adjacent to the municipality of Salinas. The main gate is located off Highway 52, approximately 51 miles south of San Juan, the Capital of Puerto Rico, and 30 miles east of Ponce, the second biggest city in Puerto Rico. The Camp is accessible by highway from virtually all points on the island (see **Figure 2-1**).

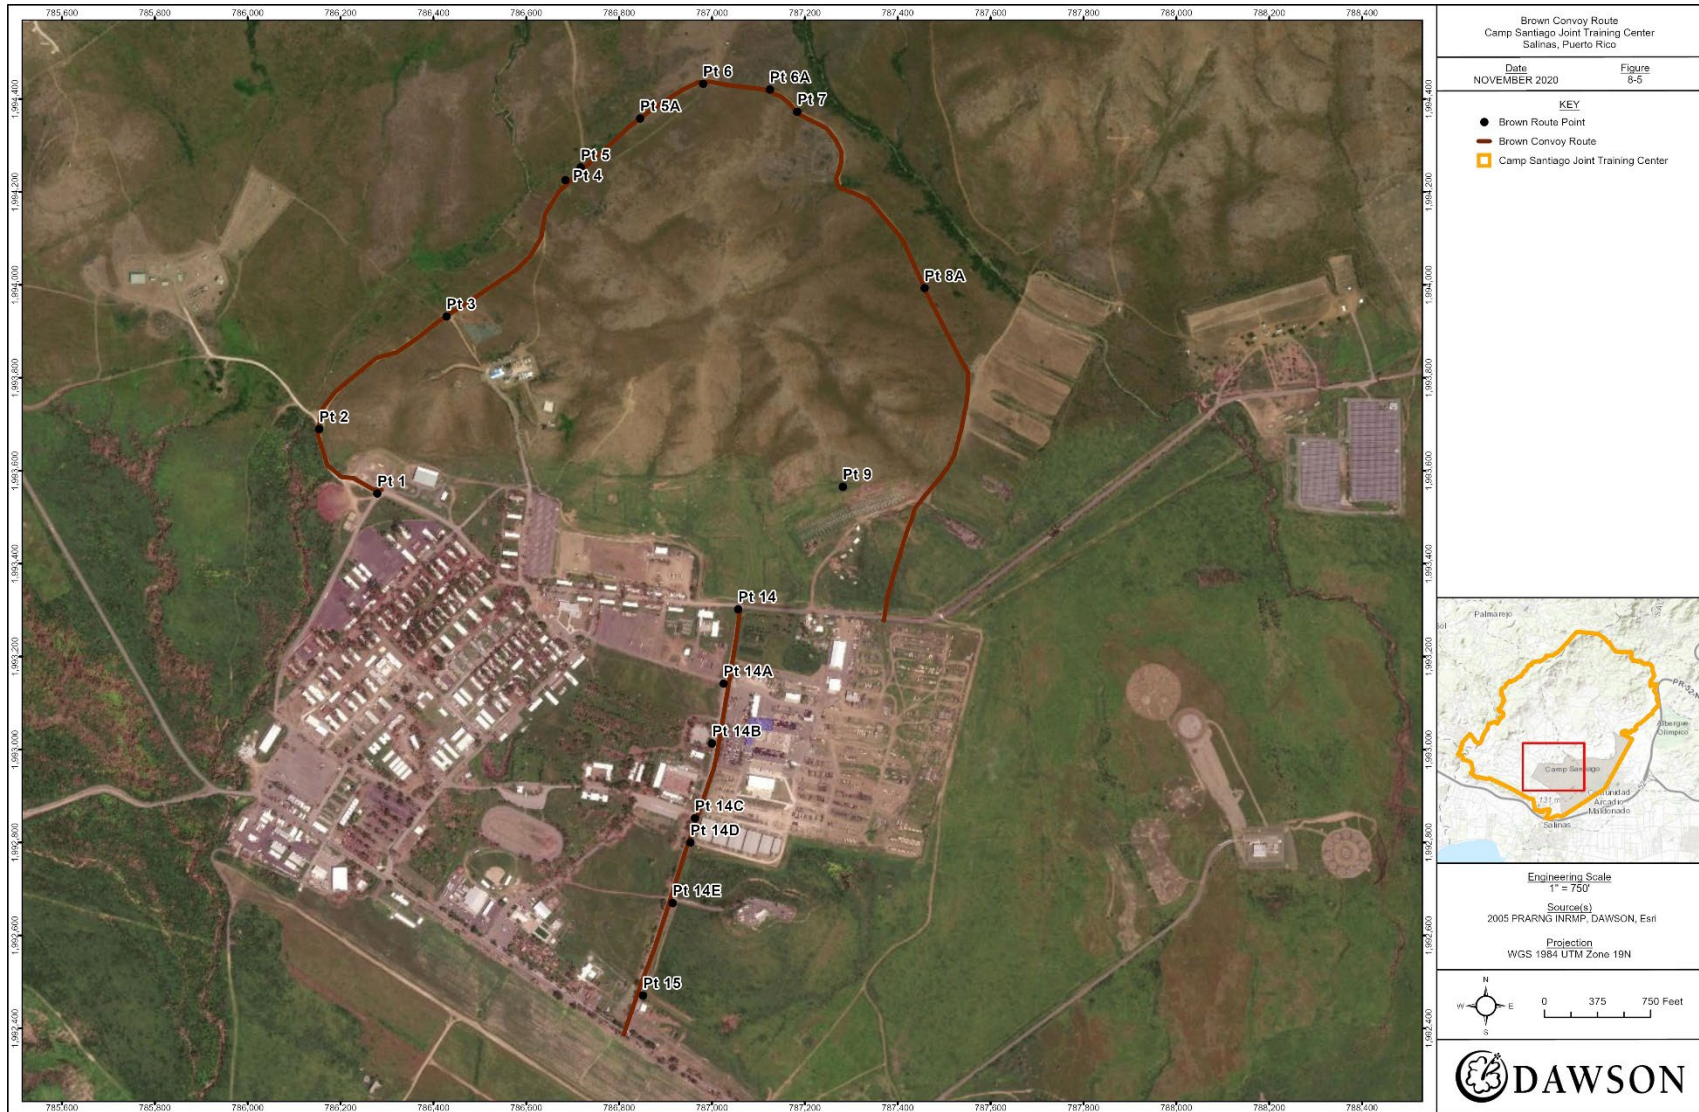
Figure 8-5. Brown Convoy Route

Brown Convoy Route Point 1A

Water shading occurring in a low laying area of the route, close to a local drainage collection channel, is causing erosion, sedimentation, and rutting and rills formation. A gully is forming at the adjacent northern hill.

- Riprap material or gravel should be placed at the junction of the two routes to prevent erosion, sedimentation and rill formation.

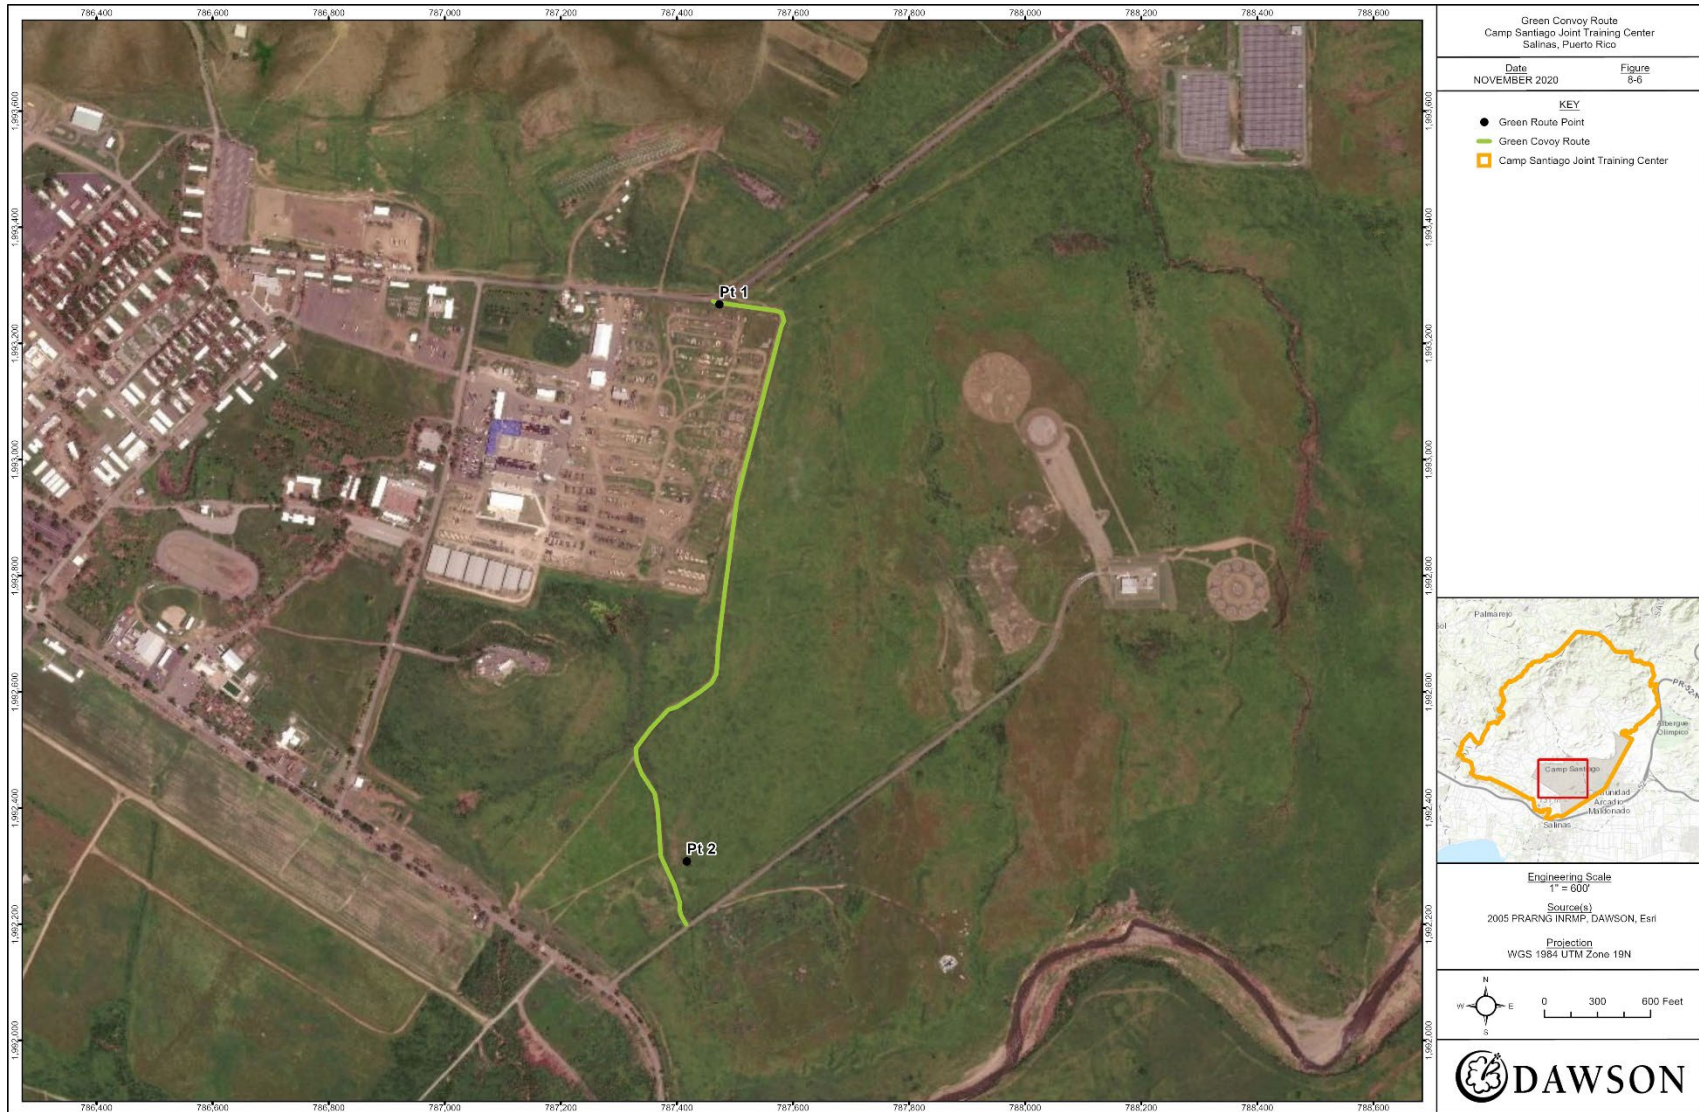
Figure 8-6. Green Convoy Route

The Green Convoy Route is approximately 0.75 miles long, starts at the Blue Convoy Route, provides access to Training Area DCA, and heads in a southerly direction to the intersection with the road to the U.S. Air Force High Frequency Global Communications System. **Figure 8-6** shows the location of the Green Convoy Route. The Green Convoy Route appears to be in disuse or abandoned.

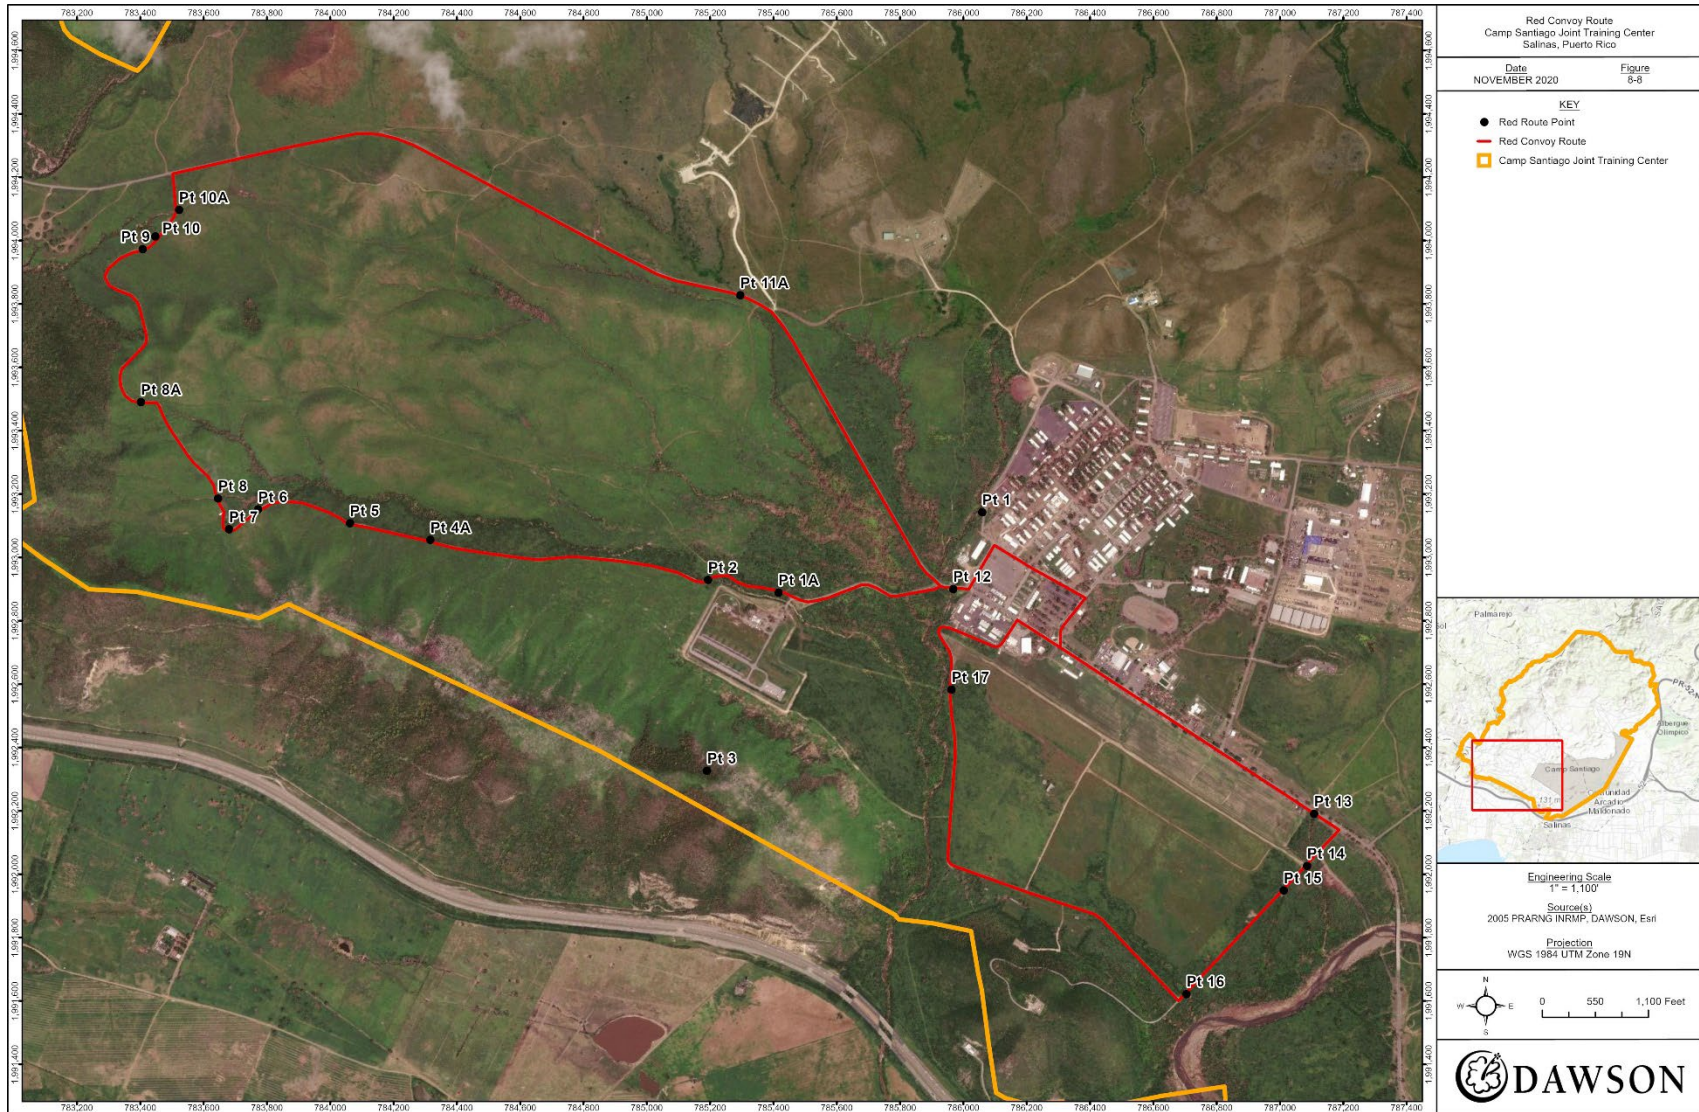
Figure 8-8. Red Convoy Route

A detailed hydrologic and hydraulic analysis and a route survey should be completed to specify the design for improvements of surface drainage, failed stream crossings, and to address sediment source problems. Headcuts may require grading, gabion installation, filling, hardening and other measures to stabilize the route. Route surface drainages should be diverted prior to stream crossings in order to protect water resources. Soil berms to the side of the road, resulting from past grading activities, should be removed and/or pulled back onto the route to fill gullies in areas where a shoulder berm exists, and where berms make the route function as a drainage ditch. The interval of surface drainage structures should depend on route grade and local drainage patterns. Both the inlet and outlet ditches of the surface drainage structures should be hardened

with riprap to prevent erosion of the route shoulder, and vegetation around drainage structures should be cut to the ground surface on a regular basis without disturbing the soils.

During field survey, the following points along the Red Convoy Route were identified as specific areas of concern, interest, or reference:

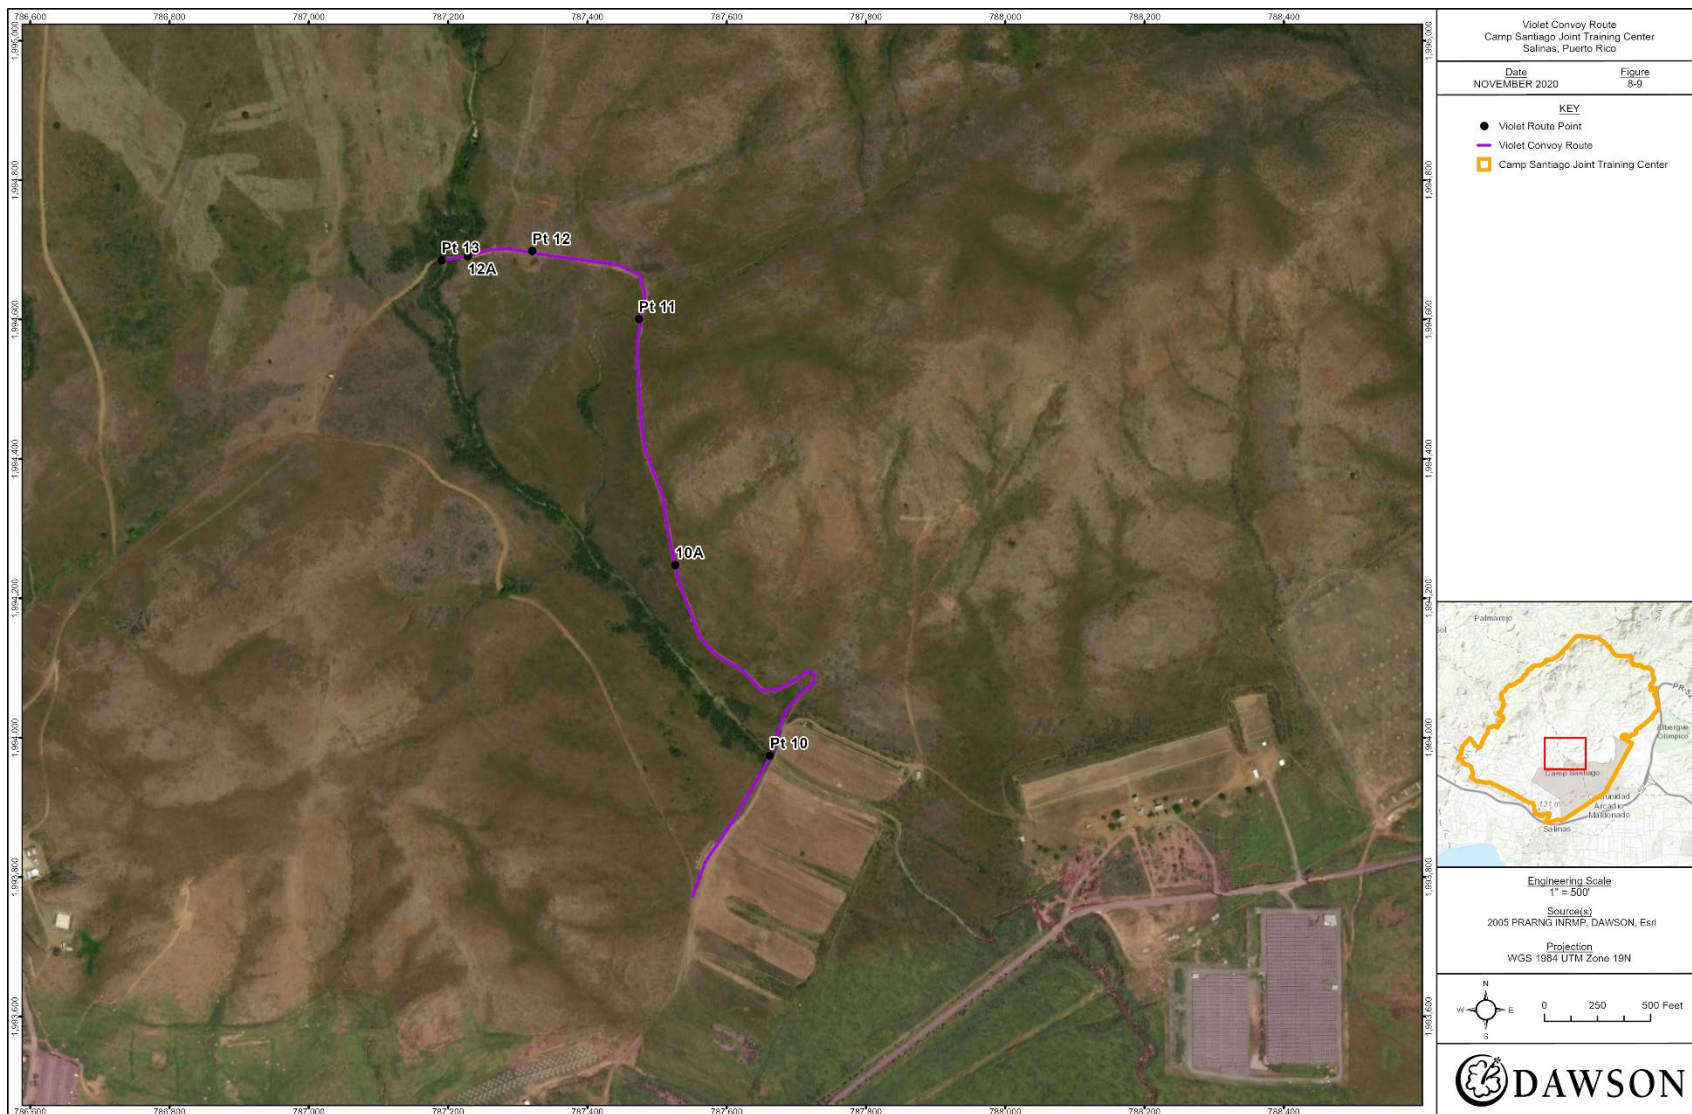
Figure 8-9. Violet Convoy Route

Violet Convoy Route Point 11

This point is a crossing consisting of a double-barrel 21-inch CMP encased in concrete. Both inlet and outlet headwalls and wingwalls are broken, creating a safety hazard. The inlet is sedimented. At both the inlet and outlet vegetation is encroaching the structures.

- The route should be graded to be outsloped. Deposit of well-graded aggregate and hardening should be performed. Riprap material should be used at focal areas.
- Local drainage features (gutters, dips, water bars, inlets, and outlets) should be built to keep surface flows off the route and from draining through it, thus avoiding erosion.
