20th-Century Building Materials and Suitable Substitutes: Exterior Materials (Legacy 15-707)

Tech Note: 15-707

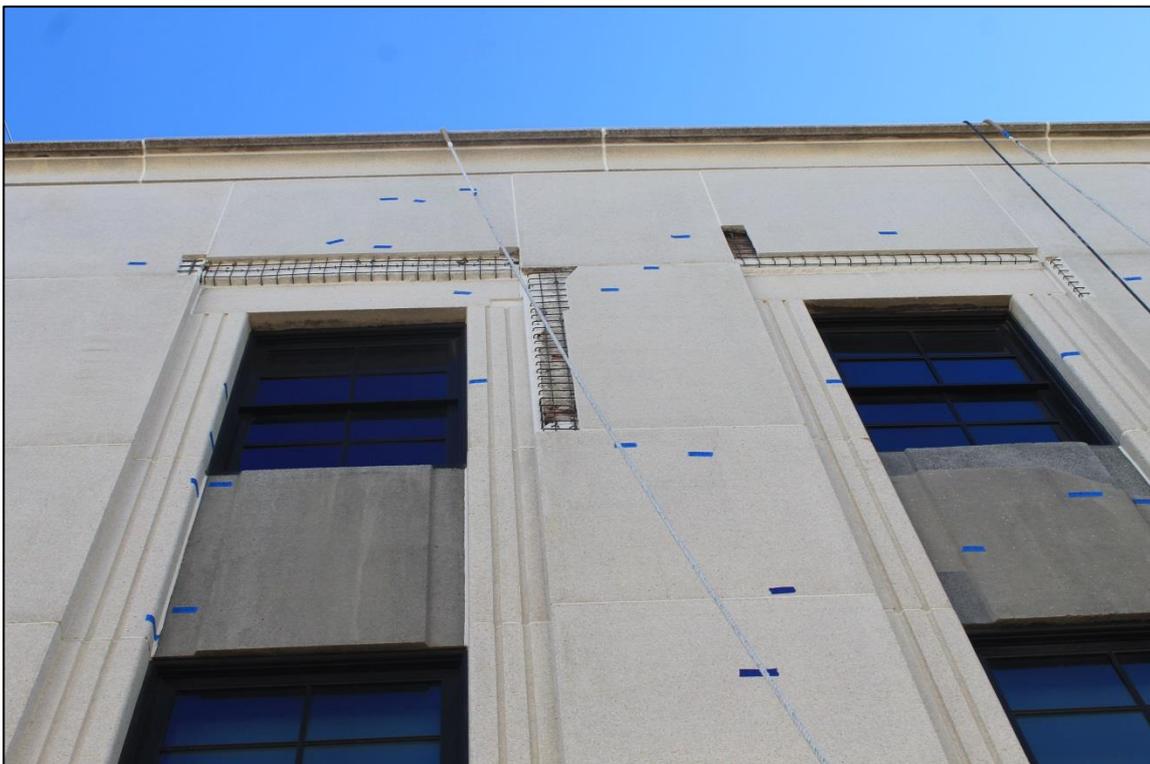
Concrete panels are a character-defining feature of this building at NSA Bethesda, Maryland.

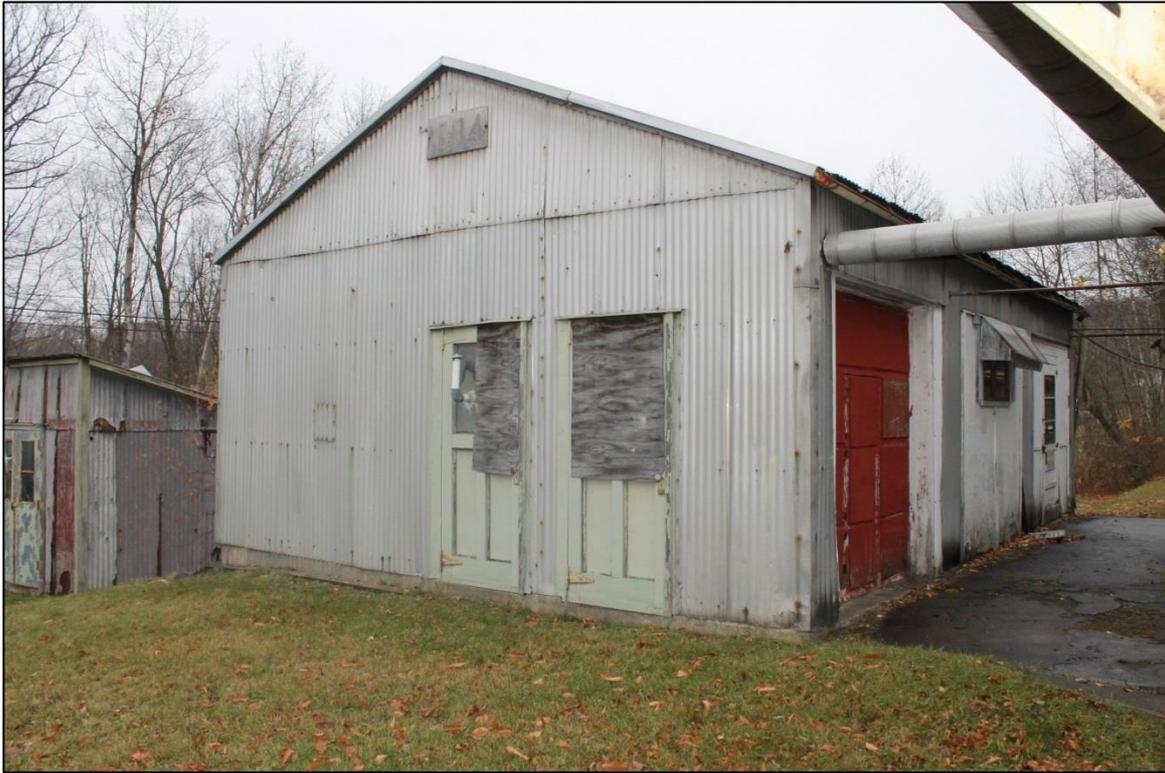
Corrugated metal is a character-defining feature of this building at Picatinny Arsenal, New Jersey.

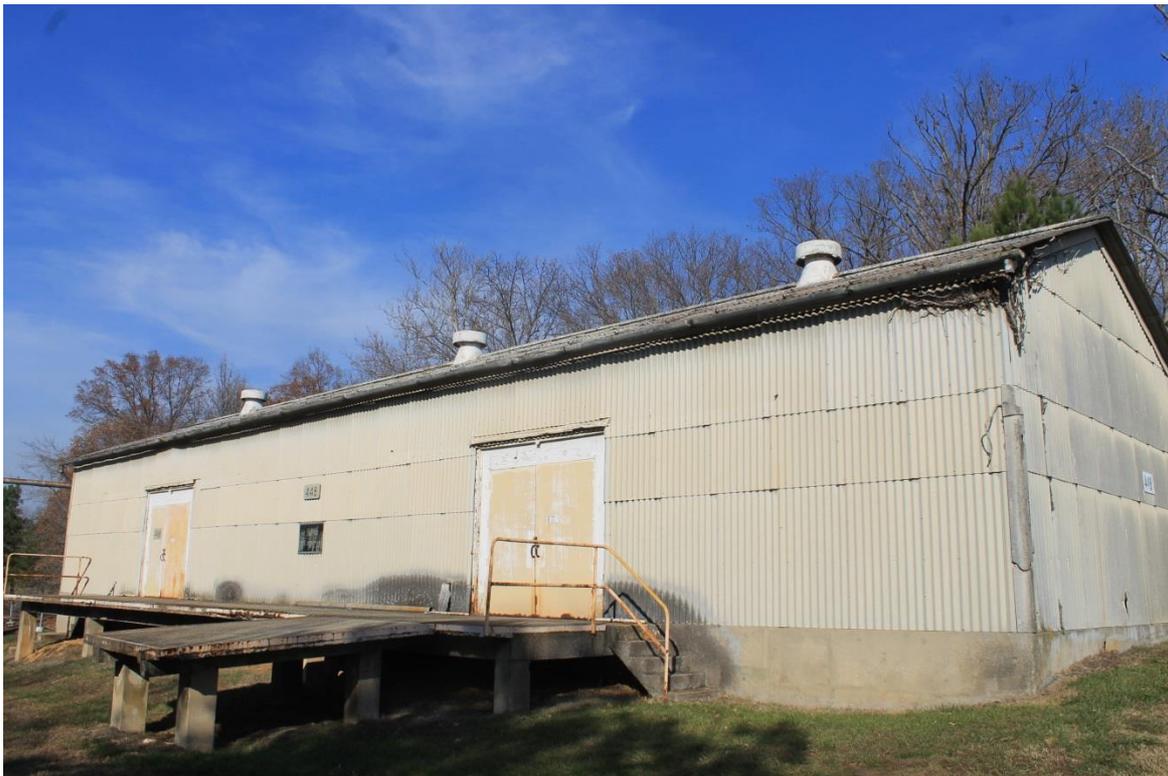
The corrugated asbestos-cement panels are a character-defining feature of this building at NSF Indian Head, Maryland.
