**Backup Data for
A Case Study of the Adaptive Rehabilitation
of
Buildings 705 and 706
Norfolk Naval Shipyard**

Norfolk Naval Shipyard

**United States Navy
NAVFAC MIDLANT
N40085-10-D-9426**

**DUTTON + ASSOCIATES, LLC
812 Moorefield Park Drive, Suite 126
Richmond, Virginia 23236**

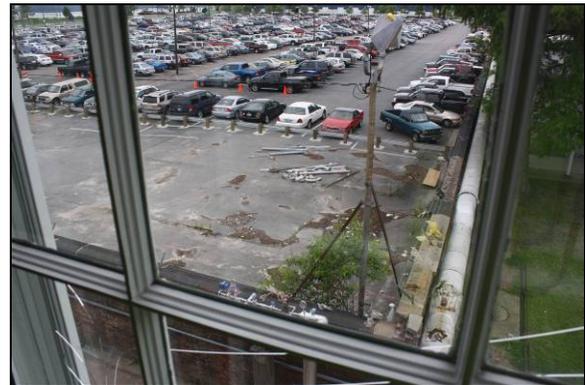
*Abandoned portion of parking lot and
Portsmouth Avenue*

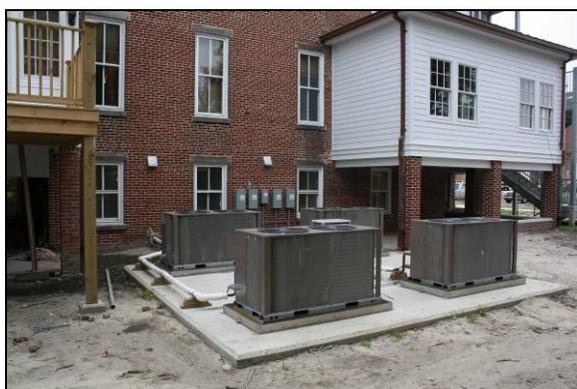
New HVAC equipment

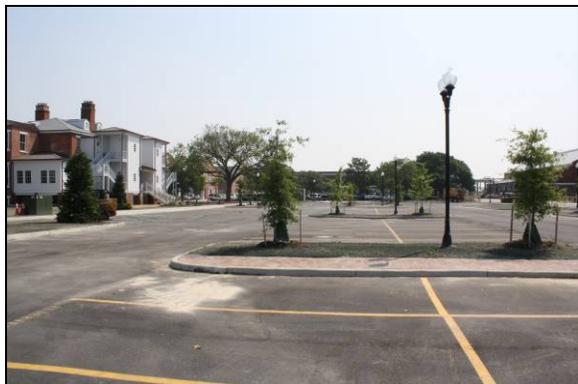
New Parking lot to the rear of the buildings

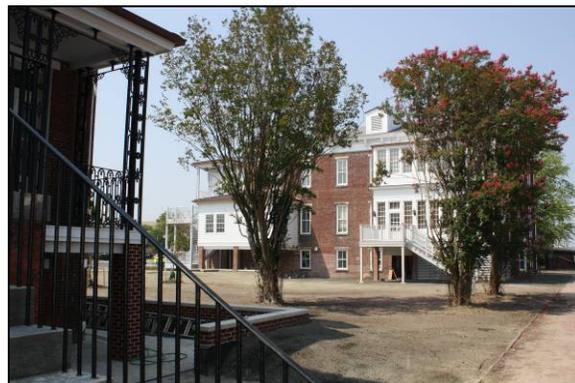
Appropriate landscaping at the project site

All of the existing landscaping was removed at the outset of the project. The majority of vegetation was overgrown and causing problems to the buildings themselves and would not meet ATRP requirements. Most of the brick walkways and trench drains had settled unevenly and were trip-hazards in addition to preventing access to existing and proposed underground utilities. Following grading, utility installation, and other site work, new walkways were installed using salvaged bricks and appropriate vegetation was planted. The trench drains were not reinstalled because they were no longer necessary with proper grading.

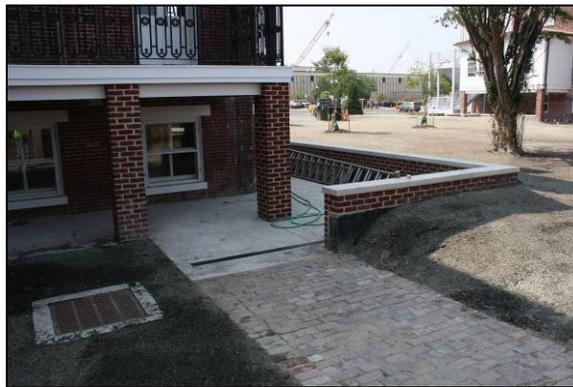
The front porches on both buildings did require reinforcement however. The historic cast iron columns supporting these porches were determined to be too deteriorated to support the increased load from the project and were not designed for lateral forces. These columns therefore were removed and replaced with masonry columns that were properly bolted to both the foundation and porch above. The wrought iron railings and posts supporting the roof over the porches on Building 705 were also determined to be unstable and had to be replaced. It was determined that the intricate ironwork posts and railings alone were not capable of supporting the roof system so the

New masonry piers under porches

replacement posts were reinforced by the addition of hidden solid steel posts.

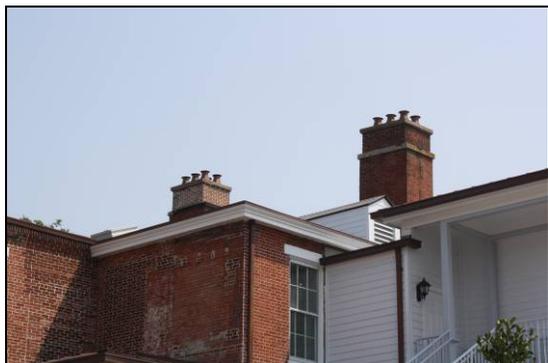
Section of cleaned brick where previous addition was removed

Portions of the exterior brick walls, particularly those on the raised basement level and those that had been encapsulated within rear additions had been painted and required cleaning to restore the original exposed brick. Various methods including scraping, chemical, and blasting were used depending on the tenacity of the paint. Sections of wall that had not been painted were only cleaned. Tuck pointing was only done on damaged sections of mortar and was done using similar color and tooling as the original sections.

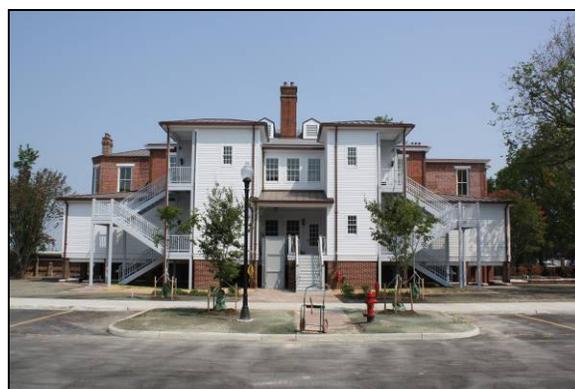
New addition to the rear of Building 705

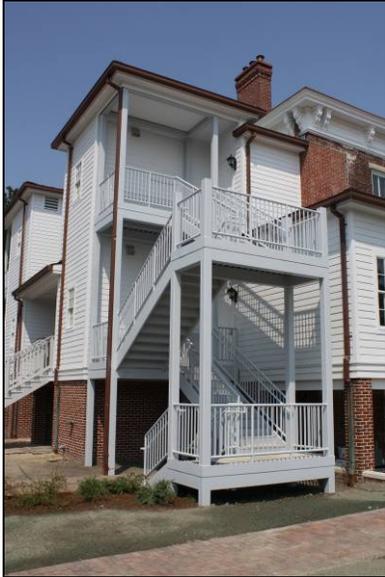
New exterior fire egress stairway

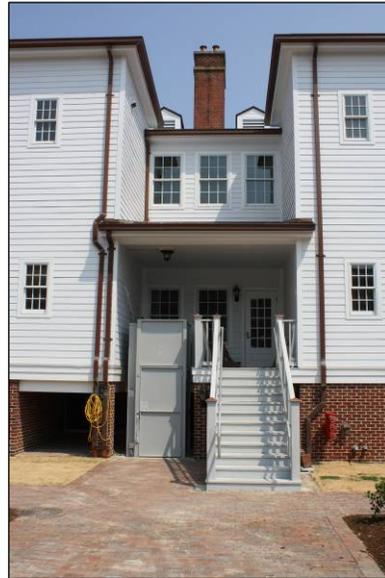
To meet ADA requirements, handicapped accesses had to be incorporated and were integrated into the rear additions. Because of the historic nature of the building and the

Wheelchair lift on rear deck

interior layout, it was determined that providing access only to the primary floor was required which meant exterior lifts as opposed to full elevators could be used.

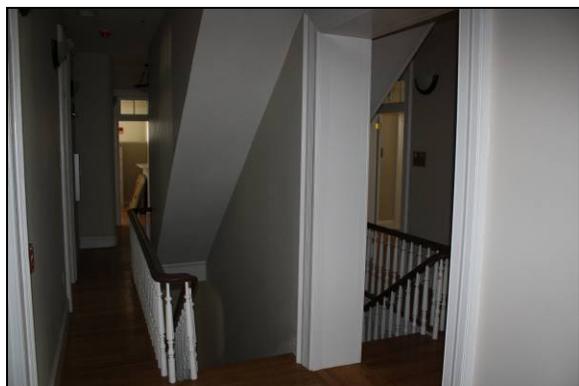
Very few changes were made to the floor plans of the original buildings. The largest modification to the layouts was the breaching of the central walls in one place on each floor of both buildings to convert the former duplexes into single spaces. In Building 705, the wall breaches were placed within closets that were also opened to create a central break room area on each floor, while in Building 706, the breaches are simply openings cut between the hallways in each side of the building.

Breach between two sides of Building 706

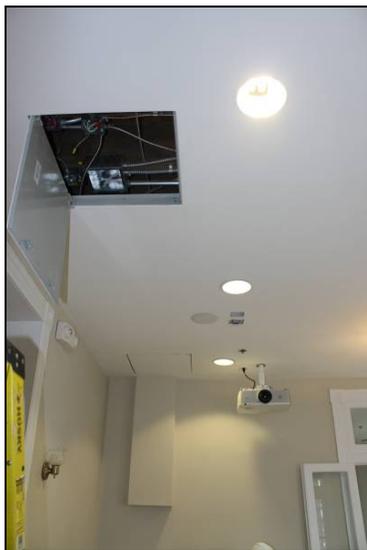
The lowered ceilings permitted the installation of electrical wiring and HVAC ductwork, as well as audio-visual equipment. Small hatches had to be provided in the ceiling of each room to permit access to the systems and utilities above; however these doors were designed to be flush with the ceiling and blend in. The decorative plaster medallions in formal rooms of Building 706 were safely removed from the original ceilings and reinstalled on the new drywall ceilings.

Access hatch in lowered ceiling

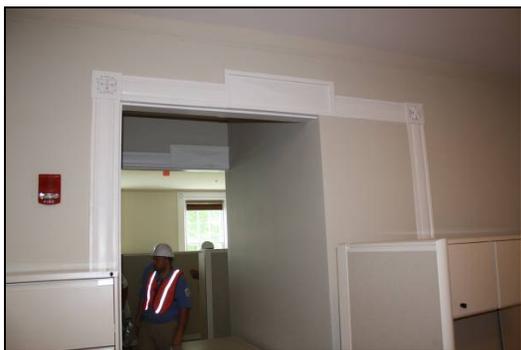
While most doors were off their hinges in both buildings at the time of initial inspection, many were able to be reinstalled. Missing and damaged doors were replaced with reproductions that match the originals in construction and appearance. Every historic door and doorway was accounted for and retained in the final design because of good design. Most are still operable; only a few had to be tied-back to allow for furniture. Most large openings were also retained, less one on the first floor of Building 705 which had to be partially infilled.

Partially infilled opening in Building 705

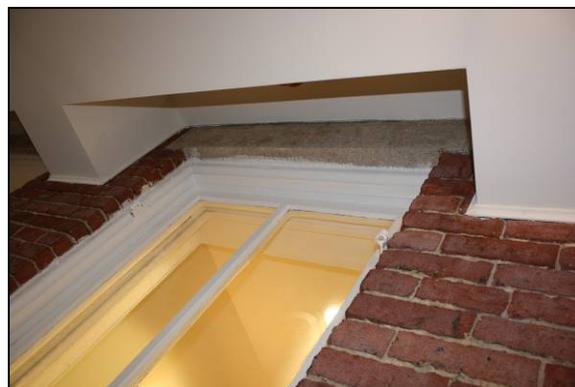
The majority of original windows were also retained and all were made operable to ensure better ventilation and pleasant conditions. In some cases, pockets had to be used on the dropped ceilings to allow for the windows and their surrounds to remain intact and full-height.

Window pocket to allow original lintel to show

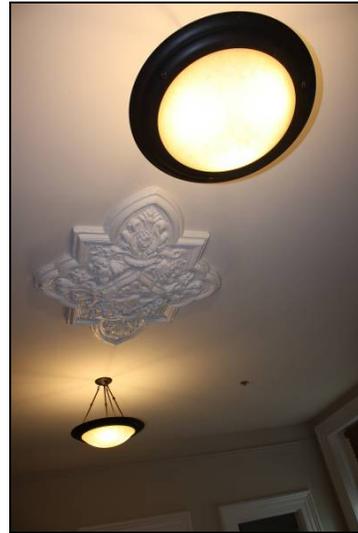
Crown moldings which were present only in Building 706 were lost due to the lowering of ceilings. Despite the historic plaster ceilings being lost, plaster medallions were removed and repaired, and then reinstalled on the drywall replacement ceilings. All fireplaces and mantels were also retained and preserved, although none are operable.

Original medallions reinstalled on drywall ceiling

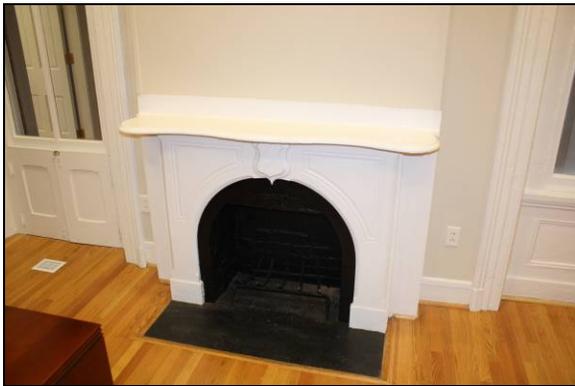
Original fireplace and mantel retained

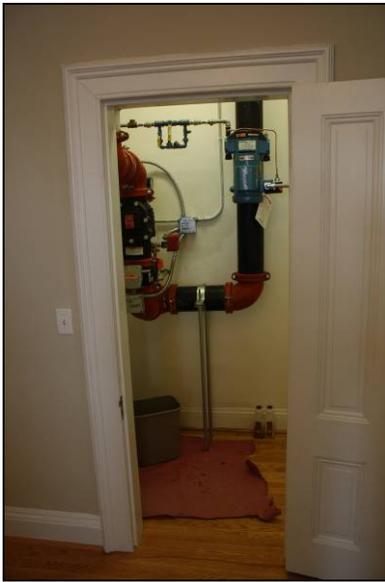
A new fire alarm and fire suppression system was installed throughout both buildings. Sprinkler heads were placed in every room and all piping was concealed in ceiling cavities and within closets. A new pump had to be installed for the system due to tests at the nearby hydrant revealing insufficient pressure.

Sprinkler pump hidden in closet

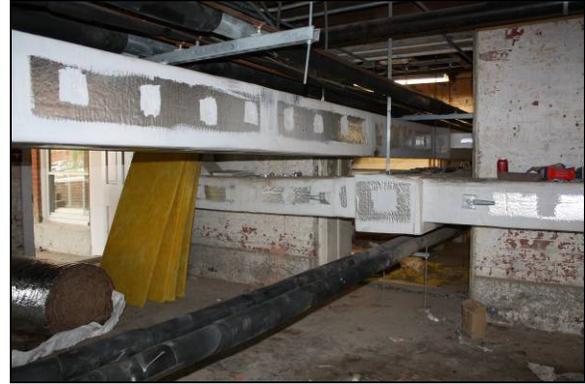
Ducts were run through closets, ceilings, and other concealed areas to screen them from visibility. Major system components were

Ductwork and piping installed in basement

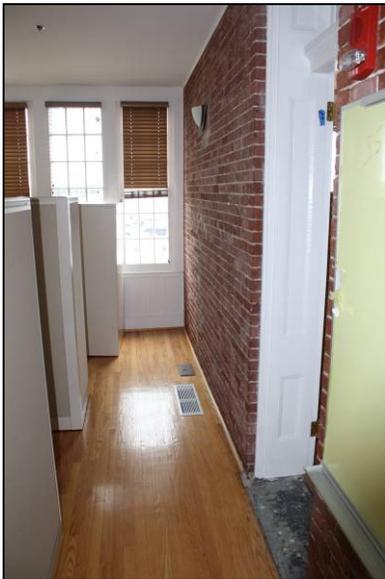
The building feeds were tied into the existing shipyard power supply through their basements. New wiring was then strung throughout the wall and ceiling cavities, causing as little damage as possible to the historic walls. A flexible approach was used for outlets allowing both floor- and wall-mounted boxes to decrease the need for cutting the historic plaster or brick. Brick channeling was avoided wherever possible, instead relocating switch boxes to adjacent wood frame walls.

Floor-mounted register and outlet box

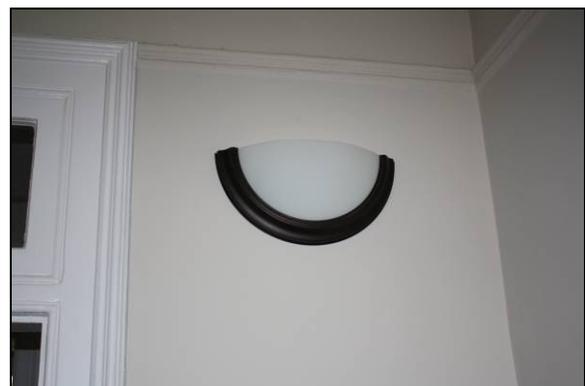
New light fixtures were installed throughout the buildings to provide adequate illumination for the tenants. Most of the historic lighting could not be reused due to code, so appropriate style replacements were found. Chandeliers were hung from the ceilings in larger rooms while wall-mounted pendant lights were installed throughout smaller spaces and hallways. Historic sconces found throughout the buildings prior to the renovations were replaced with similar, non-functional units.

New pendant style light fixture

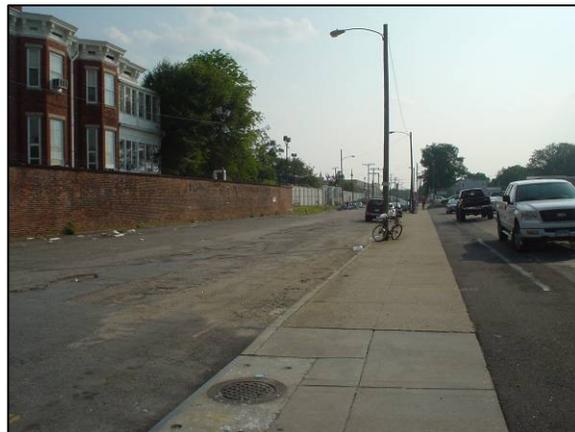
unsecured parking outside of the brick wall (shipyard boundary). This issue was caused by the density of the shipyard's layout and the fact these buildings are located immediately adjacent to the base

perimeter. Many of the parking spaces had to be abandoned and blocked off, which meant additional secured parking had to be constructed as part of the project.

*Proximity of Portsmouth Avenue and
Parking lot to the project site*
