DoD Ergonomics Working Group NEWS

Issue 110, October 2010

Sierra Army Depot Palletized Loading System Ergonomic Safety Improvement Part 2: The Ladder

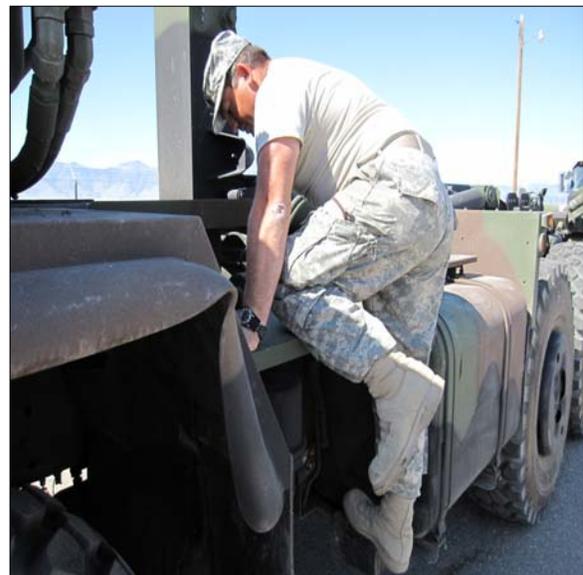
A 423rd team member demonstrates the old method of climbing up on PLS to conduct service checks. Note the pressure on shins from contact with angled platform, the right foot on the crossover valve mount, and no handle grabs.

To access the service platform, maintenance personnel had to step on the fuel system crossover valve. This is a dicey process because the valve is not designed to be climbed on. The employee's foot could slide off this small, no step area, causing a fall. Mechanics would also sometimes kick the fuel bowl when climbing up which, if broken, could cause an environmental spill of up to 75 gallons of fuel. After conducting a job hazard analysis (JHA), the teams mitigated the hazard by designing a simple but effective ergonomic ladder modification.

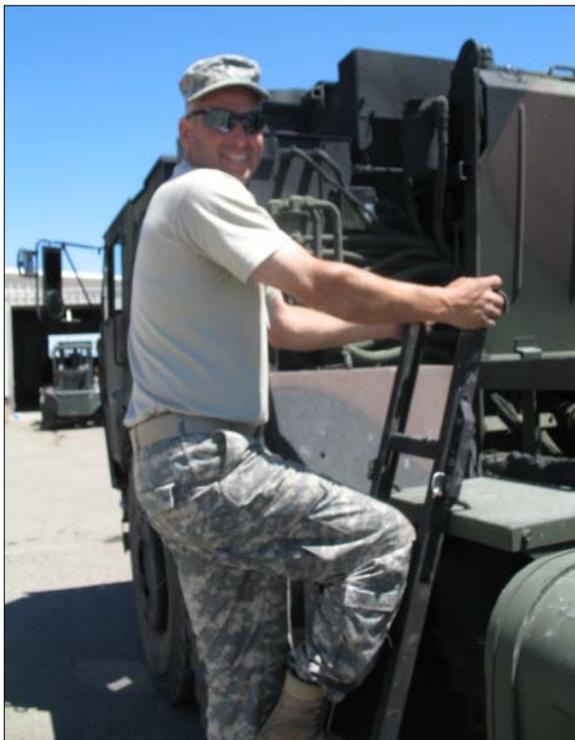
A 423rd soldier demonstrates the existing PLS ladder that was modified to access the rear service platform. This new modification will help prevent climbing, falling, and ergonomic injuries on the PLS.

After conducting the JHA, the teams came up with a low-cost (less than \$10 for material) engineering control. A simple, but effective ladder modification was the answer to mitigate the hazard. The teams designed and added two more hooks and drilled two holes so the existing ladder could be used in another area.
